View Acres Elementary School

Clac_sch23A

FEMA 154 Rapid Visual Screening Score Card

Rapid Visual Screening - Senate Bill #2 - Seismic Needs Assessment
Oregon Department of Geology and Mineral Industries

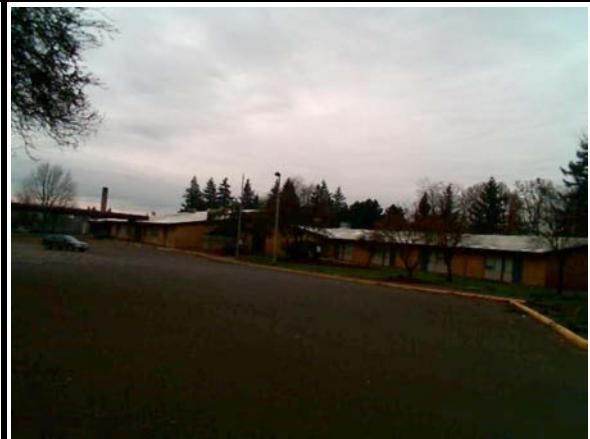
Building Type	County	
School	Clackamas	
Street		
4828 SE View Acres Rd		
City	State	Zip
Milwaukie	OR	97267
Latitude	Longitude	
45.41743	122.61311	
Tracking Code	Inspection Date	
Already Retrofitted	12/20/2006

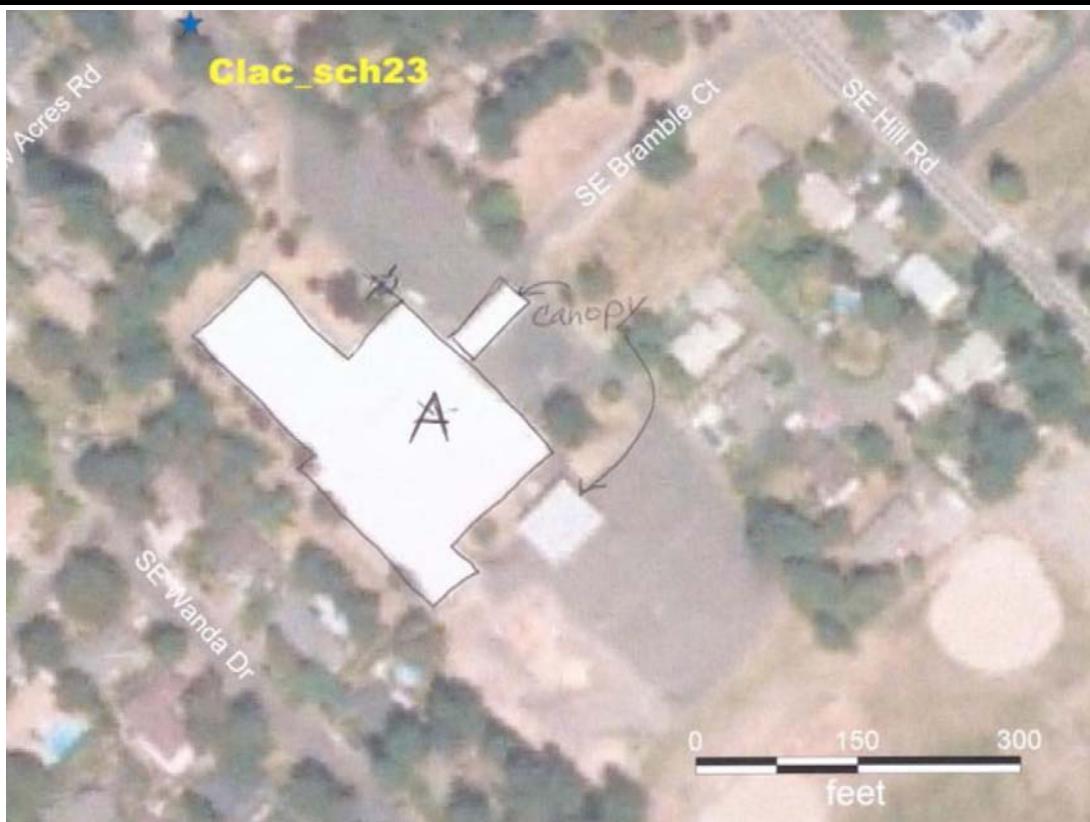
Enrollment	Year Built (Field Verified)	Year Built (Alt. Source)	Est. Decade Built
469	1964	1964	1960
Total Area (square ft)	Number of Stories	Basement	Pounding Potential
54459	1	Yes	No
Plan Irregularities		Vertical Irregularities	
Reentrant Corners: Other		Steps in Elevation View: 2 to 3 Changes	
None		Building On Hill or Sloped Site	
None		None	
Falling Hazards		Poor Conditions	
Unreinforced Chimneys		None	
Other: Ornamental Hazard Over Exit		None	
None		None	
NE Elevation View	NE Vertical Irregularity Primary	NE Falling Hazard	
E Primary Structural Type	E Falling Hazard	E Primary Structural Type	
SE Vertical Irregularity Secondary	SE Falling Hazard	SW Elevation View

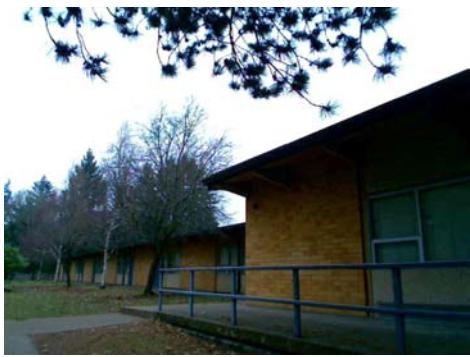
SW Plan Irregularity Primary
