Jennings Lodge Elementary School

Clac_sch45A

FEMA 154 Rapid Visual Screening Score Card

Rapid Visual Screening - Senate Bill #2 - Seismic Needs Assessment
Oregon Department of Geology and Mineral Industries

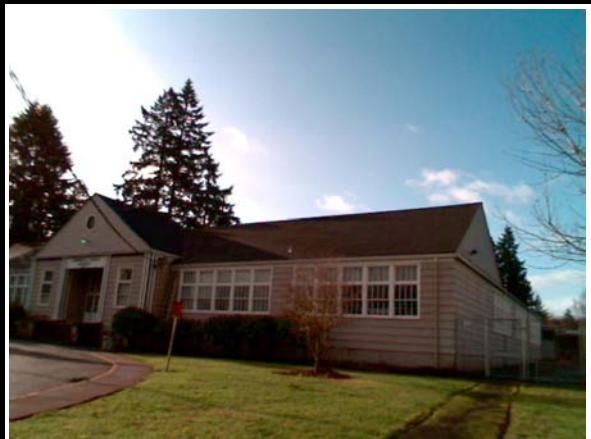
Building Type	County
School	Clackamas
Street	
18521 Se River Rd	
City	State Zip
Milwaukie	OR 97267
Latitude	Longitude
45.38847	122.61574
Tracking Code	Inspection Date
RVS in 2006	12/27/2006

Seismicity Zone: High

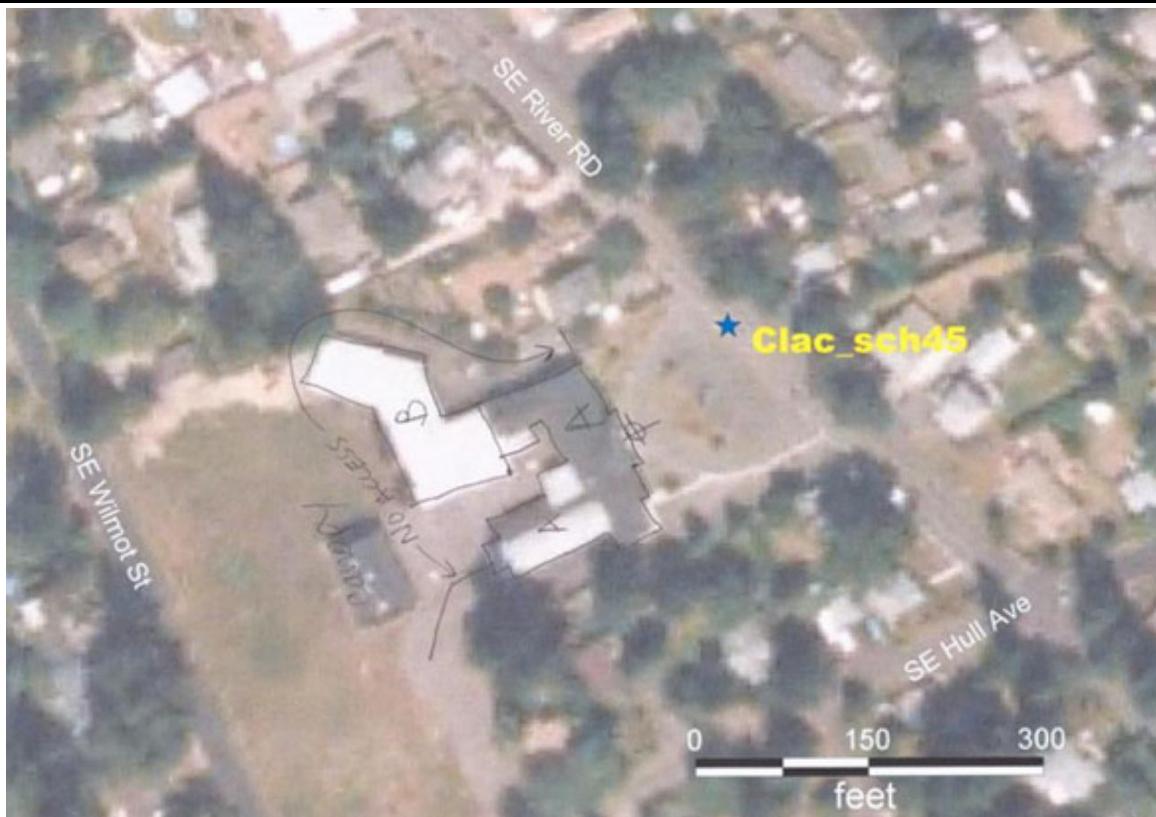
Enrollment 293	Year Built (Field Verified) 1938	Year Built (Alt. Source) 1938	Est. Decade Built 1930
Total Area (square ft) 32030	Number of Stories 1	Basement	Pounding Potential No
Plan Irregularities		Vertical Irregularities	
Reentrant Corners: Other		Steps in Elevation View: 2 to 3 Changes	
Reentrant Corners: Other (Adjacent Build/Entity)		Steps in Elevation View: Single Change (Adjacent Building/Entity)	
None		None	
Falling Hazards		Poor Conditions	
None		None	
None		None	
None		None

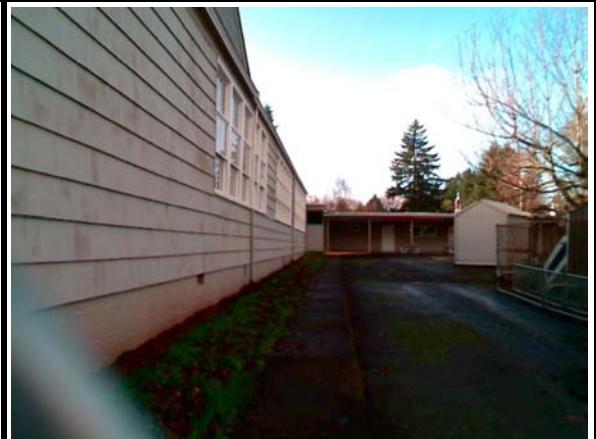
Building Type	County
School	Clackamas
Street	
18521 Se River Rd	
City	State Zip
Milwaukie	OR 97267
Latitude	Longitude
45.38865	122.61634
Tracking Code	Inspection Date
RVS in 2006	12/27/2006

Enrollment 293	Year Built (Field Verified) 1938	Year Built (Alt. Source) 1938	Est. Decade Built 1950
Total Area (square ft) 32030	Number of Stories 1	Basement	Pounding Potential No
Plan Irregularities Reentrant Corners: L Shaped Reentrant Corners: Other (Adjacent Build/Entity) None		Vertical Irregularities Steps in Elevation View: Single Change (Adjacent Building/Entity) None None	
Falling Hazards None None None		Poor Conditions None None None
