John McLoughlin Elementary School

Clac_sch91A

FEMA 154 Rapid Visual Screening Score Card

Rapid Visual Screening - Senate Bill #2 - Seismic Needs Assessment
Oregon Department of Geology and Mineral Industries

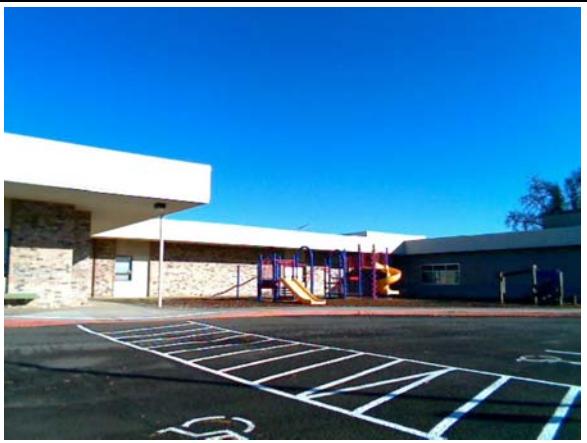
Building Type	County
School	Clackamas
Street	
19230 S End Rd	
City	State Zip
Oregon City	OR 97045
Latitude	Longitude
45.32796	122.62908
Tracking Code	Inspection Date
RVS in 2006	12/28/2006

Seismicity Zone: High

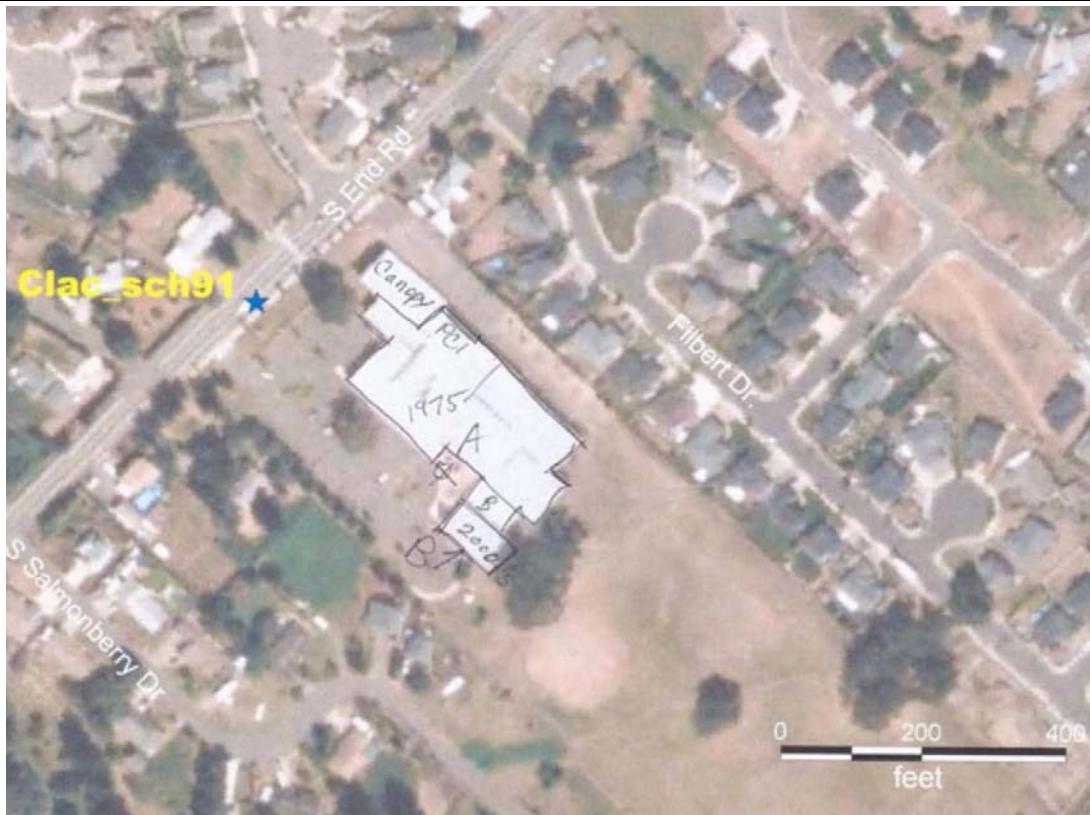
Type	Basic Score	Vert Irreg	Plan Irreg	Pre-Code	Post-Bench	Soil C	Soil D	Soil E	RVS Score
Primary	RM1	2.8	-1	-0.5	0	0	-0.4	0	0	0.9
Secondary	W2	3.8	-2	-0.5	0	0	-0.4	0	0	0.9
Tertiary	PC1	2.6	0	-0.5	0	0	-0.4	0	0	1.7

Final Type	Final Score
RM1	0.9

High (>10%)

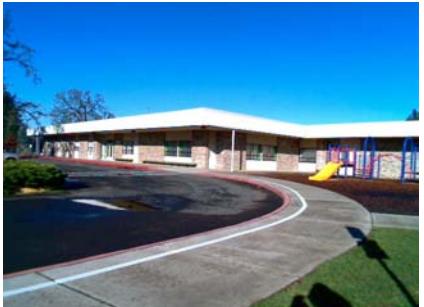
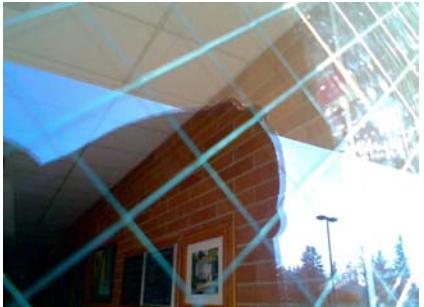
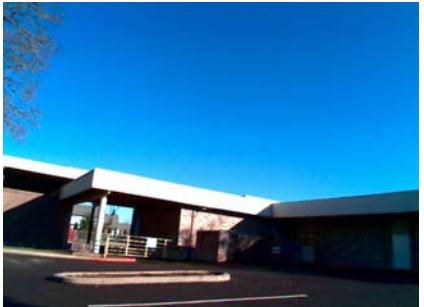
Enrollment 572	Year Built (Field Verified) 1976	Year Built (Alt. Source) 1975	Est. Decade Built 1970
Total Area (square ft) 57780	Number of Stories 1	Basement	Pounding Potential No
Plan Irregularities		Vertical Irregularities	
Reentrant Corners: Other		Steps in Elevation View: Single Change	
Reentrant Corners: Other (Adjacent Build/Entity)		None	
None		None	
Falling Hazards		Poor Conditions	
Other: Brick Veneer		None	
Other: Heavy cornice or other overhead decoration		None	
None		None

SE Plan Irregularity Primary	S Primary Structural Type 1976	SW Plan Irregularity Primary

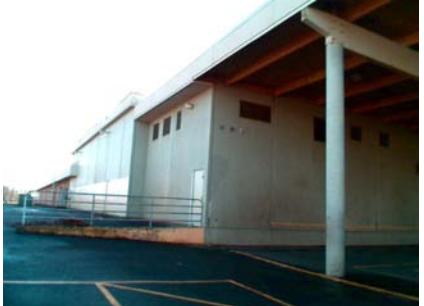
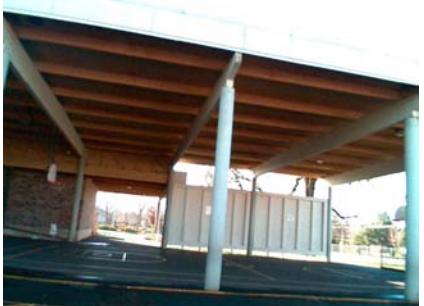
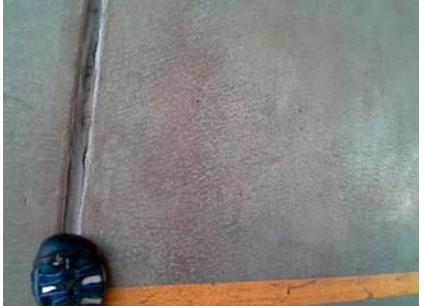
NW Tertiary Structural Type	NW Falling Hazard	W Tertiary Structural Type caulked vert jts

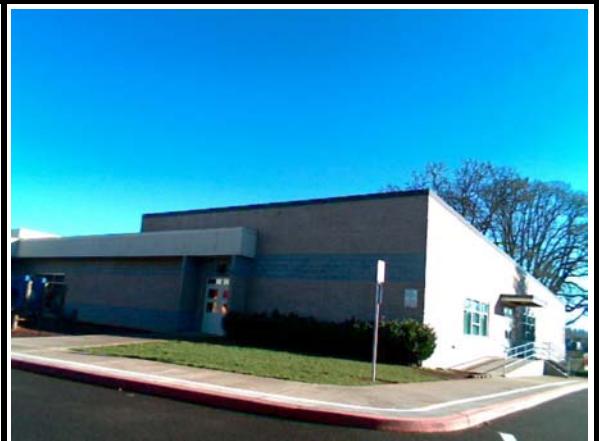
Building Type	County	
School	Clackamas	
Street		
19230 S End Rd		
City	State	Zip
Oregon City	OR	97045
Latitude	Longitude	
45.3274	122.62897	
Tracking Code	Inspection Date	
RVS in 2006	12/28/2006

Seismicity Zone: High

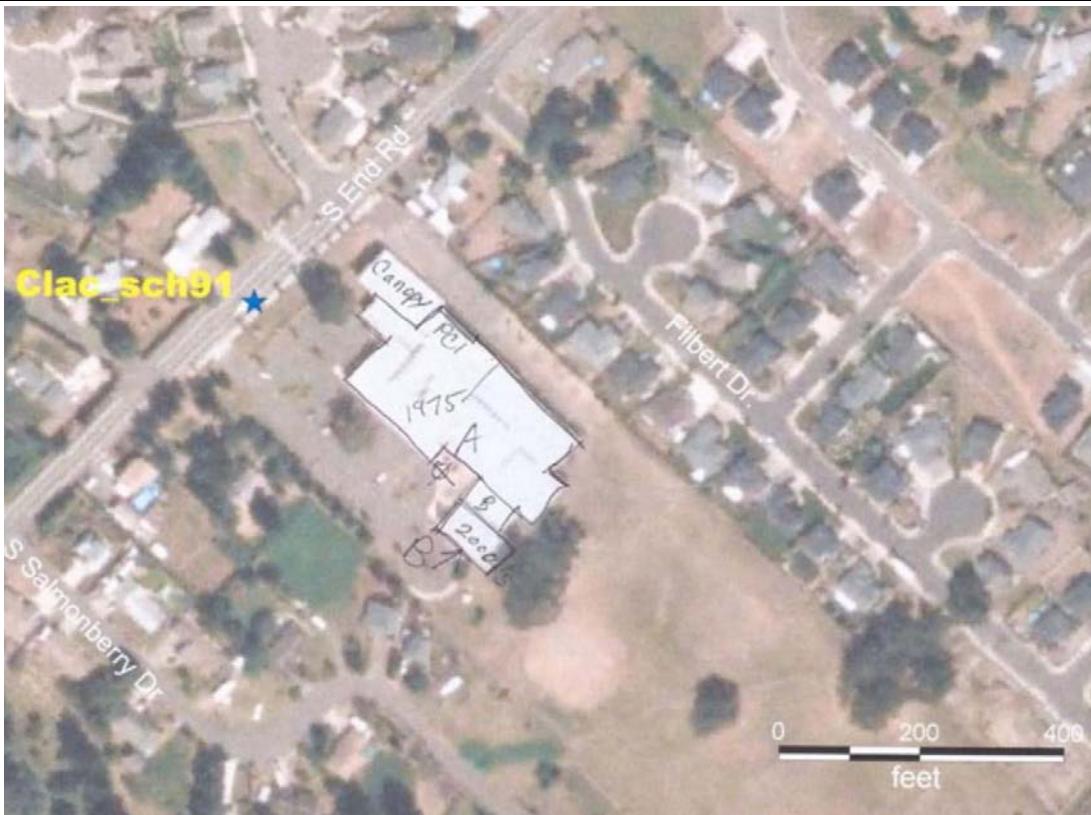
Type	Basic Score	Vert Irreg	Plan Irreg	Pre-Code	Post-Bench	Soil C	Soil D	Soil E	RVS Score
Primary	RM1	2.8	-1	-0.5	0	2.8	-0.4	0	0	3.7
Secondary		0	0	0	0	0	0	0	0	0
Tertiary		0	0	0	0	0	0	0	0	0

Final Type	Final Score
RM1	3.7

Low (<1%)

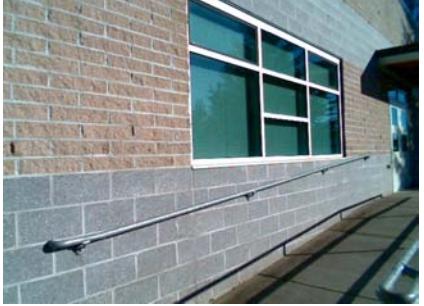
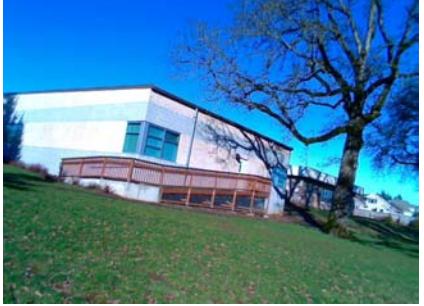
Enrollment 572	Year Built (Field Verified) 1975	Year Built (Alt. Source) 1975	Est. Decade Built 2000
Total Area (square ft) 57780	Number of Stories 1	Basement	Pounding Potential No
Plan Irregularities Reentrant Corners:Other (Adjacent Build/Entity) None None		Vertical Irregularities Steps in Elevation View: Single Change None None	
Falling Hazards None None None		Poor Conditions None None None

S Primary Structural Type		SE Plan Irregularity Primary
