# Elsie-Vinemaple RFPD #11

Clat\_fir03A

## FEMA 154 Rapid Visual Screening Score Card

Rapid Visual Screening - Senate Bill #2 - Seismic Needs Assessment  
Oregon Department of Geology and Mineral Industries

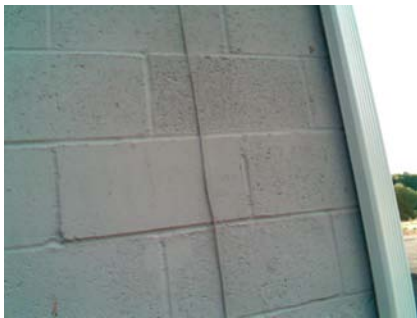
SW Primary Structural Type

| | Type | Basic Score | Vert Irreg | Plan Irreg | Pre-Code | Post-Bench | Soil C | Soil D | Soil E | RVS Score |
|---|---|---|---|---|---|---|---|---|---|---|
| Primary | RM1 | 2.8 | -1 | -0.5 | 0 | 0 | -0.4 | 0 | 0 | 0.9 |

| Torsion: Eccentric Stiffness | Soft Story |

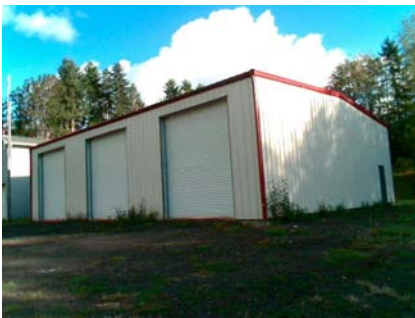
NW Elevation View

| | Type | Basic Score | Vert Irreg | Plan Irreg | Pre-Code | Post-Bench | Soil C | Soil D | Soil E | RVS Score |
|---|---|---|---|---|---|---|---|---|---|---|
| Primary | S3 | 3.2 | 0 | 0 | 0 | 0 | -0.4 | 0 | 0 | 2.8 |
