# Jewell School

Clat\_sch15A

## FEMA 154 Rapid Visual Screening Score Card

Rapid Visual Screening - Senate Bill #2 - Seismic Needs Assessment  
Oregon Department of Geology and Mineral Industries

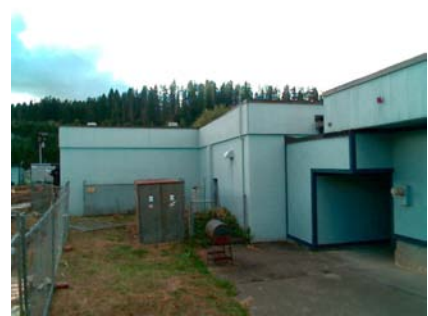
E Plan Irregularity Secondary

Plan Irregularities	Vertical Irregularities
Reentrant Corners: Other (Adjacent Build/Entity)	Steps in Elevation View: 2 to 3 Changes
Reentrant Corners: Other	Steps in Elevation View: 2 to 3 Changes (Adjacent Building/Entity)
None	None

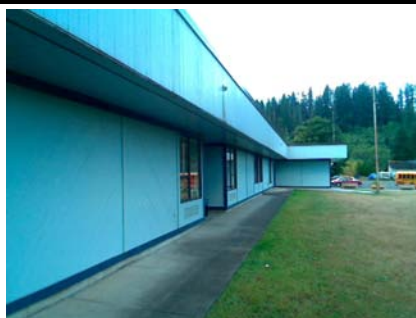
NE Plan Irregularity Primary

Plan Irregularities	Vertical Irregularities
Reentrant Corners: Other	Steps in Elevation View: 2 to 3 Changes
Reentrant Corners: Other (Adjacent Build/Entity)	Steps in Elevation View: 2 to 3 Changes (Adjacent Building/Entity)
None	None
