Col R F&R Fire Station - Columbia City

Colu_fir04A

Rapid Visual Screening - Senate Bill #2 - Seismic Needs Assessment
Oregon Department of Geology and Mineral Industries

Colu_fir04B

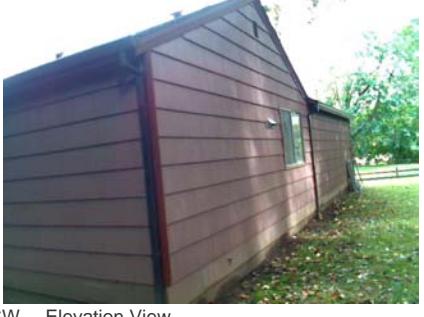
E	Building Name	SW	Elevation View

Enrollment	Year Built (Field Verified)	Year Built (Alt. Source)	Est. Decade Built
			1970
Total Area (square ft)	Number of Stories	Basement	Pounding Potential
	1	No	No
Plan Irregularities		Vertical Irregularities	
Reentrant Corners: L Shaped		None	
None		None	
None		None	
Falling Hazards		Poor Conditions	
None		None	
None		None	
None		None

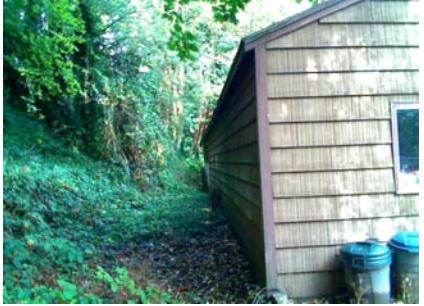
SW Elevation View

Enrollment	Year Built (Field Verified)	Year Built (Alt. Source)	Est. Decade Built
			1970
Total Area (square ft)	Number of Stories	Basement	Pounding Potential
	1	No	No
Plan Irregularities		Vertical Irregularities	
Torsion: Building Shape		None	
None		None	
None		None	
Falling Hazards		Poor Conditions	
None		None	
None		None	
None		None
