Coquille Fire

Coos_fir20A

FEMA 154 Rapid Visual Screening Score Card

Rapid Visual Screening - Senate Bill #2 - Seismic Needs Assessment
Oregon Department of Geology and Mineral Industries

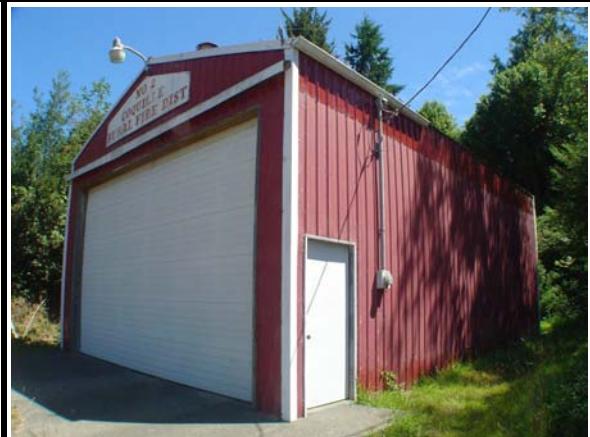
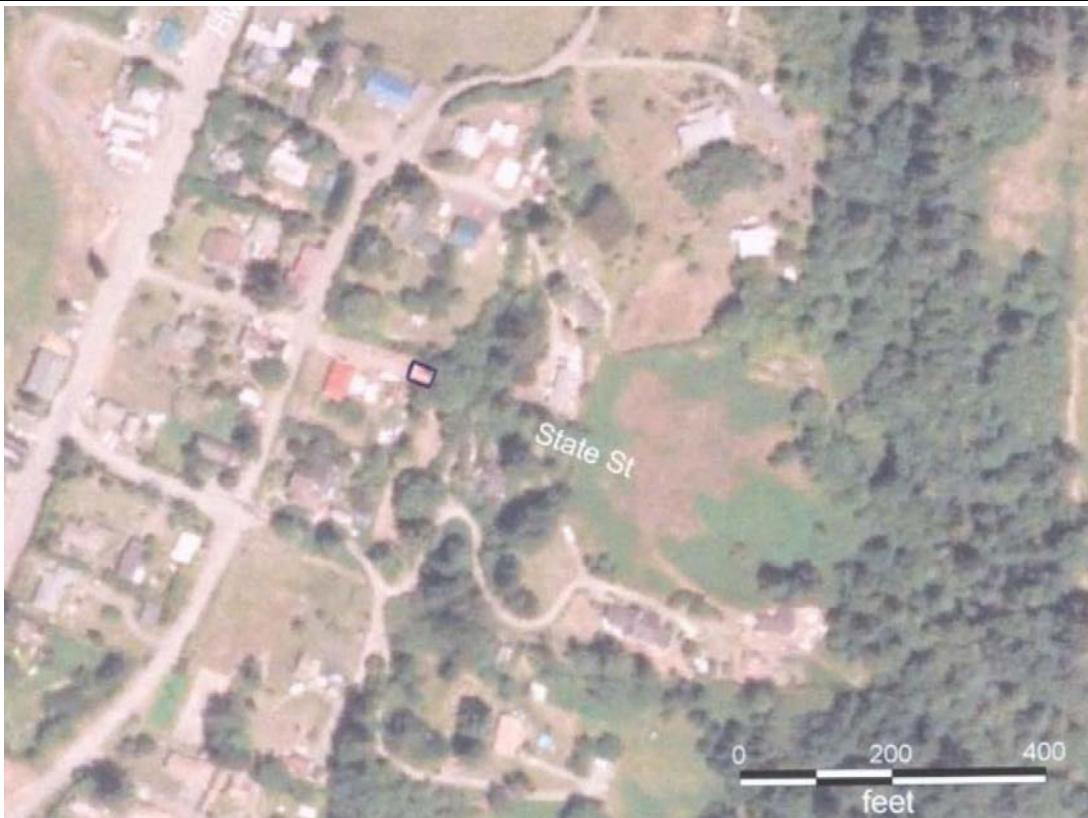
Type	Basic Score	Vert Irreg	Plan Irreg	Pre-Code	Post-Bench	Soil C	Soil D	Soil E	RVS Score
Primary	S3	3.2	0	-0.5	0	0	0	-0.6	0	2.1
Secondary		0	0	0	0	0	0	0	0	0
Tertiary		0	0	0	0	0	0	0	0	0

Final Type	Final Score
S3	2.1

Low (<1%)

Enrollment	Year Built (Field Verified)	Year Built (Alt. Source)	Est. Decade Built
			1980
Total Area (square ft)	Number of Stories	Basement	Pounding Potential
	1	No	No
Plan Irregularities		Vertical Irregularities	
Torsion: Eccentric Stiffness		None	
None		None	
None		None	
Falling Hazards		Poor Conditions	
None		None	
None		None	
None		None
