Crook County F & R - Main Station

Croo_fir02A

Rapid Visual Screening - Senate Bill #2 - Seismic Needs Assessment
Oregon Department of Geology and Mineral Industries

Croo_fir02B

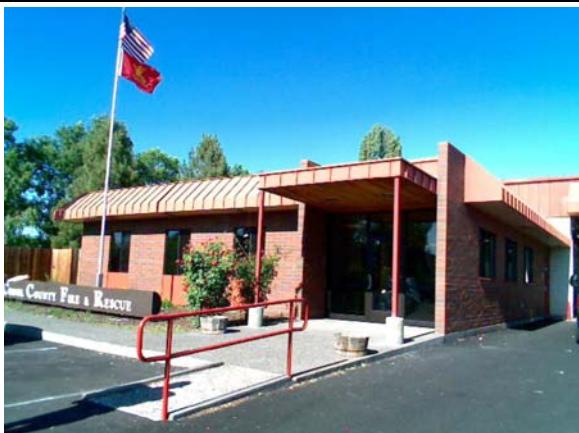
Seismicity Zone: Moderate

Type	Basic Score	Vert Irreg	Plan Irreg	Pre-Code	Post-Bench	Soil C	Soil D	Soil E	RVS Score
Primary	RM1	3.6	-2	-0.5	0	0	0	-1.2	0	-0.1
Secondary		0	0	0	0	0	0	0	0	0
Tertiary		0	0	0	0	0	0	0	0	0

Final Type	Final Score
RM1	-0.1

Very High (100%)

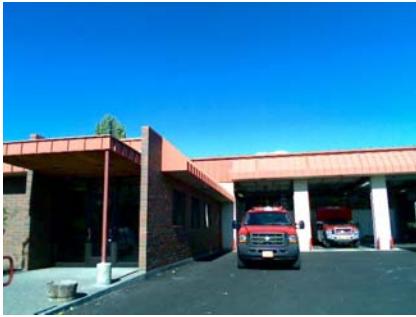
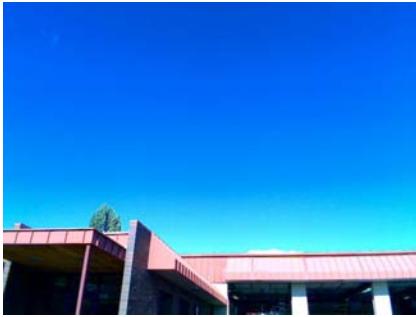
Enrollment	Year Built (Field Verified)	Year Built (Alt. Source)	Est. Decade Built
		1977	1970
Total Area (square ft)	Number of Stories	Basement	Pounding Potential
	1	No	No
Plan Irregularities		Vertical Irregularities	
Reentrant Corners: L Shaped		Steps in Elevation View: Single Change (Adjacent Building/Entity)	
Reentrant Corners: Other		None	
None		None	
Falling Hazards		Poor Conditions	
None		None	
None		None	
None		None

W	Plan Irregularity Primary	W	Vertical Irregularity Primary

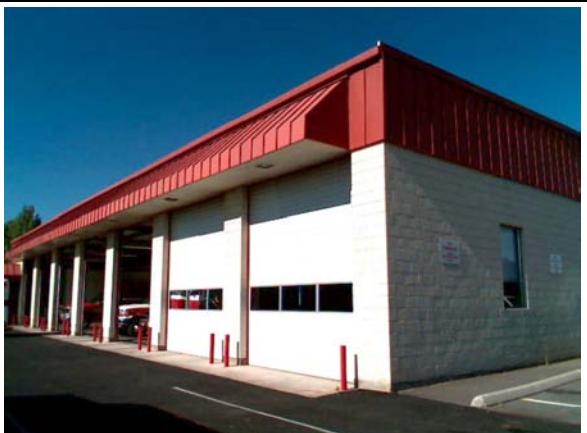
Seismicity Zone: Moderate

Type	Basic Score	Vert Irreg	Plan Irreg	Pre-Code	Post-Bench	Soil C	Soil D	Soil E	RVS Score
Primary	RM1	3.6	-2	-0.5	0	0	0	-1.2	0	-0.1
Secondary		0	0	0	0	0	0	0	0	0
Tertiary		0	0	0	0	0	0	0	0	0

Final Type	Final Score
RM1	-0.1

Very High (100%)

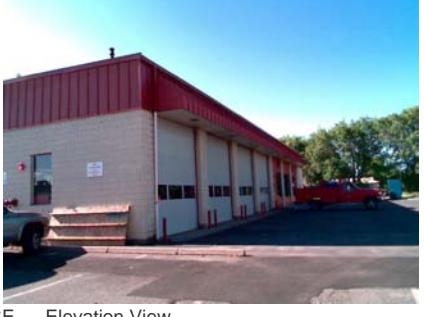
SE Elevation View

Enrollment	Year Built (Field Verified)	Year Built (Alt. Source)	Est. Decade Built
		1977	1970
Total Area (square ft)	Number of Stories	Basement	Pounding Potential
	1	No	No
Plan Irregularities		Vertical Irregularities	
Reentrant Corners:L shaped (Adjacent Build/Entity)		Steps in Elevation View: Single Change	
None		None	
None		None	
Falling Hazards		Poor Conditions	
None		None	
None		None	
None		None
