# Crook County F & R - Powell Butte Station

## FEMA 154 Rapid Visual Screening Score Card

Rapid Visual Screening - Senate Bill #2 - Seismic Needs Assessment  
Oregon Department of Geology and Mineral Industries

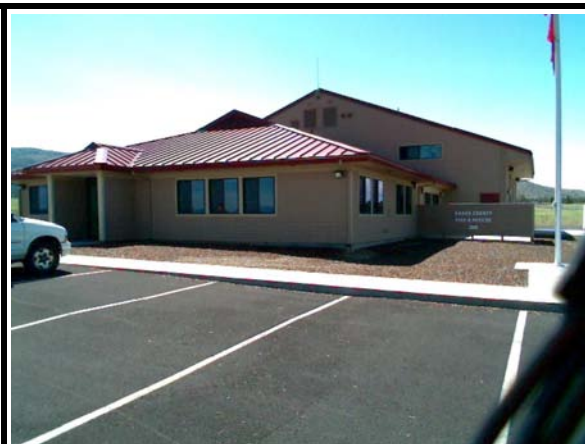
Croo\_fir03A

Type	Basic Score	Vert Irreg	Plan Irreg	Pre-Code	Post-Bench	Soil C	Soil D	Soil E	RVS Score
Primary	W1	5.2	-3.5	-0.5	0	1.6	-0.2	0	0	2.6
Secondary		0	0	0	0	0	0	0	0	0
Tertiary		0	0	0	0	0	0	0	0	0

FEMA-154 Collapse Potential

Low (<1%)

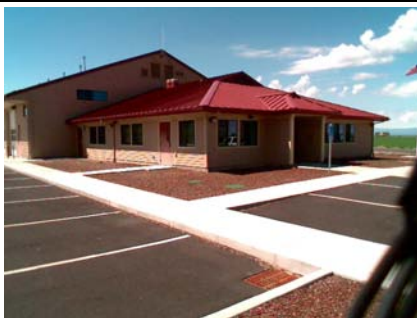
NE Plan Irregularity Primary

Plan Irregularities	Vertical Irregularities
Reentrant Corners:T shaped (Adjacent Build/Entity)	Steps in Elevation View: Single Change (Adjacent Building/Entity)
None	None
None	None

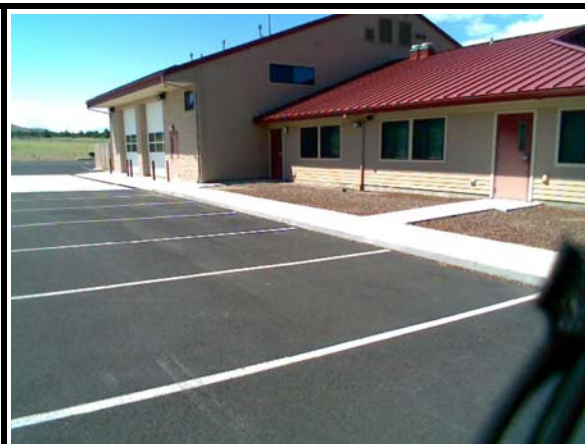
Croo\_fir03B

Type	Basic Score	Vert Irreg	Plan Irreg	Pre-Code	Post-Bench	Soil C	Soil D	Soil E	RVS Score
Primary	RM1	3.6	-2	-0.5	0	2	-0.8	0	0	2.3
Secondary		0	0	0	0	0	0	0	0	0
Tertiary		0	0	0	0	0	0	0	0	0

FEMA-154 Collapse Potential

Low (<1%)

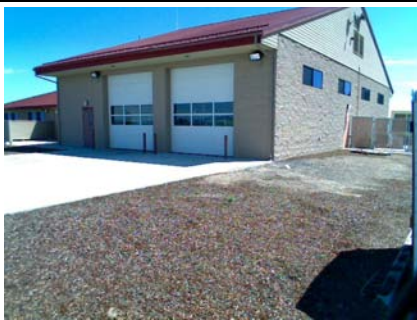
SW General Site

Plan Irregularities	Vertical Irregularities
Reentrant Corners:T shaped (Adjacent Build/Entity)	Steps in Elevation View: Single Change (Adjacent Building/Entity)
None	None
None	None
