Crooked River Elementary School

Crook County SD

FEMA 154 Rapid Visual Screening Score Card

Rapid Visual Screening - Senate Bill #2 - Seismic Needs Assessment
Oregon Department of Geology and Mineral Industries

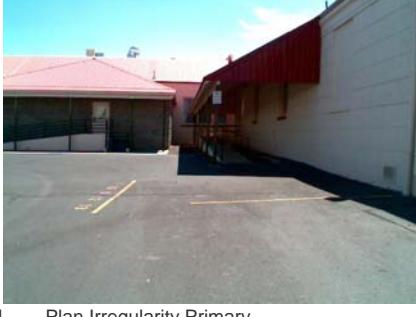
Enrollment 390	Year Built (Field Verified) 1939	Year Built (Alt. Source) 1939	Est. Decade Built 1930
Total Area (square ft) 42043	Number of Stories 1	Basement	Pounding Potential No
Plan Irregularities		Vertical Irregularities	
Reentrant Corners: L Shaped		Steps in Elevation View: 2 to 3 Changes	
Reentrant Corners: Other		Steps in Elevation View: Single Change (Adjacent Building/Entity)	
None		None	
Falling Hazards		Poor Conditions	
None		None	
None		None	
None		None

N Plan Irregularity Primary		NW Vertical Irregularity Primary	
		N Building Name

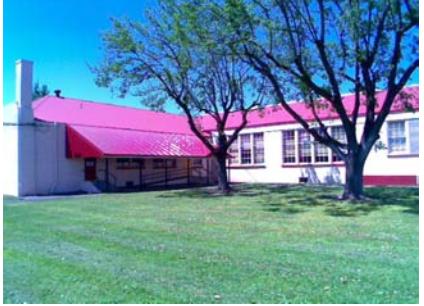
Enrollment 390	Year Built (Field Verified) 1939	Year Built (Alt. Source) 1939	Est. Decade Built 1930
Total Area (square ft) 42043	Number of Stories 1	Basement	Pounding Potential No
Plan Irregularities Reentrant Corners: L Shaped None None		Vertical Irregularities None None None	
Falling Hazards Other: Smokestack None None		Poor Conditions None None None

SW Plan Irregularity Primary		NE General Site
