# Ochoco Elementary School

Crook County SD

## FEMA 154 Rapid Visual Screening Score Card

Rapid Visual Screening - Senate Bill #2 - Seismic Needs Assessment  
Oregon Department of Geology and Mineral Industries

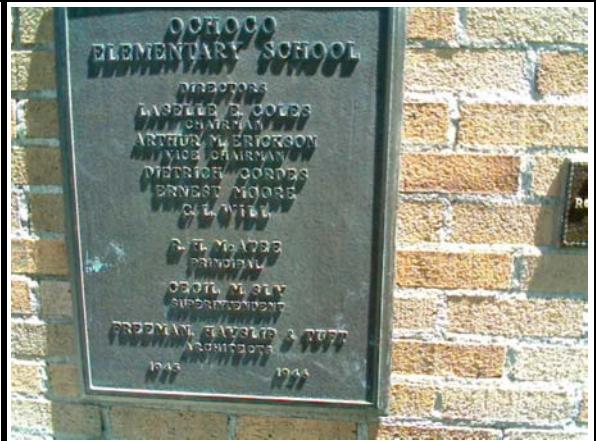
Croo\_sch04A

Building Type	County	
School	Crook	
Street		
440 NW Madras Hwy		
City	State	Zip
Prineville	OR	97754
Latitude	Longitude	
44.30424	120.85903	
Tracking Code	Inspection Date	
RVS in 2006	7/6/2006

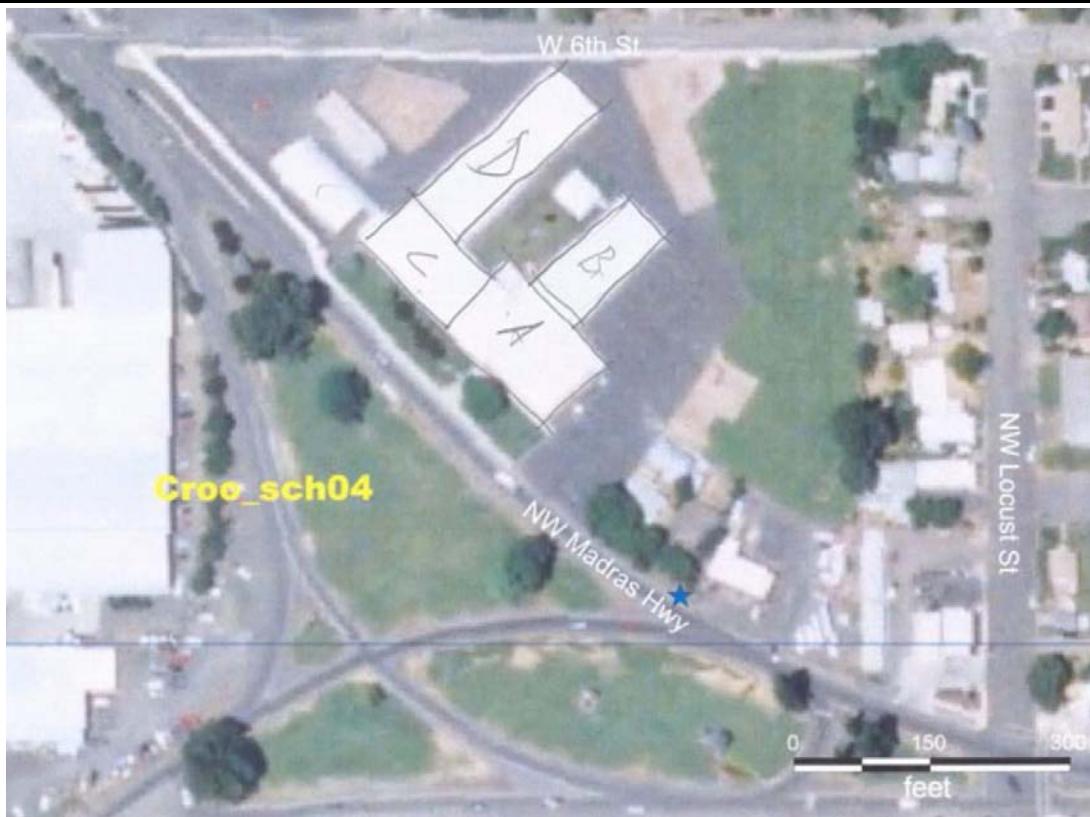
Type	Basic Score	Vert Irreg	Plan Irreg	Pre-Code	Post-Bench	Soil C	Soil D	Soil E	RVS Score
Primary	C2	3.6	-2	0	0	0	0	-1.2	0	0.4
Secondary		0	0	0	0	0	0	0	0	0
Tertiary		0	0	0	0	0	0	0	0	0

Final Type	Final Score
C2	0.4

High (>10%)

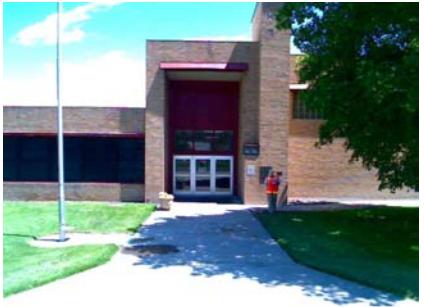
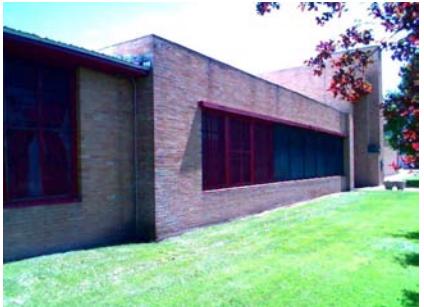
Enrollment 413	Year Built (Field Verified) 1945	Year Built (Alt. Source) 1945	Est. Decade Built 1940
Total Area (square ft) 39694	Number of Stories 1	Basement	Pounding Potential No
Plan Irregularities None None None		Vertical Irregularities Steps in Elevation View: Single Change Steps in Elevation View: Single Change (Adjacent Building/Entity) None	
Falling Hazards None None None		Poor Conditions None None None

S Elevation View		SE Vertical Irregularity Primary	
		SE Vertical Irregularity Secondary

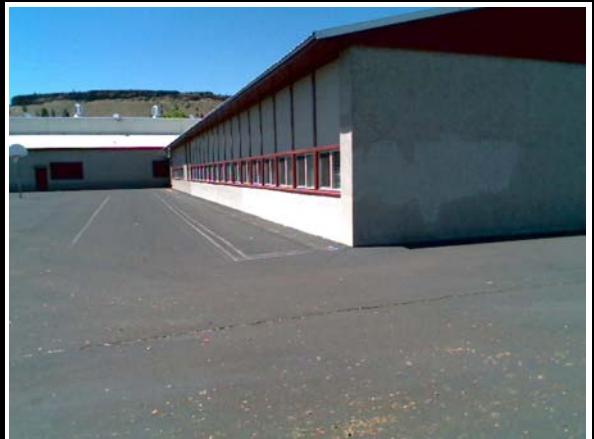
Croo\_sch04B

Building Type School	County Crook	
Street 440 NW Madras Hwy		
City Prineville	State OR	Zip 97754
Latitude 44.30449	Longitude 120.85873	
Tracking Code RVS in 2006	Inspection Date 7/6/2006

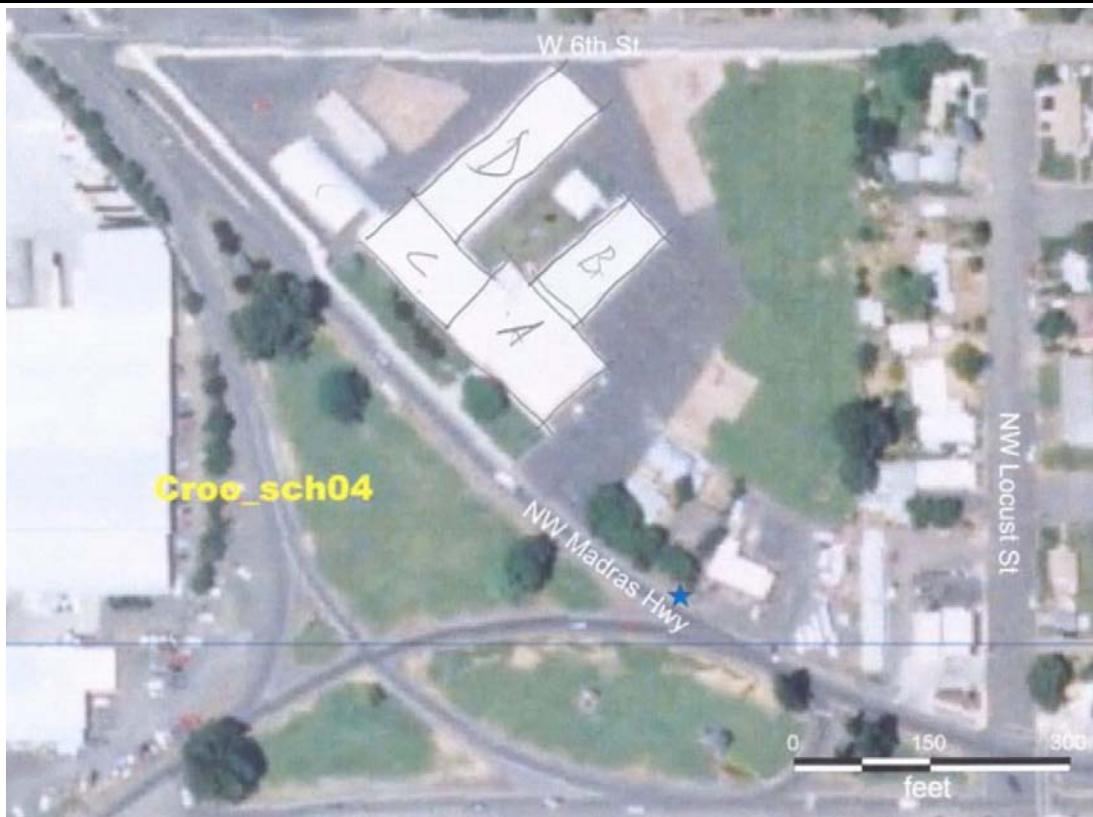
Type	Basic Score	Vert Irreg	Plan Irreg	Pre-Code	Post-Bench	Soil C	Soil D	Soil E	RVS Score
Primary	RM1	3.6	-2	-0.5	0	0	0	-1.2	0	-0.1
Secondary	C2	3.6	-2	-0.5	0	0	0	-1.2	0	-0.1
Tertiary		0	0	0	0	0	0	0	0	0

Final Type	Final Score
RM1	-0.1

Very High (100%)

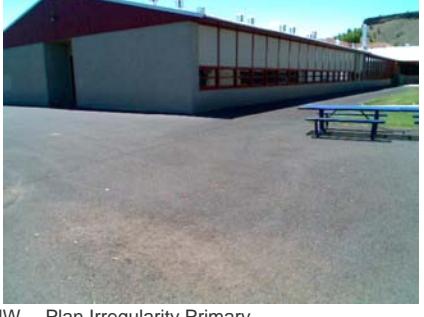
Enrollment 413	Year Built (Field Verified) 1945	Year Built (Alt. Source) 1945	Est. Decade Built 1950
Total Area (square ft) 39694	Number of Stories 1	Basement	Pounding Potential No
Plan Irregularities Reentrant Corners:T shaped (Adjacent Build/Entity) None None		Vertical Irregularities Steps in Elevation View: Single Change (Adjacent Building/Entity) None None	
Falling Hazards None None None		Poor Conditions None None None

NW Plan Irregularity Primary

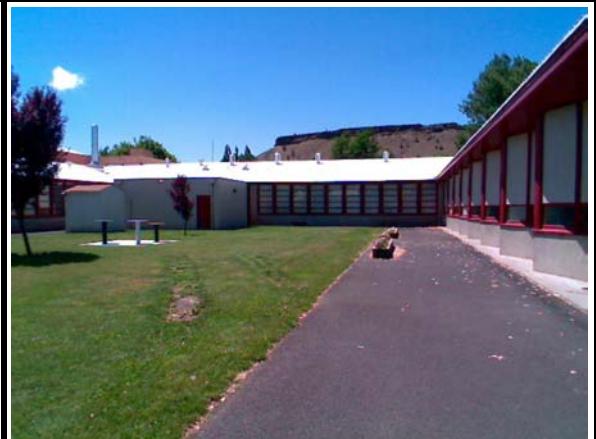
Croo\_sch04C

Building Type School	County Crook	
Street 440 NW Madras Hwy		
City Prineville	State OR	Zip 97754
Latitude 44.30448	Longitude 120.85945	
Tracking Code RVS in 2006	Inspection Date 7/6/2006

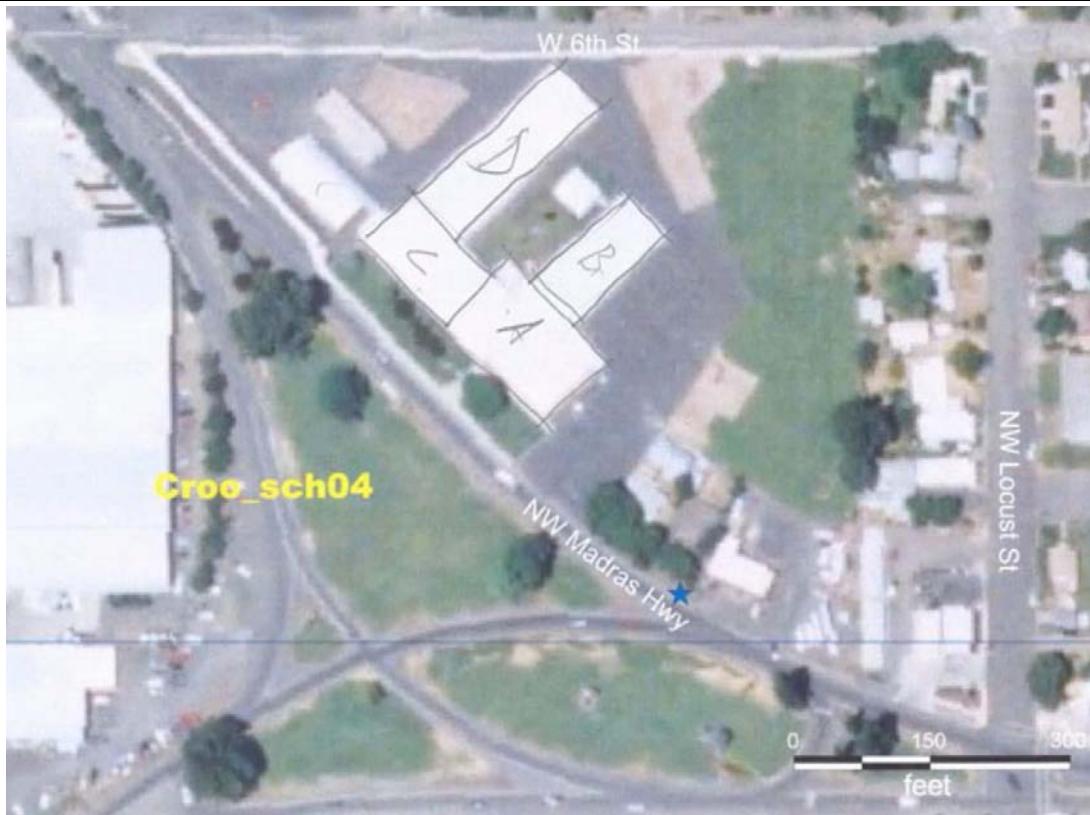
Type	Basic Score	Vert Irreg	Plan Irreg	Pre-Code	Post-Bench	Soil C	Soil D	Soil E	RVS Score
Primary	RM1	3.6	-2	-0.5	0	0	0	-1.2	0	-0.1
Secondary	C2	3.6	-2	-0.5	0	0	0	-1.2	0	-0.1
Tertiary		0	0	0	0	0	0	0	0	0

Final Type	Final Score
RM1	-0.1

Very High (100%)

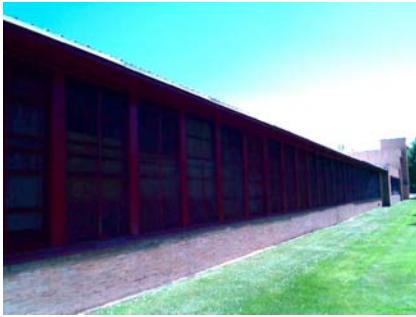
Enrollment 413	Year Built (Field Verified) 1945	Year Built (Alt. Source) 1945	Est. Decade Built 1960
Total Area (square ft) 39694	Number of Stories 1	Basement	Pounding Potential No
Plan Irregularities Reentrant Corners:Other (Adjacent Build/Entity) None None		Vertical Irregularities Steps in Elevation View: Single Change (Adjacent Building/Entity) None None	
Falling Hazards None None None		Poor Conditions None None None

SW Elevation View

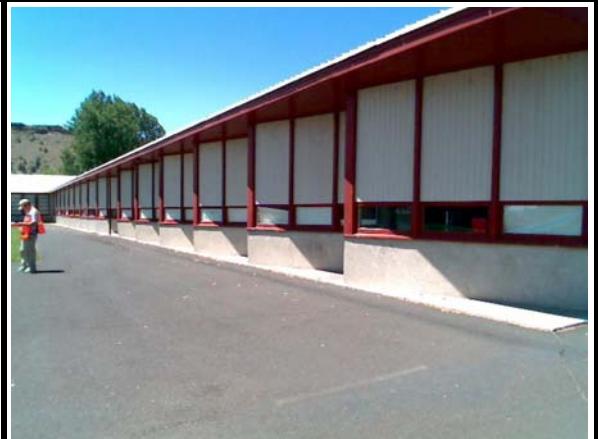
Croo\_sch04D

Building Type School	County Crook	
Street 440 NW Madras Hwy		
City Prineville	State OR	Zip 97754
Latitude 44.30478	Longitude 120.85918	
Tracking Code RVS in 2006	Inspection Date 7/6/2006

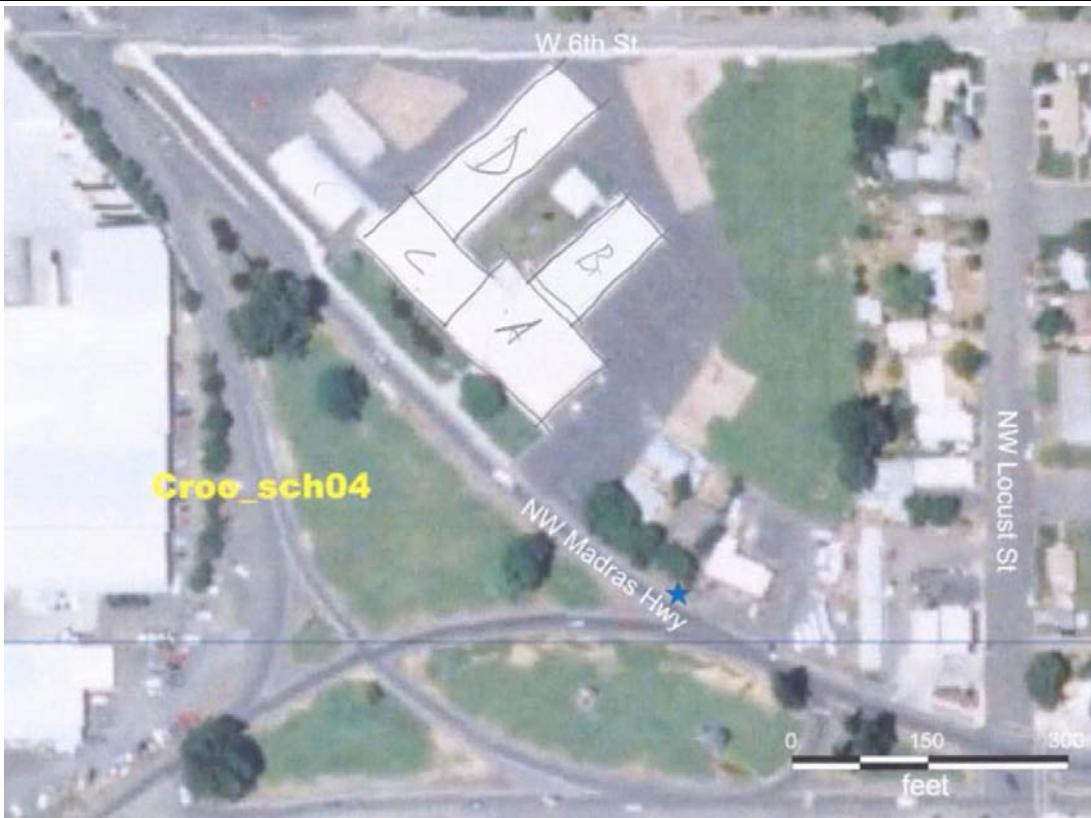
Type	Basic Score	Vert Irreg	Plan Irreg	Pre-Code	Post-Bench	Soil C	Soil D	Soil E	RVS Score
Primary	W2	4.8	0	-0.5	0	0	0	-1.2	0	3.1
Secondary	RM1	3.6	0	-0.5	0	0	0	-1.2	0	1.9
Tertiary		0	0	0	0	0	0	0	0	0

Final Type	Final Score
RM1	1.9

Moderate (>1%)

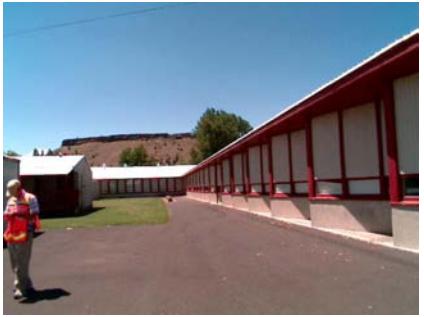
Enrollment 413	Year Built (Field Verified) 1945	Year Built (Alt. Source) 1945	Est. Decade Built 1970
Total Area (square ft) 39694	Number of Stories 1	Basement	Pounding Potential No
Plan Irregularities Reentrant Corners:L shaped (Adjacent Build/Entity) None None		Vertical Irregularities None None None	
Falling Hazards None None None		Poor Conditions None None None

N Plan Irregularity Secondary

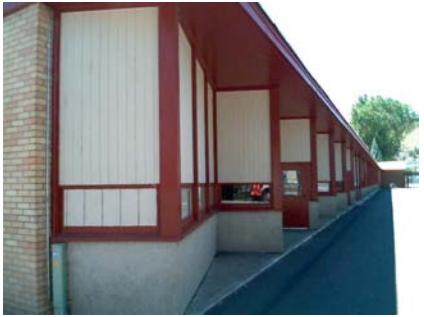
NW Elevation View
