Kalmiopsis Elementary School

Curr_sch03A

FEMA 154 Rapid Visual Screening Score Card

Rapid Visual Screening - Senate Bill #2 - Seismic Needs Assessment
Oregon Department of Geology and Mineral Industries

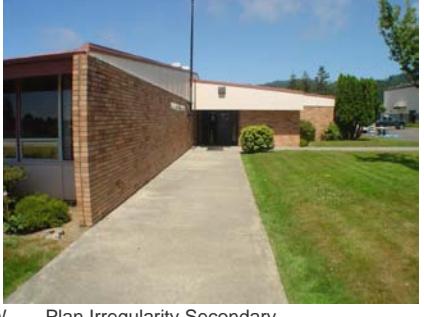
W Plan Irregularity Secondary		E Vertical Irregularity Primary

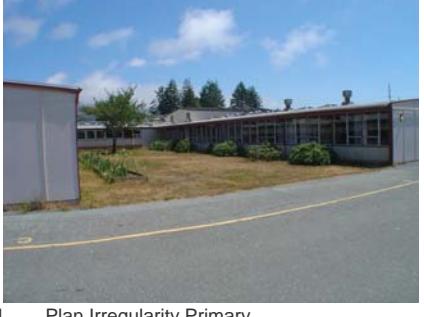
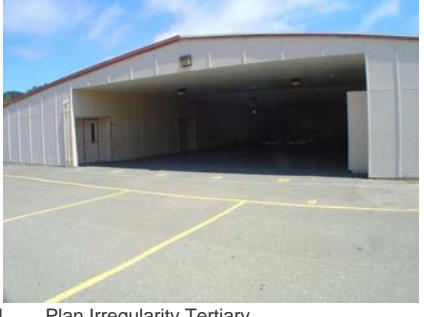
N Plan Irregularity Primary		N Plan Irregularity Tertiary All 3 legs of this building have a very large and deep opening.
