Pilot Butte Middle School

Bend-LaPine SD 1

Desc_sch02A

Rapid Visual Screening - Senate Bill #2 - Seismic Needs Assessment
Oregon Department of Geology and Mineral Industries

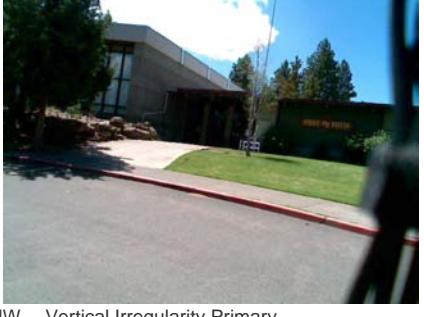
Enrollment 646	Year Built (Field Verified) 1967	Year Built (Alt. Source) 1960	Est. Decade Built 1960
Total Area (square ft) 101803	Number of Stories 1	Basement	Pounding Potential No
Plan Irregularities		Vertical Irregularities	
Reentrant Corners: Other		Steps in Elevation View: Single Change	
Torsion: Eccentric Stiffness		Building On Hill or Sloped Site	
None		None	
Falling Hazards		Poor Conditions	
None		None	
None		None	
None		None

NW Vertical Irregularity Primary		NW Plan Irregularity Primary

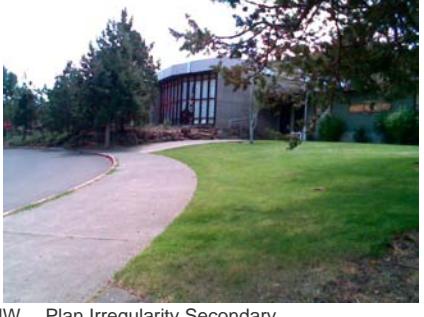
NW Plan Irregularity Secondary

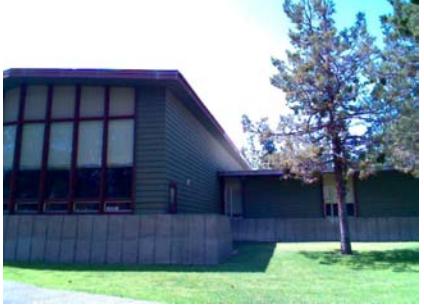
Enrollment 646	Year Built (Field Verified) 1967	Year Built (Alt. Source) 1967	Est. Decade Built 1960
Total Area (square ft) 101803	Number of Stories 1	Basement	Pounding Potential No
Plan Irregularities Reentrant Corners: Other None None		Vertical Irregularities Steps in Elevation View: 2 to 3 Changes Building On Hill or Sloped Site None	
Falling Hazards None None None		Poor Conditions None None None

N Vertical Irregularity Primary		N Plan Irregularity Secondary

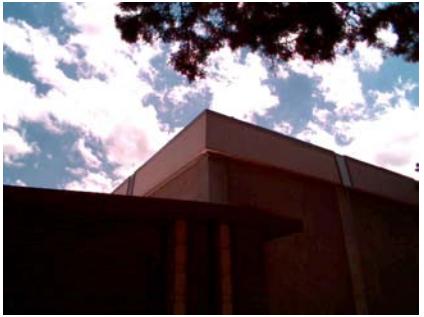
Enrollment 646	Year Built (Field Verified) 1967	Year Built (Alt. Source) 1960	Est. Decade Built 1960
Total Area (square ft) 101803	Number of Stories 1	Basement	Pounding Potential No
Plan Irregularities		Vertical Irregularities	
Reentrant Corners: L Shaped		Steps in Elevation View: Single Change (Adjacent Building/Entity)	
Reentrant Corners: L Shaped		Building On Hill or Sloped Site	
None		None	
Falling Hazards		Poor Conditions	
None		None	
None		None	
None		None

W	Vertical Irregularity Primary	NW	Plan Irregularity Primary

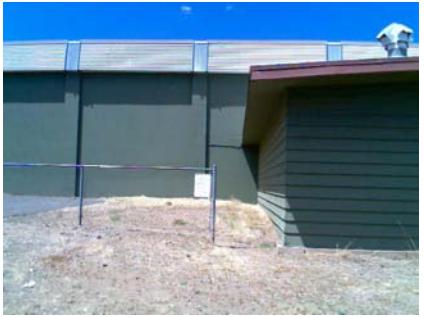
E	Plan Irregularity Secondary

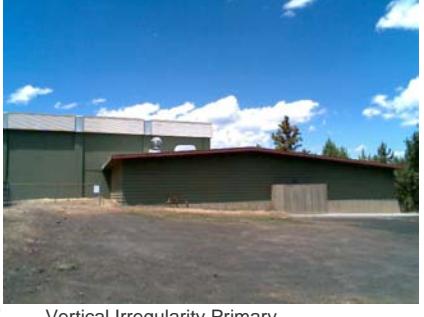
Enrollment 646	Year Built (Field Verified) 1967	Year Built (Alt. Source) 1967	Est. Decade Built 1970
Total Area (square ft) 101803	Number of Stories 1	Basement	Pounding Potential No
Plan Irregularities Reentrant Corners:L shaped (Adjacent Build/Entity) None None		Vertical Irregularities Steps in Elevation View: Single Change Building On Hill or Sloped Site None	
Falling Hazards None None None		Poor Conditions None None None

E Vertical Irregularity Primary
