# John Tuck Elementary School

Redmond SD 2J

## FEMA 154 Rapid Visual Screening Score Card

Rapid Visual Screening - Senate Bill #2 - Seismic Needs Assessment  
Oregon Department of Geology and Mineral Industries

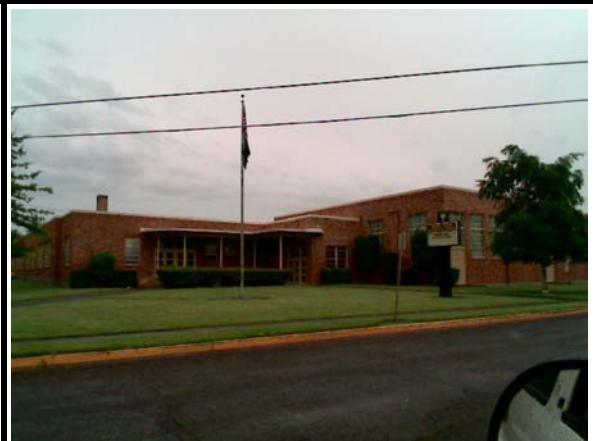
Desc\_sch08A

Type	Basic Score	Vert Irreg	Plan Irreg	Pre-Code	Post-Bench	Soil C	Soil D	Soil E	RVS Score
Primary	C2	3.6	-2	-0.5	0	0	0	0	0	1.1
Secondary		0	0	0	0	0	0	0	0	0
Tertiary		0	0	0	0	0	0	0	0	0

Moderate (>1%)

Enrollment 502	Year Built (Field Verified) 1947	Year Built (Alt. Source) 1940	Est. Decade Built 1940
Total Area (square ft) 50425	Number of Stories 1	Basement	Pounding Potential No
Plan Irregularities Reentrant Corners:L shaped (Adjacent Build/Entity) None None		Vertical Irregularities Steps in Elevation View: 2 to 3 Changes (Adjacent Building/Entity) None None	
Falling Hazards Unreinforced Chimneys None None		Poor Conditions None None None

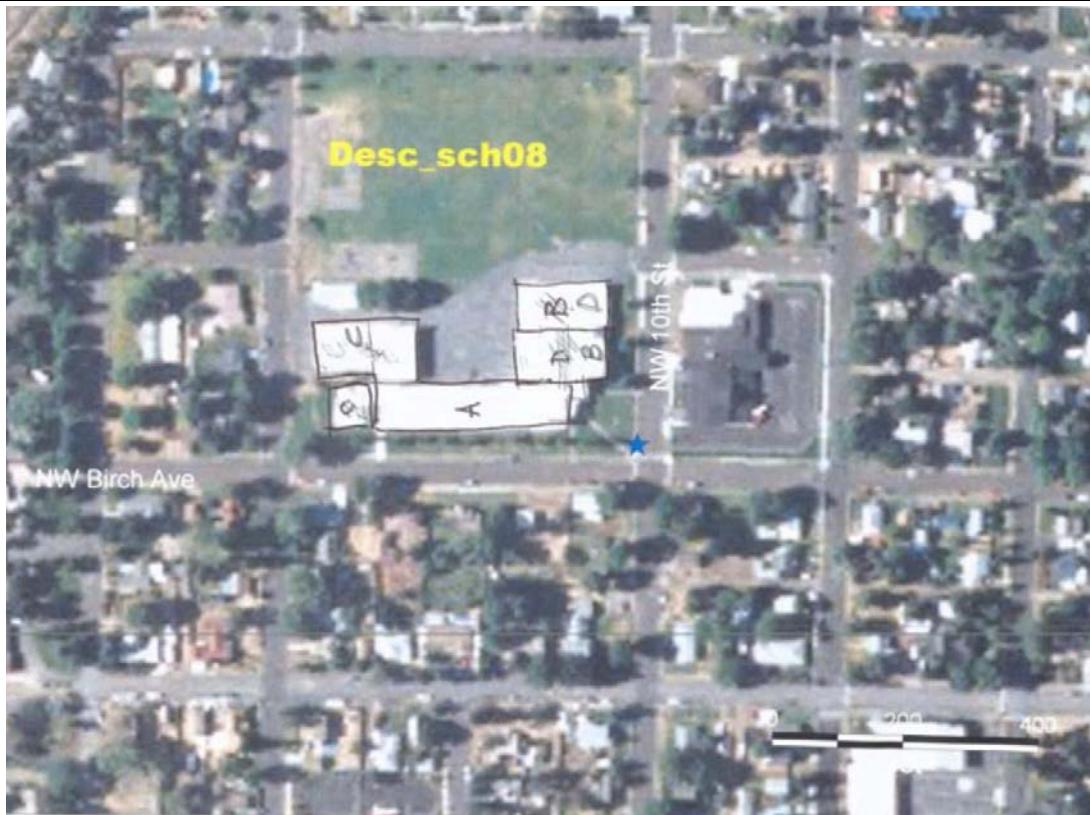
Final Type	Final Score
C2	1.1

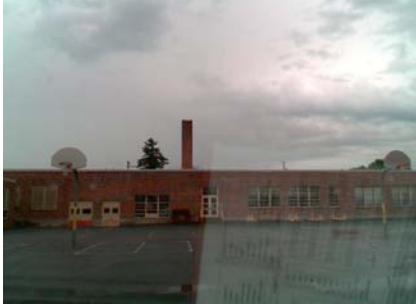
N Falling Hazard

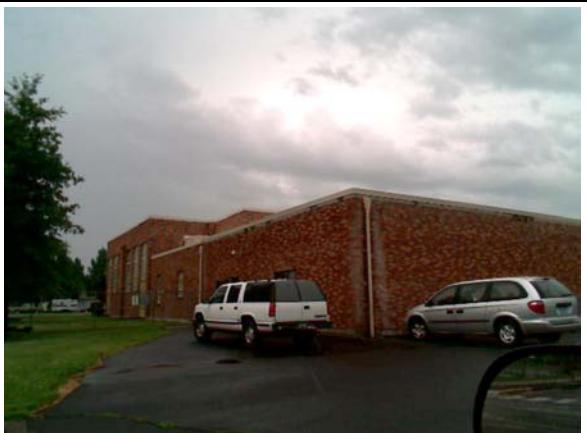
Desc\_sch08B

Type	Basic Score	Vert Irreg	Plan Irreg	Pre-Code	Post-Bench	Soil C	Soil D	Soil E	RVS Score
Primary	C2	3.6	-2	0	0	0	0	0	0	1.6
Secondary	RM1	3.6	-2	0	0	0	0	0	0	1.6
Tertiary		0	0	0	0	0	0	0	0	0

Moderate (>1%)

Enrollment 502	Year Built (Field Verified) 1947	Year Built (Alt. Source) 1947	Est. Decade Built 1950
Total Area (square ft) 50425	Number of Stories 1	Basement	Pounding Potential No
Plan Irregularities None None None		Vertical Irregularities Steps in Elevation View: Single Change (Adjacent Building/Entity) None None	
Falling Hazards None None None		Poor Conditions None None None

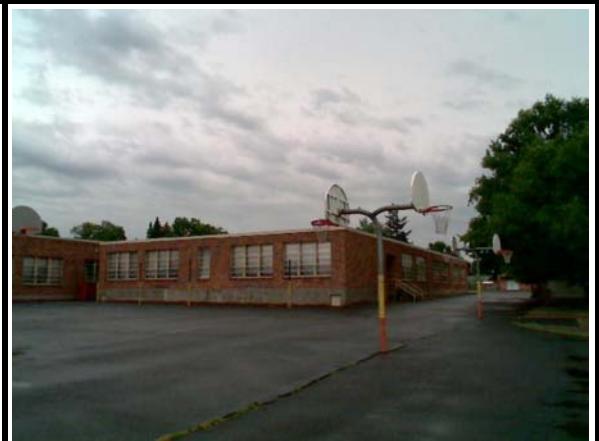
Desc\_sch08C

Type	Basic Score	Vert Irreg	Plan Irreg	Pre-Code	Post-Bench	Soil C	Soil D	Soil E	RVS Score
Primary	C2	3.6	-2	-0.5	0	0	0	0	0	1.1
Secondary		0	0	0	0	0	0	0	0	0
Tertiary		0	0	0	0	0	0	0	0	0

Moderate (>1%)

Enrollment 502	Year Built (Field Verified) 1947	Year Built (Alt. Source) 1947	Est. Decade Built 1950
Total Area (square ft) 50425	Number of Stories 1	Basement	Pounding Potential No
Plan Irregularities Reentrant Corners:L shaped (Adjacent Build/Entity) None None		Vertical Irregularities Steps in Elevation View: Single Change (Adjacent Building/Entity) None None	
Falling Hazards None None None		Poor Conditions None None None

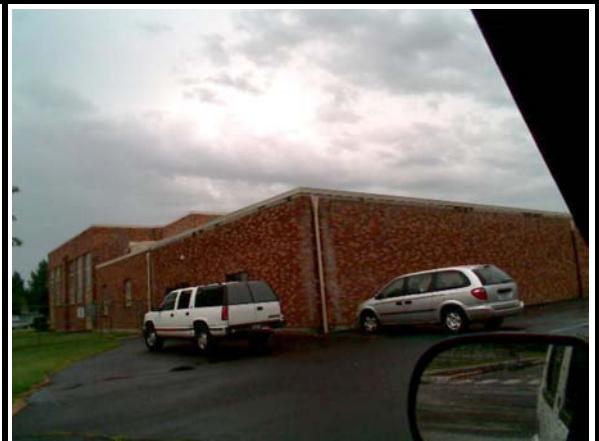
Desc\_sch08D

Type	Basic Score	Vert Irreg	Plan Irreg	Pre-Code	Post-Bench	Soil C	Soil D	Soil E	RVS Score
Primary	RM1	3.6	0	0	0	0	0	0	0	3.6
Secondary		0	0	0	0	0	0	0	0	0
Tertiary		0	0	0	0	0	0	0	0	0

Low (<1%)

Enrollment 502	Year Built (Field Verified) 1947	Year Built (Alt. Source) 1947	Est. Decade Built 1980
Total Area (square ft) 50425	Number of Stories 1	Basement	Pounding Potential No
Plan Irregularities None None None		Vertical Irregularities None None None	
Falling Hazards None None None		Poor Conditions None None None

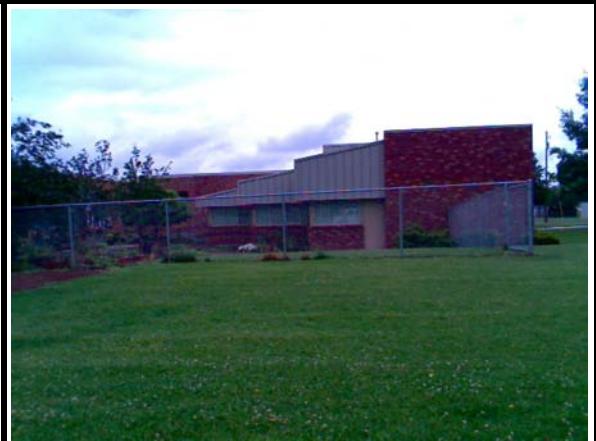
Desc\_sch08E

Type	Basic Score	Vert Irreg	Plan Irreg	Pre-Code	Post-Bench	Soil C	Soil D	Soil E	RVS Score
Primary	W2	4.8	-3	-0.5	0	1.6	0	0	0	2.9
Secondary	RM1	3.6	-2	-0.5	0	0	0	0	0	1.1
Tertiary		0	0	0	0	0	0	0	0	0

Moderate (>1%)

Enrollment 502	Year Built (Field Verified) 1947	Year Built (Alt. Source) 1947	Est. Decade Built 1990
Total Area (square ft) 50425	Number of Stories 1	Basement	Pounding Potential No
Plan Irregularities Reentrant Corners:L shaped (Adjacent Build/Entity) None None		Vertical Irregularities Steps in Elevation View: 2 to 3 Changes None None	
Falling Hazards None None None		Poor Conditions None None None

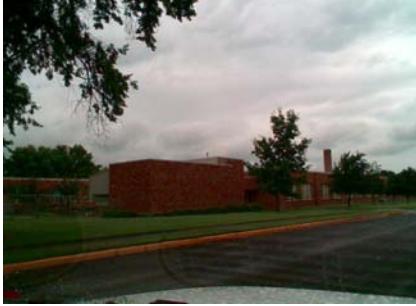
<p>SW Vertical Irregularity Primary IRREGULARITIES AND REASON FOR POSSIBLE DIFFERENT STRUCTURAL TYPE.</p>
