Obsidian Middle School

Building Type		County	
School		Deschutes	
Street			
1335 SW Obsidian Ave			
City	State	Zip	
Redmond	OR	97756	
Latitude		Longitude	
44.26323		121.18253	
Tracking Code		Inspection Date	
RVS in 2006		6/29/2006

FEMA 154 Rapid Visual Screening Score Card

Rapid Visual Screening - Senate Bill #2 - Seismic Needs Assessment
Oregon Department of Geology and Mineral Industries

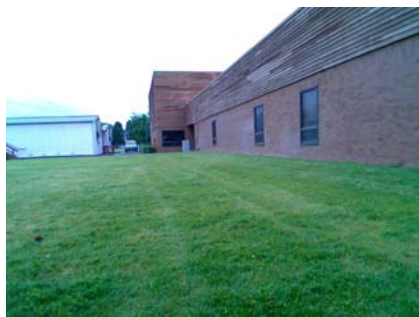
W Vertical Irregularity Primary

Plan Irregularities	Vertical Irregularities
Reentrant Corners: Other	Steps in Elevation View: Very Irregular Changes
None	None
None	None

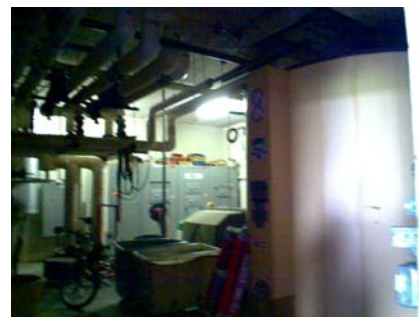
N Secondary Structural Type

Type	Basic Score	Vert Irreg	Plan Irreg	Pre-Code	Post-Bench	Soil C	Soil D	Soil E	RVS Score
Primary	S2	3.6	-2	-0.5	0	0	-0.8	0	0	0.3
Secondary	RM1	3.6	-2	-0.5	0	0	-0.8	0	0	0.3
Tertiary		0	0	0	0	0	0	0	0	0
