Sisters Elementary School

Sisters SD 6

FEMA 154 Rapid Visual Screening Score Card

Rapid Visual Screening - Senate Bill #2 - Seismic Needs Assessment
Oregon Department of Geology and Mineral Industries

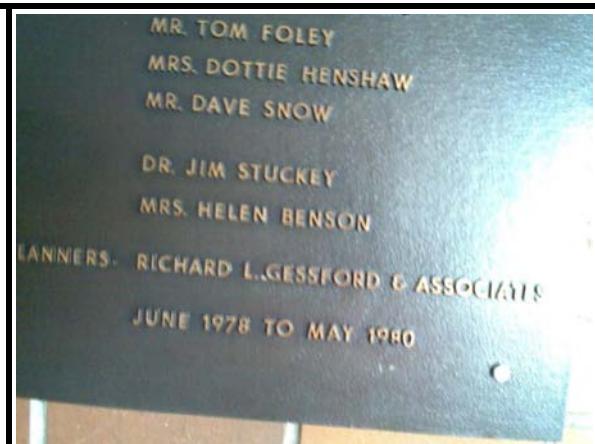
Desc_sch14A

Building Type	County	
School	Deschutes	
Street		
611 E Cascade		
City	State	Zip
Sisters	OR	97759
Latitude	Longitude	
44.29081	121.54163	
Tracking Code	Inspection Date	
RVS in 2006	6/27/2006

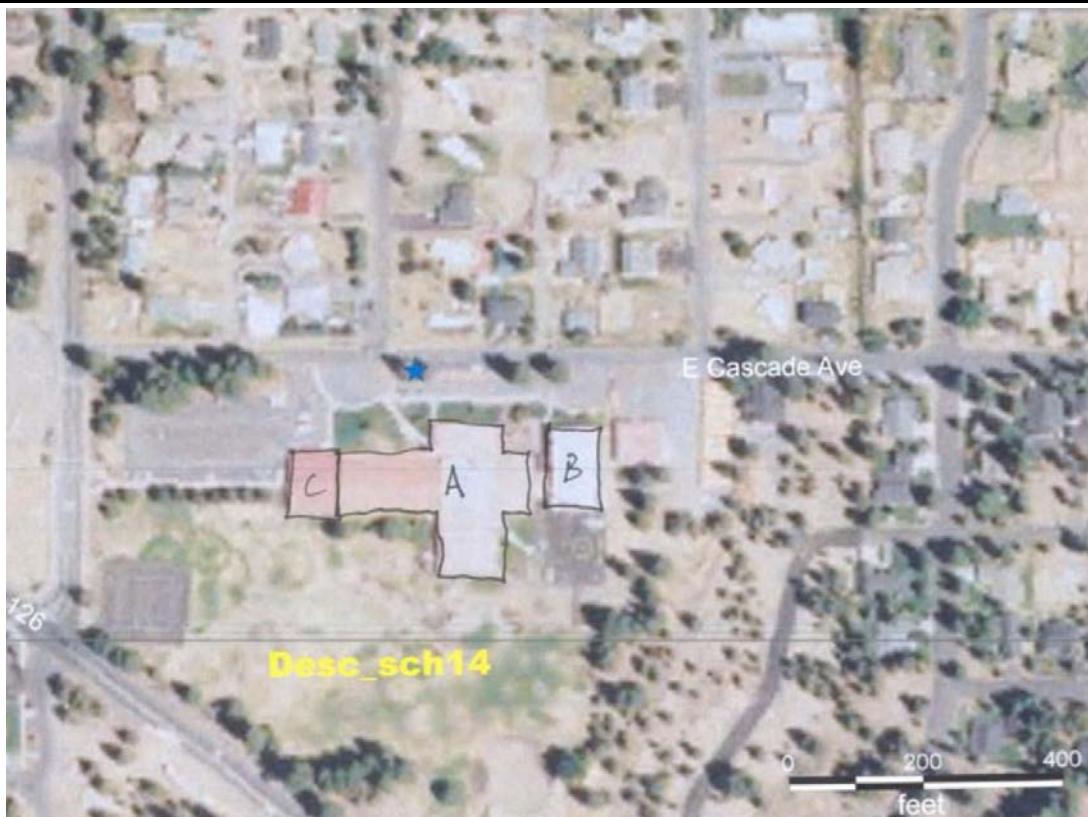
Type	Basic Score	Vert Irreg	Plan Irreg	Pre-Code	Post-Bench	Soil C	Soil D	Soil E	RVS Score
Primary	W2	4.8	-3	-0.5	0	0	0	-1.2	0	0.1
Secondary	RM1	3.6	-2	-0.5	0	0	0	-1.2	0	-0.1
Tertiary		0	0	0	0	0	0	0	0	0

Final Type	Final Score
RM1	-0.1

Very High (100%)

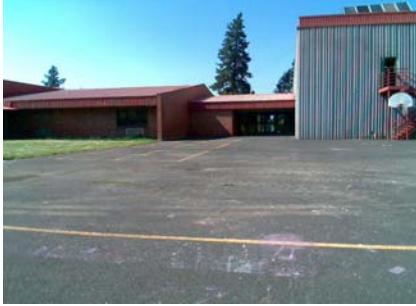
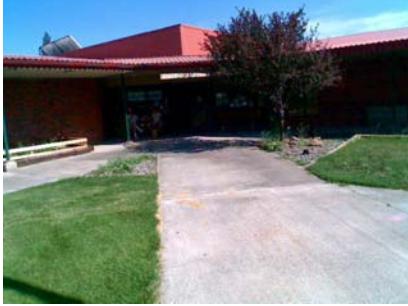
Enrollment	Year Built (Field Verified)	Year Built (Alt. Source)	Est. Decade Built
475	1978	1978	1970
Total Area (square ft)	Number of Stories	Basement	Pounding Potential
63000	1	No	No
Plan Irregularities		Vertical Irregularities	
Reentrant Corners: T shaped		Steps in Elevation View: Single Change	
Reentrant Corners: Other		None	
None		None	
Falling Hazards		Poor Conditions	
None		None	
None		None	
None		None

S Plan Irregularity Secondary		NW Plan Irregularity Primary and vert irregularity

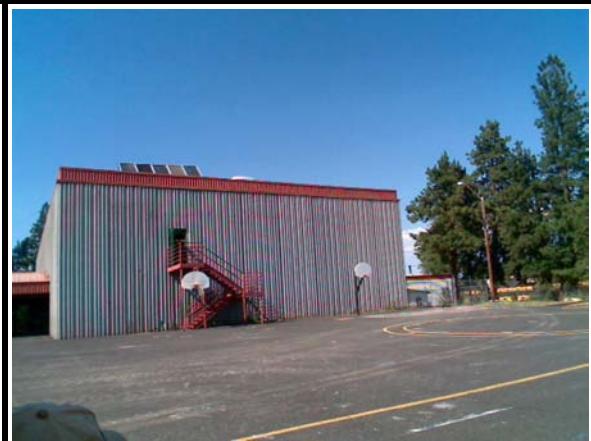
Desc_sch14B

Building Type School	County Deschutes	
Street 611 E Cascade		
City Sisters	State OR	Zip 97759
Latitude 44.29088	Longitude 121.54088	
Tracking Code RVS in 2006	Inspection Date 6/27/2006

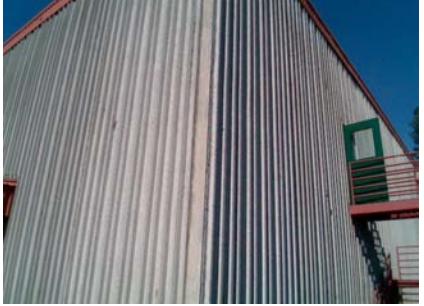
Enrollment 475	Year Built (Field Verified) 1978	Year Built (Alt. Source) 1970	Est. Decade Built 1970
Total Area (square ft) 63000	Number of Stories 2	Basement	Pounding Potential No
Plan Irregularities None None None		Vertical Irregularities Steps in Elevation View: Single Change (Adjacent Building/Entity) None None	
Falling Hazards None None None		Poor Conditions None None None

SW Primary Structural Type

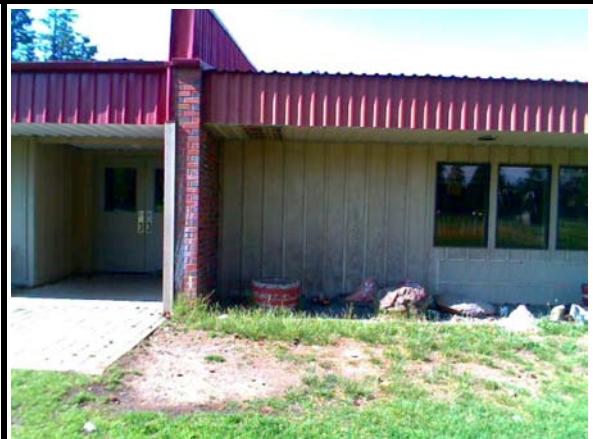
Desc_sch14C

Building Type School	County Deschutes	
Street 611 E Cascade		
City Sisters	State OR	Zip 97759
Latitude 44.29083	Longitude 121.54235	
Tracking Code RVS in 2006	Inspection Date 6/27/2006

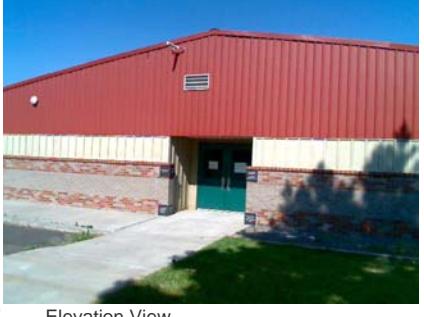
E Elevation View
