Juniper Elementary School

Bend-LaPine SD 1

FEMA 154 Rapid Visual Screening Score Card

Rapid Visual Screening - Senate Bill #2 - Seismic Needs Assessment
Oregon Department of Geology and Mineral Industries

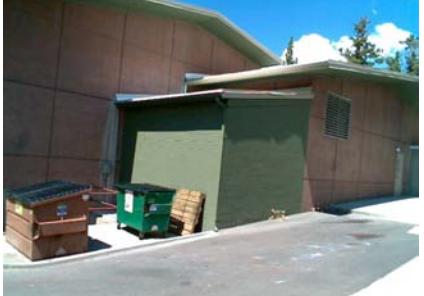
Enrollment 408	Year Built (Field Verified) 1965	Year Built (Alt. Source) 1965	Est. Decade Built 1960
Total Area (square ft) 52134	Number of Stories 1	Basement	Pounding Potential No
Plan Irregularities Reentrant Corners: L Shaped None None		Vertical Irregularities Steps in Elevation View: Single Change Building On Hill or Sloped Site None	
Falling Hazards None None None		Poor Conditions None None None

SW Vertical Irregularity Primary		NW General Site	NE General Site

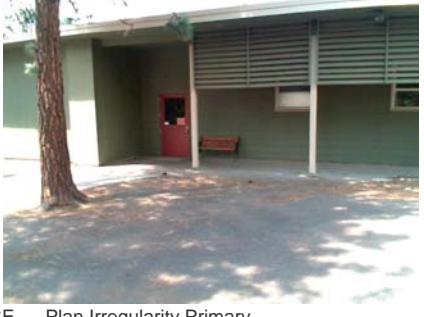
Enrollment 408	Year Built (Field Verified) 1965	Year Built (Alt. Source) 1965	Est. Decade Built 1970
Total Area (square ft) 52134	Number of Stories 1	Basement	Pounding Potential No
Plan Irregularities Reentrant Corners: T shaped None None		Vertical Irregularities None None None	
Falling Hazards None None None		Poor Conditions None None None

SE Plan Irregularity Primary

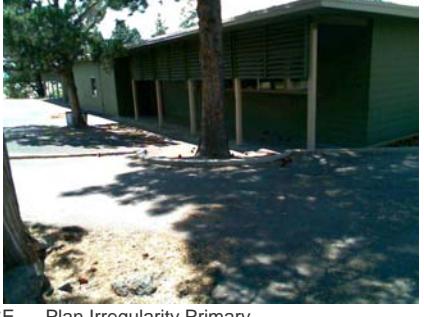
Enrollment 408	Year Built (Field Verified) 1965	Year Built (Alt. Source) 1965	Est. Decade Built 1970
Total Area (square ft) 52134	Number of Stories 1	Basement	Pounding Potential No
Plan Irregularities Reentrant Corners: T shaped None None		Vertical Irregularities None None None	
Falling Hazards None None None		Poor Conditions None None None

SE Plan Irregularity Primary		SE General Site

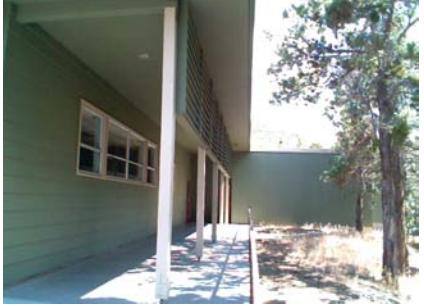
Enrollment 408	Year Built (Field Verified) 1965	Year Built (Alt. Source) 1965	Est. Decade Built 1970
Total Area (square ft) 52134	Number of Stories 1	Basement	Pounding Potential No
Plan Irregularities Reentrant Corners: Other None None		Vertical Irregularities None None None	
Falling Hazards None None None		Poor Conditions None None None

N Plan Irregularity Primary

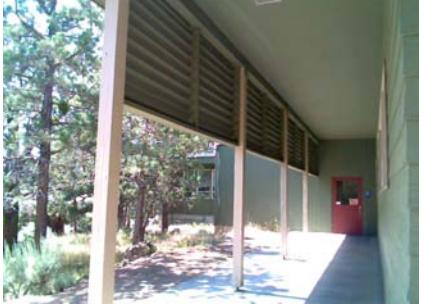
S Plan Irregularity Primary

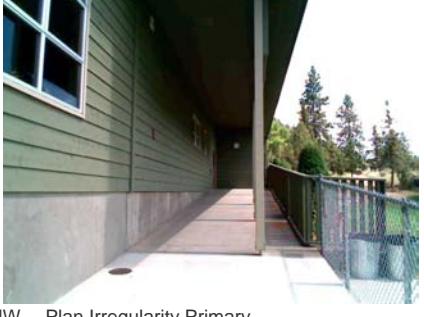
Enrollment 408	Year Built (Field Verified) 1965	Year Built (Alt. Source) 1965	Est. Decade Built 1970
Total Area (square ft) 52134	Number of Stories 1	Basement	Pounding Potential No
Plan Irregularities Reentrant Corners: L Shaped None None		Vertical Irregularities None Building On Hill or Sloped Site None	
Falling Hazards None None None		Poor Conditions None None None

NW Plan Irregularity Primary
