Amity Creek Elementary School

Desc_sch36A

FEMA 154 Rapid Visual Screening Score Card

Rapid Visual Screening - Senate Bill #2 - Seismic Needs Assessment
Oregon Department of Geology and Mineral Industries

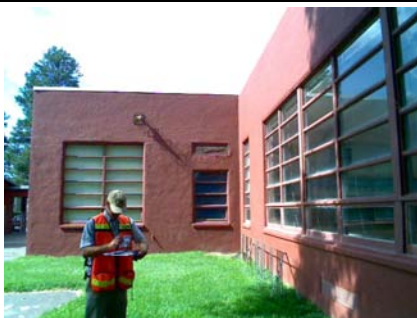
Plan Irregularities	Vertical Irregularities
Reentrant Corners: T shaped	Steps in Elevation View: Single Change (Adjacent Building/Entity)
None	None
None	None

S Plan Irregularity Primary

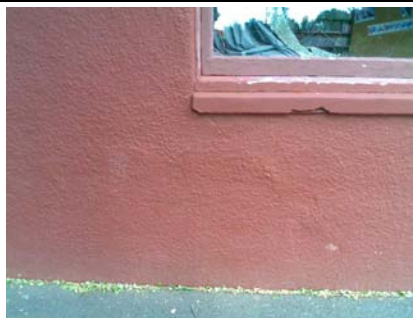
Falling Hazards	Poor Conditions
Parapets: Unreinforced Around Entire Building	Cracks
Other: Ornamental Hazard Over Exit	None
None	None

S Poor Condition

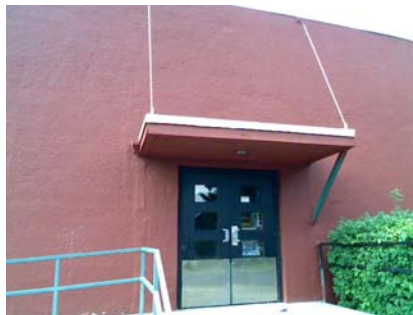
W Falling Hazard
