# Tiller RFPD

## FEMA 154 Rapid Visual Screening Score Card

Rapid Visual Screening - Senate Bill #2 - Seismic Needs Assessment  
Oregon Department of Geology and Mineral Industries

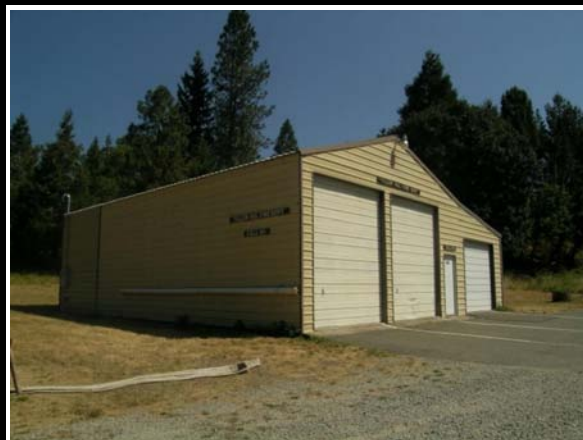
Seismicity Zone: Moderate

| | Type | Basic Score | Vert Irreg | Plan Irreg | Pre-Code | Post-Bench | Soil C | Soil D | Soil E | RVS Score |
| Primary | S3 | 3.8 | 0 | -0.5 | 0 | 0 | -0.6 | 0 | 0 | 2.7 |

Low (<1%)
