# Camas Valley FD

Building Type		County	
Fire - RFPD		Douglas	
Street			
261 Main Camas Rd			
City	State	Zip	
Camas Valley	OR	97416	
Latitude		Longitude	
43.03373		123.6762	
Tracking Code		Inspection Date	
RVS in 2006		8/18/2006

## FEMA 154 Rapid Visual Screening Score Card

Rapid Visual Screening - Senate Bill #2 - Seismic Needs Assessment  
Oregon Department of Geology and Mineral Industries

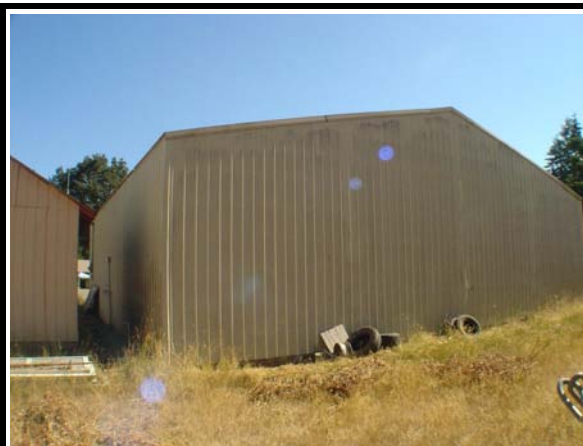
Type	Basic Score	Vert Irreg	Plan Irreg	Pre-Code	Post-Bench	Soil C	Soil D	Soil E	RVS Score
Primary	S3	3.2	0	-0.5	0	0	-0.4	0	0	2.3
Secondary		0	0	0	0	0	0	0	0	0
Tertiary		0	0	0	0	0	0	0	0	0

Low (<1%)

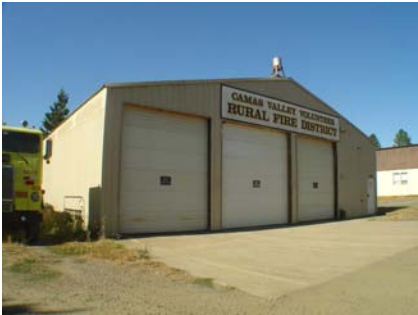
SW Plan Irregularity Primary
