Green Elementary School

Douglas County SD 4

FEMA 154 Rapid Visual Screening Score Card

Rapid Visual Screening - Senate Bill #2 - Seismic Needs Assessment
Oregon Department of Geology and Mineral Industries

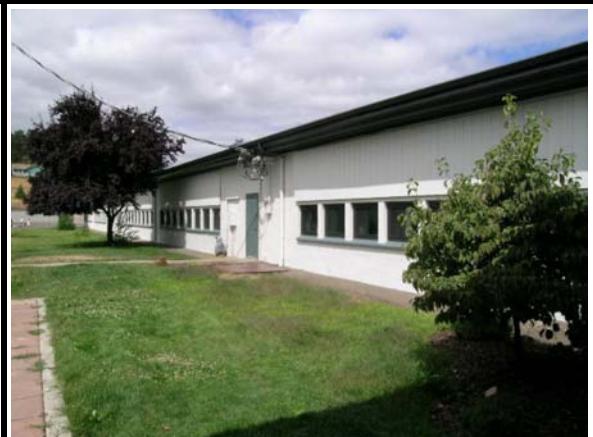
Doug_sch04A

Type	Basic Score	Vert Irreg	Plan Irreg	Pre-Code	Post-Bench	Soil C	Soil D	Soil E	RVS Score
Primary	URM	1.8	0	0	0	0	-0.4	0	0	1.4
Secondary	RM1	2.8	0	0	0	0	-0.4	0	0	2.4
Tertiary		0	0	0	0	0	0	0	0	0

Final Type	Final Score
URM	1.4

Moderate (>1%)

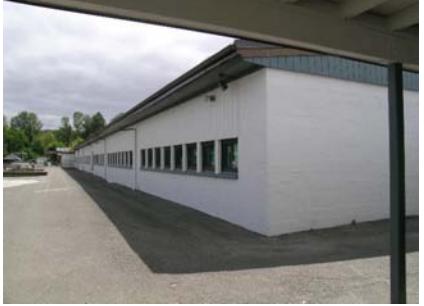
NE Primary Structural Type

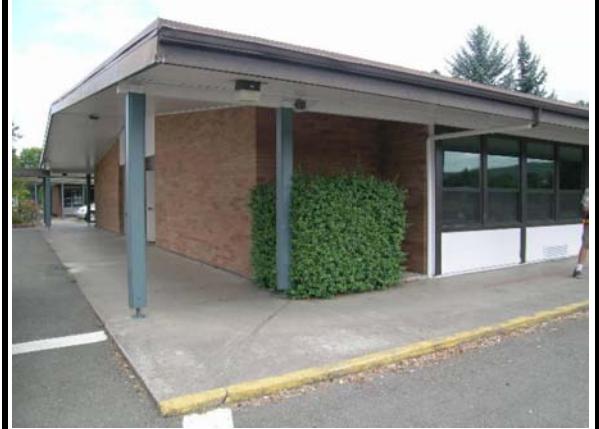
Doug_sch04B

Type	Basic Score	Vert Irreg	Plan Irreg	Pre-Code	Post-Bench	Soil C	Soil D	Soil E	RVS Score
Primary	W2	3.8	0	-0.5	0	0	-0.4	0	0	2.9
Secondary	RM1	2.8	0	-0.5	0	0	-0.4	0	0	1.9
Tertiary		0	0	0	0	0	0	0	0	0

Final Type	Final Score
RM1	1.9

Moderate (>1%)

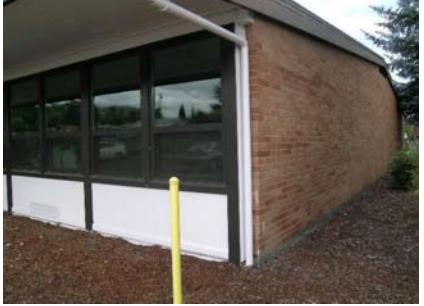
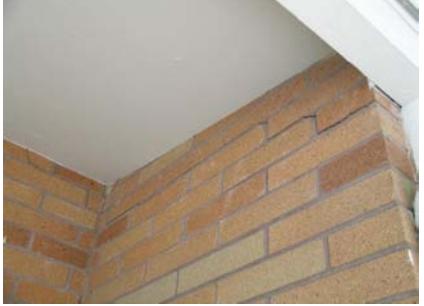
Enrollment 426	Year Built (Field Verified) 1949	Year Built (Alt. Source) 1949	Est. Decade Built 1960
Total Area (square ft) 36298	Number of Stories 1	Basement	Pounding Potential No
Plan Irregularities		Vertical Irregularities	
Out of Plane Lateral-Force-Resistance Elements None		None	
None		None	
Falling Hazards		Poor Conditions	
None		Cracks	
None		None	
None		None

SW Primary Structural Type also shows secondary structure type.		W Poor Condition

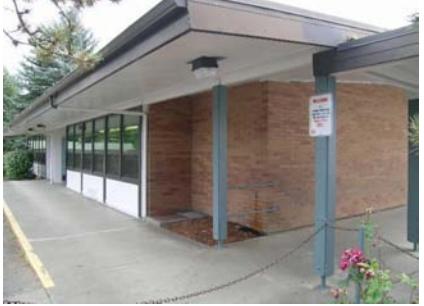
NE Elevation View

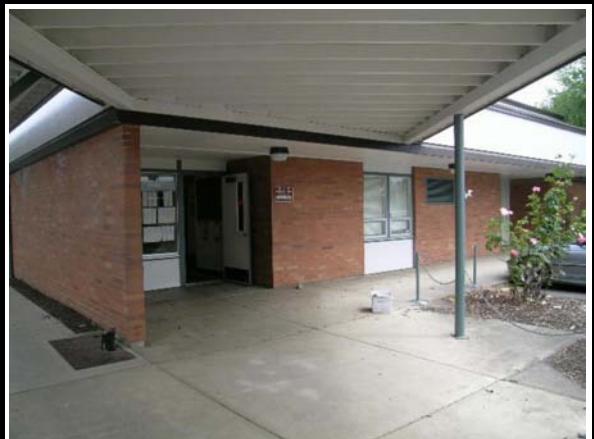
Doug_sch04C

Type	Basic Score	Vert Irreg	Plan Irreg	Pre-Code	Post-Bench	Soil C	Soil D	Soil E	RVS Score
Primary	RM1	2.8	-1	-0.5	0	0	-0.4	0	0	0.9
Secondary		0	0	0	0	0	0	0	0	0
Tertiary		0	0	0	0	0	0	0	0	0

Final Type	Final Score
RM1	0.9

High (>10%)

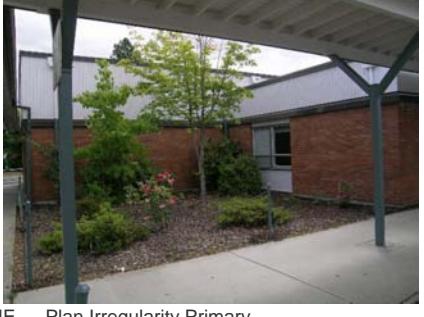
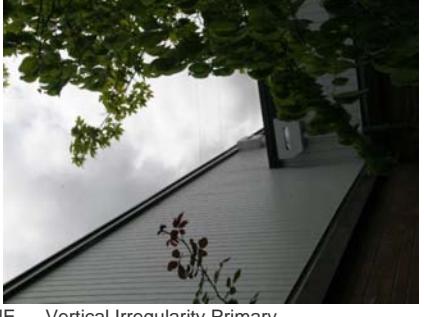
Enrollment 426	Year Built (Field Verified) 1949	Year Built (Alt. Source) 1949	Est. Decade Built 1960
Total Area (square ft) 36298	Number of Stories 1	Basement	Pounding Potential No
Plan Irregularities Reentrant Corners: L Shaped None None		Vertical Irregularities Steps in Elevation View: Single Change None None	
Falling Hazards None None None		Poor Conditions None None None

NE Plan Irregularity Primary		NE Vertical Irregularity Primary

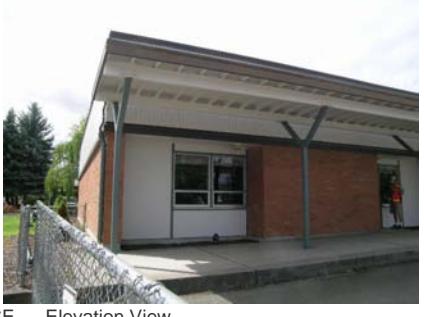
SE Elevation View

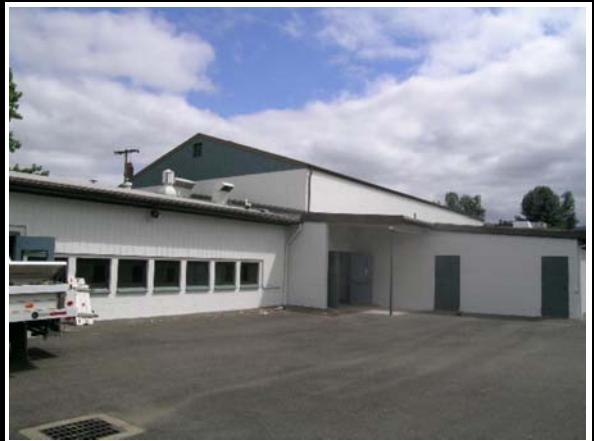
Doug_sch04D

Type	Basic Score	Vert Irreg	Plan Irreg	Pre-Code	Post-Bench	Soil C	Soil D	Soil E	RVS Score
Primary	URM	1.8	-1	-0.5	0	0	-0.4	0	0	-0.1
Secondary	RM1	2.8	-1	-0.5	0	0	-0.4	0	0	0.9
Tertiary		0	0	0	0	0	0	0	0	0

Final Type	Final Score
URM	-0.1

Very High (100%)

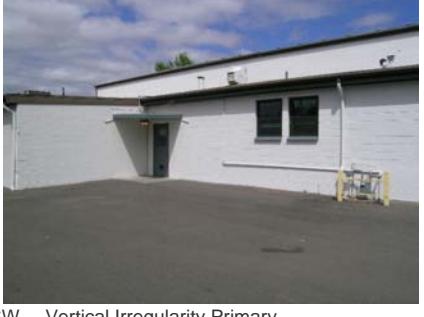
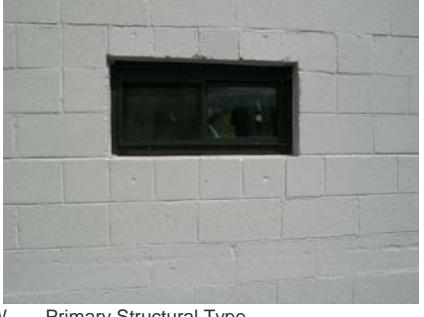
Enrollment 426	Year Built (Field Verified) 1949	Year Built (Alt. Source) 1949	Est. Decade Built 1950
Total Area (square ft) 36298	Number of Stories 1	Basement	Pounding Potential No
Plan Irregularities Reentrant Corners: T shaped None None		Vertical Irregularities Steps in Elevation View: Single Change None None	
Falling Hazards None None None		Poor Conditions None None None

SW Vertical Irregularity Primary also shows a reentrant corner		W Primary Structural Type	
		S Vertical Irregularity Primary
