Yoncalla Elementary School

Doug_sch19A

FEMA 154 Rapid Visual Screening Score Card

Rapid Visual Screening - Senate Bill #2 - Seismic Needs Assessment
Oregon Department of Geology and Mineral Industries

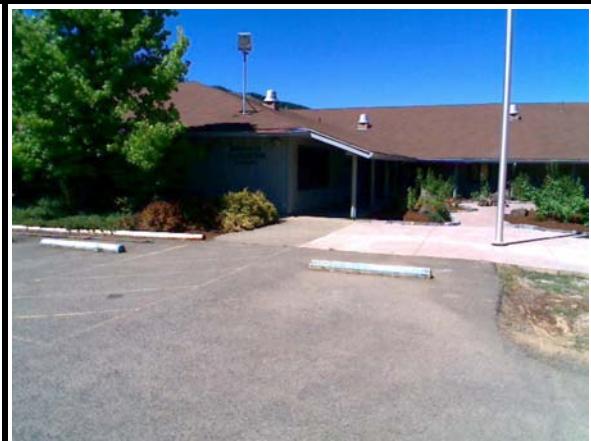
Type	Basic Score	Vert Irreg	Plan Irreg	Pre-Code	Post-Bench	Soil C	Soil D	Soil E	RVS Score
Primary	W2	3.8	-2	-0.5	0	0	-0.4	0	0	0.9
Secondary		0	0	0	0	0	0	0	0	0
Tertiary		0	0	0	0	0	0	0	0	0

Final Type	Final Score
W2	0.9

High (>10%)

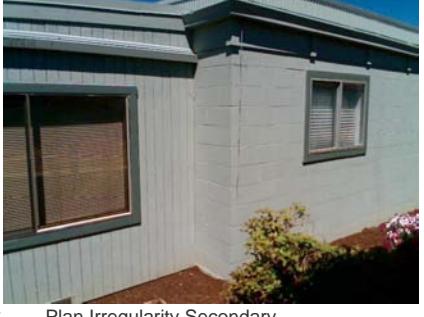
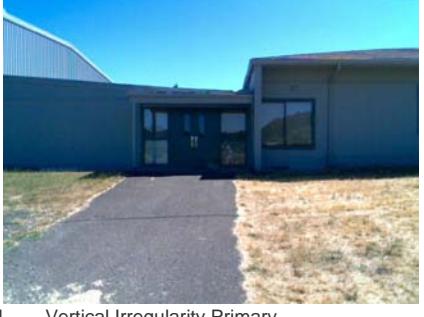
Enrollment 223	Year Built (Field Verified) 1952	Year Built (Alt. Source) 1952	Est. Decade Built 1970
Total Area (square ft) 42066	Number of Stories 1	Basement	Pounding Potential No
Plan Irregularities		Vertical Irregularities	
Reentrant Corners: Other		Steps in Elevation View: Single Change	
Out of Plane Lateral-Force-Resistance Elements		Steps in Elevation View: Single Change (Adjacent Building/Entity)	
None		None	
Falling Hazards		Poor Conditions	
None		None	
None		None	
None		None

S Plan Irregularity Secondary Building A is on the left and B is on the right.		N Vertical Irregularity Primary

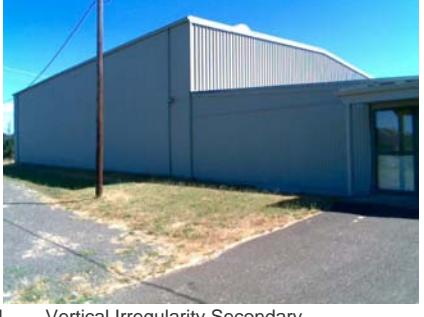
N Vertical Irregularity Secondary Building A is on the right Building B is on the left.

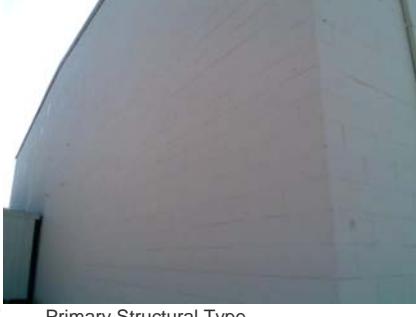
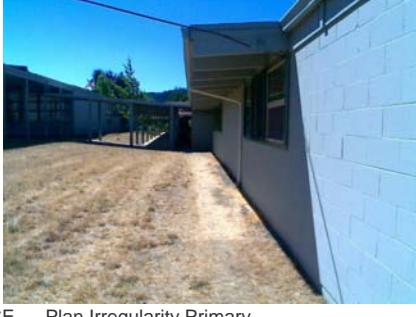
E Primary Structural Type East wall is RM1		SE Plan Irregularity Primary	
		S Vertical Irregularity Primary also shows RM1 for the lower level and S3 for the upper level.

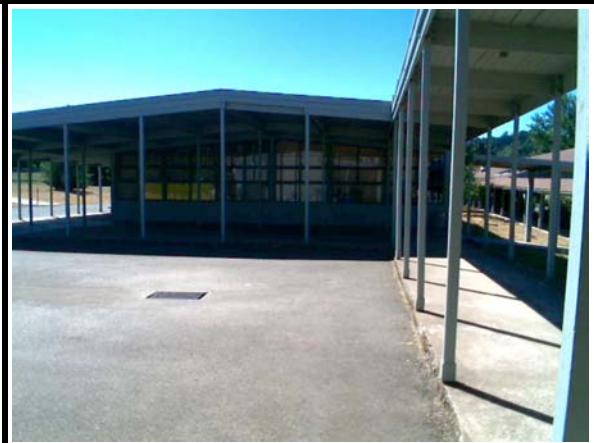
Type	Basic Score	Vert Irreg	Plan Irreg	Pre-Code	Post-Bench	Soil C	Soil D	Soil E	RVS Score
Primary	W1	4.4	0	0	0	0	0	0	0	4.4
Secondary		0	0	0	0	0	0	0	0	0
Tertiary		0	0	0	0	0	0	0	0	0

Final Type	Final Score
W1	4.4

Low (<1%)

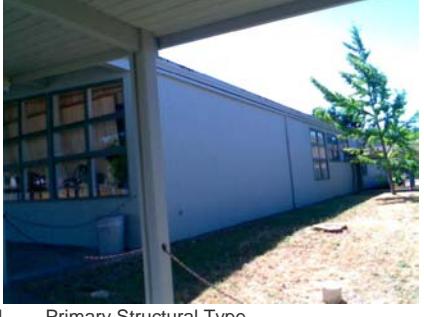
N Primary Structural Type
