# Winston Middle School

Doug\_sch25A

## FEMA 154 Rapid Visual Screening Score Card

Rapid Visual Screening - Senate Bill #2 - Seismic Needs Assessment  
Oregon Department of Geology and Mineral Industries

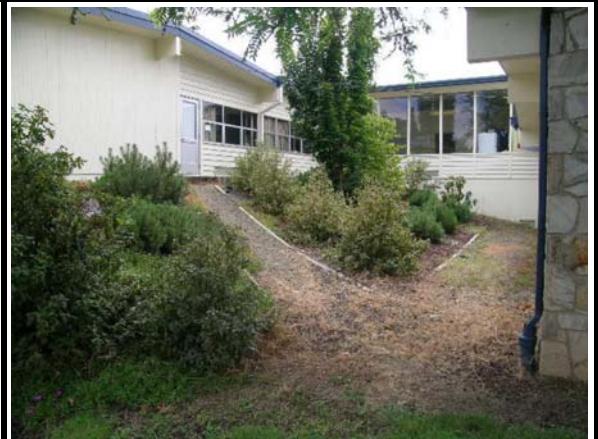
Building Type School	County Douglas	
Street 330 SE Thompson Ave		
City Winston	State OR	Zip 97496
Latitude 43.11461	Longitude 123.40896	
Tracking Code RVS in 2006	Inspection Date 8/18/2006

Type	Basic Score	Vert Irreg	Plan Irreg	Pre-Code	Post-Bench	Soil C	Soil D	Soil E	RVS Score
Primary	W2	3.8	-2	-0.5	0	0	-0.4	0	0	0.9
Secondary		0	0	0	0	0	0	0	0	0
Tertiary		0	0	0	0	0	0	0	0	0

Final Type	Final Score
W2	0.9

High (>10%)

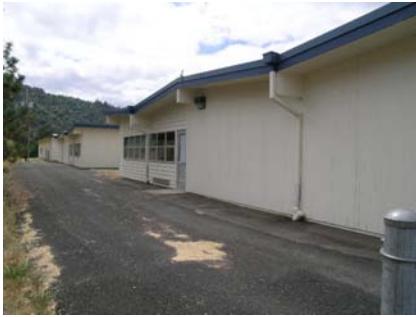
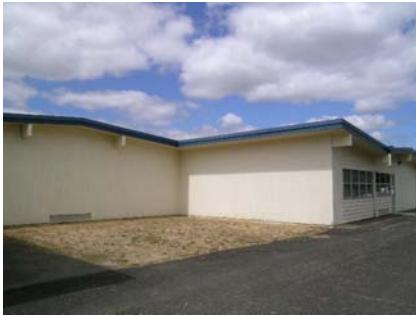
Enrollment 255	Year Built (Field Verified) 1966	Year Built (Alt. Source) 1950	Est. Decade Built
Total Area (square ft) 56534	Number of Stories 1	Basement	Pounding Potential No
<b>Plan Irregularities</b> Reentrant Corners: Other Reentrant Corners: Other (Adjacent Build/Entity) None		<b>Vertical Irregularities</b> Steps in Elevation View: Very Irregular Changes Building On Hill or Sloped Site Steps in Elevation View: Single Change (Adjacent Building/Entity)	
<b>Falling Hazards</b> None None None		<b>Poor Conditions</b> Cracks None None

E Primary Structural Type	SE Plan Irregularity Primary	W Vertical Irregularity Primary

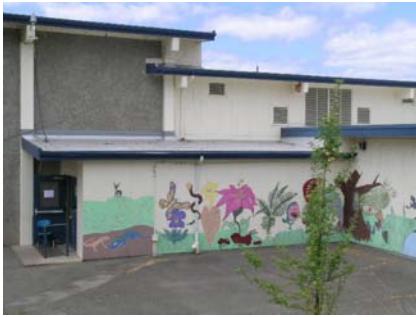
W Vertical Irregularity Secondary

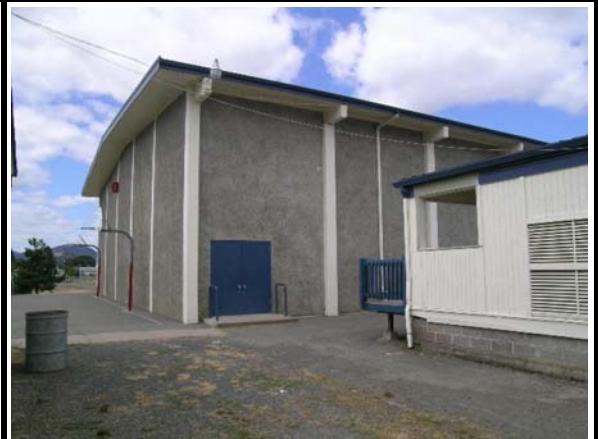
Doug\_sch25B

Building Type School	County Douglas	
Street 330 SE Thompson Ave		
City Winston	State OR	Zip 97496
Latitude 43.11438	Longitude 123.40944	
Tracking Code RVS in 2006	Inspection Date 8/18/2006

Type	Basic Score	Vert Irreg	Plan Irreg	Pre-Code	Post-Bench	Soil C	Soil D	Soil E	RVS Score
Primary	PC1	2.6	0	-0.5	0	0	-0.4	0	0	1.7
Secondary	C2	2.8	-1	-0.5	0	0	-0.4	0	0	0.9
Tertiary		0	0	0	0	0	0	0	0	0

Final Type	Final Score
C2	0.9

High (>10%)

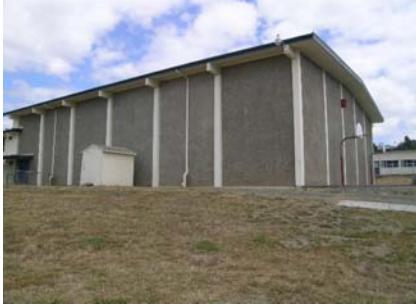
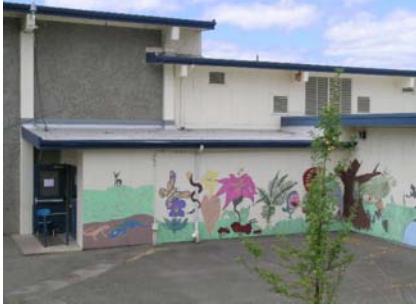
Enrollment 255	Year Built (Field Verified) 1966	Year Built (Alt. Source) 1950	Est. Decade Built 1950
Total Area (square ft) 56534	Number of Stories 1	Basement	Pounding Potential No
Plan Irregularities Reentrant Corners:Other (Adjacent Build/Entity) None None		Vertical Irregularities Steps in Elevation View: Very Irregular Changes (Adjacent Building/Ent) None None	
Falling Hazards None None None		Poor Conditions None None None

SW Elevation View		E Vertical Irregularity Primary

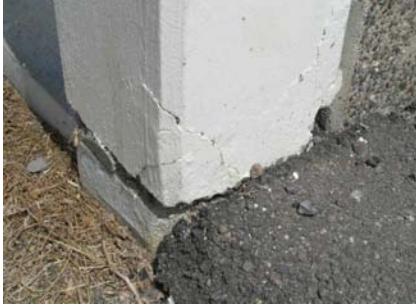
SW Poor Condition

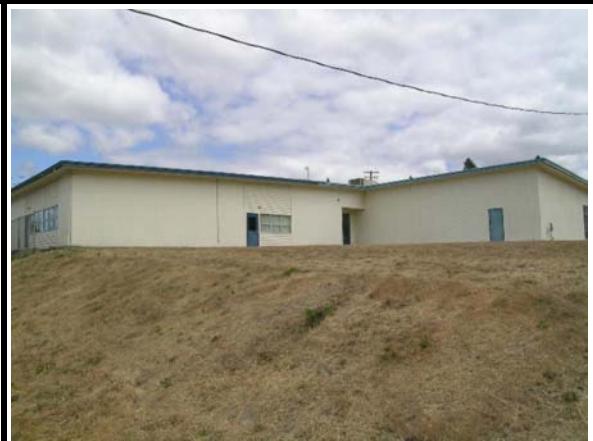
Doug\_sch25C

Building Type School	County Douglas	
Street 330 SE Thompson Ave		
City Winston	State OR	Zip 97496
Latitude 43.11418	Longitude 123.40878	
Tracking Code RVS in 2006	Inspection Date 8/18/2006

Type	Basic Score	Vert Irreg	Plan Irreg	Pre-Code	Post-Bench	Soil C	Soil D	Soil E	RVS Score
Primary	W2	3.8	0	-0.5	0	2.4	-0.4	0	0	5.3
Secondary		0	0	0	0	0	0	0	0	0
Tertiary		0	0	0	0	0	0	0	0	0

Final Type	Final Score
W2	5.3

Low (<1%)
