Oakland High School

Doug_sch37A

FEMA 154 Rapid Visual Screening Score Card

Rapid Visual Screening - Senate Bill #2 - Seismic Needs Assessment
Oregon Department of Geology and Mineral Industries

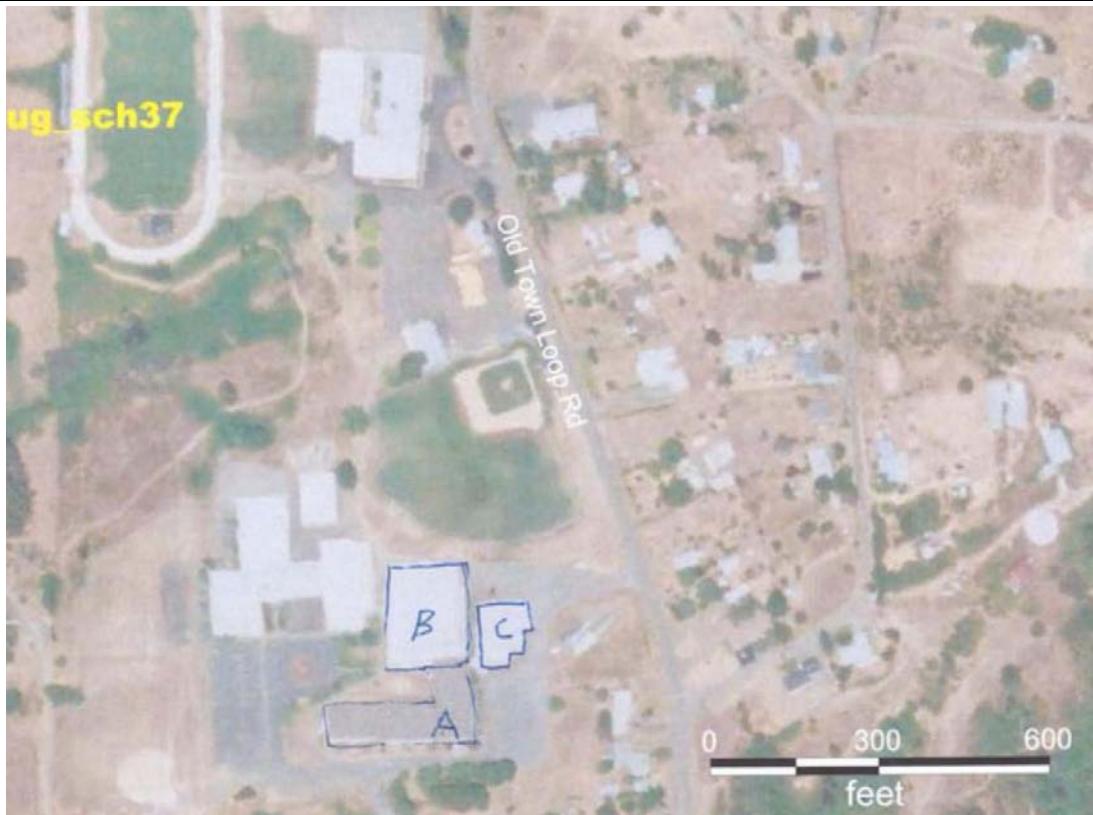
Enrollment 203	Year Built (Field Verified) 1948	Year Built (Alt. Source) 1948	Est. Decade Built 1950
Total Area (square ft) 51202	Number of Stories 1	Basement	Pounding Potential No
Plan Irregularities		Vertical Irregularities	
Reentrant Corners: Other		Steps in Elevation View: Single Change (Adjacent Building/Entity)	
Out of Plane Lateral-Force-Resistance Elements		None	
Reentrant Corners: L Shaped (Adjacent Build/Entity)		None	
Falling Hazards		Poor Conditions	
Unreinforced Chimneys		None	
None		None	
None		None

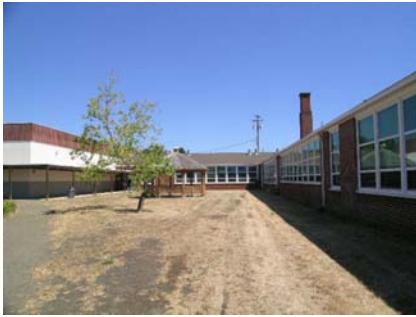
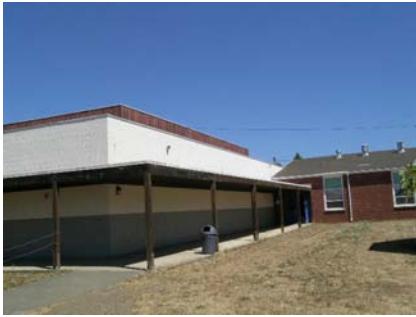
NW Falling Hazard and reentrant corner		SW Vertical Irregularity Primary

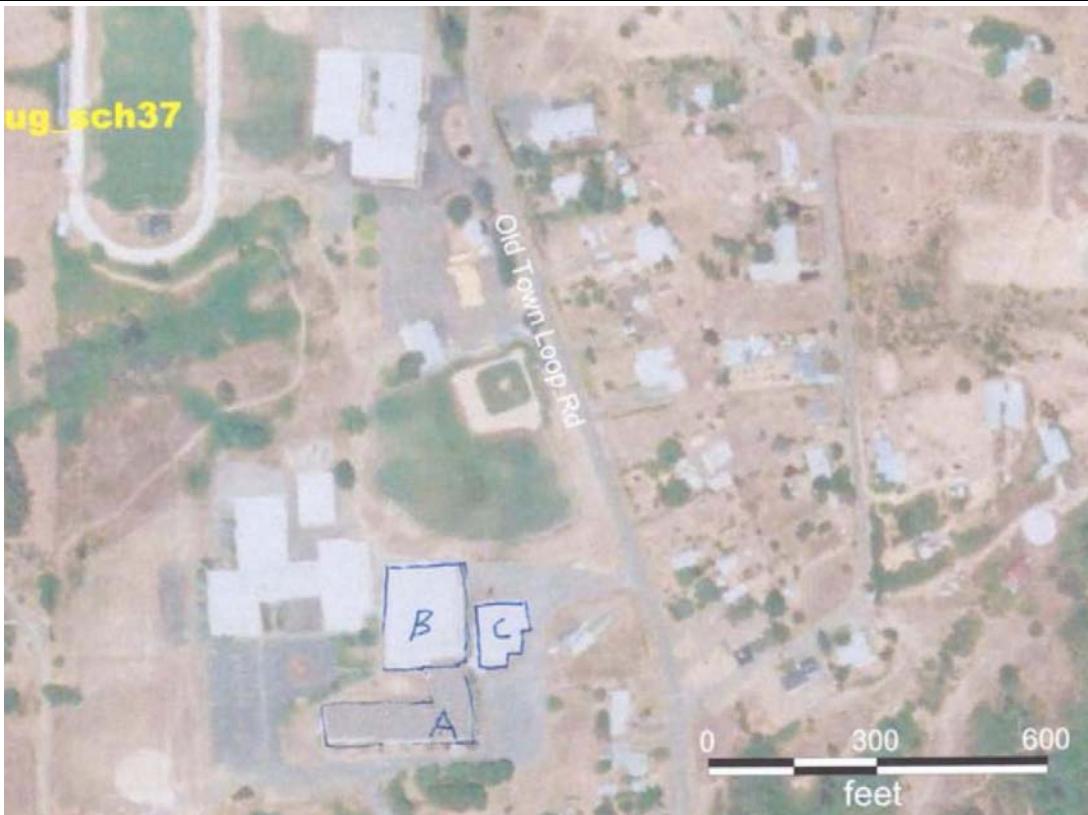
Enrollment 203	Year Built (Field Verified) 1948	Year Built (Alt. Source) 1948	Est. Decade Built 1970
Total Area (square ft) 51202	Number of Stories 1	Basement	Pounding Potential No
Plan Irregularities Reentrant Corners:L shaped (Adjacent Build/Entity) None None		Vertical Irregularities Steps in Elevation View: Single Change Steps in Elevation View: Very Irregular Changes (Adjacent Building/Ent) None	
Falling Hazards None None None		Poor Conditions None None None

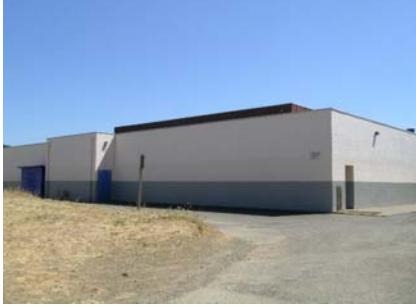
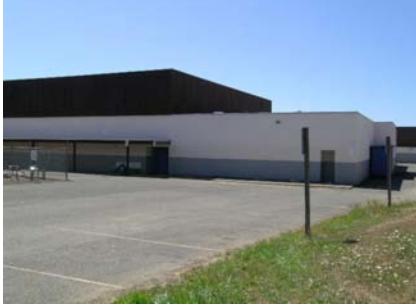
NE Elevation View		E Vertical Irregularity Primary

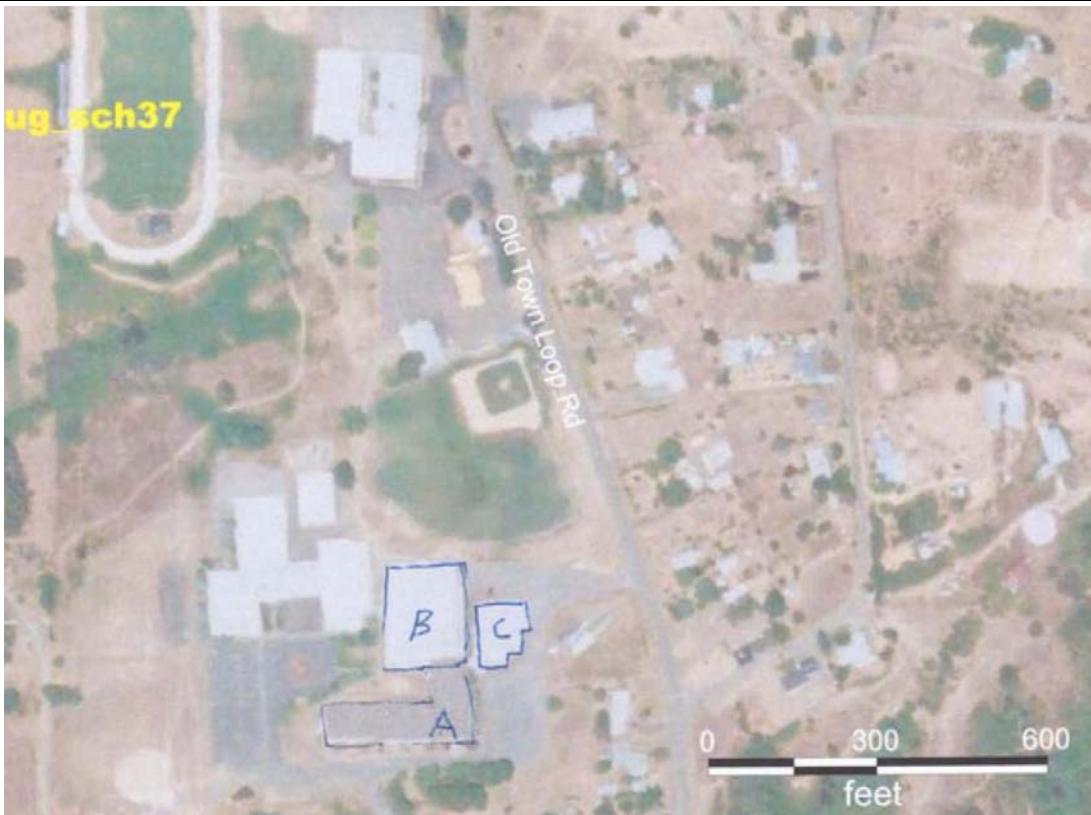
Enrollment 203	Year Built (Field Verified) 1948	Year Built (Alt. Source) 1948	Est. Decade Built 1950
Total Area (square ft) 51202	Number of Stories 1	Basement	Pounding Potential No
Plan Irregularities Reentrant Corners: Other None None		Vertical Irregularities Steps in Elevation View: Single Change None None	
Falling Hazards None None None		Poor Conditions None None None

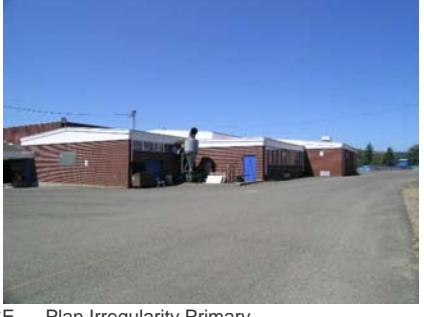
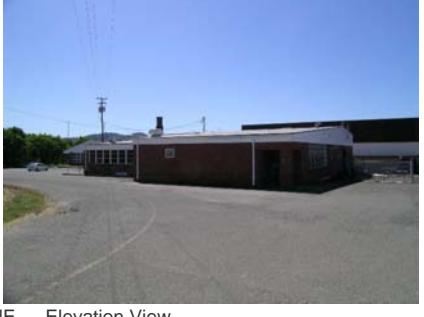
SE Plan Irregularity Primary and step in elevation		NE Elevation View
