Long Creek School

Gran_sch01A

FEMA 154 Rapid Visual Screening Score Card

Rapid Visual Screening - Senate Bill #2 - Seismic Needs Assessment
Oregon Department of Geology and Mineral Industries

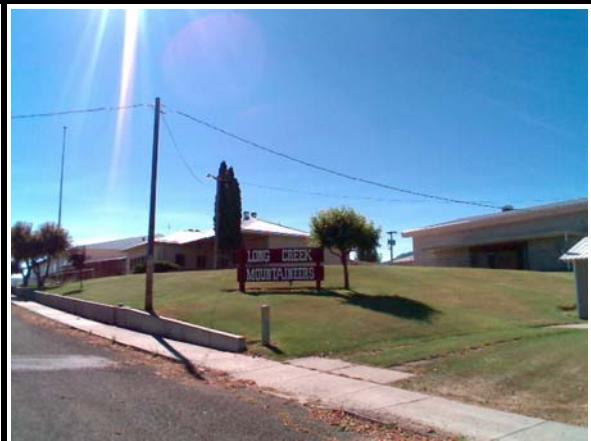
Building Type School	County Grant	
Street 375 E Main St.		
City Long Creek	State OR	Zip 97856
Latitude 44.71343	Longitude 119.09956	
Tracking Code RVS in 2006	Inspection Date 7/28/2006

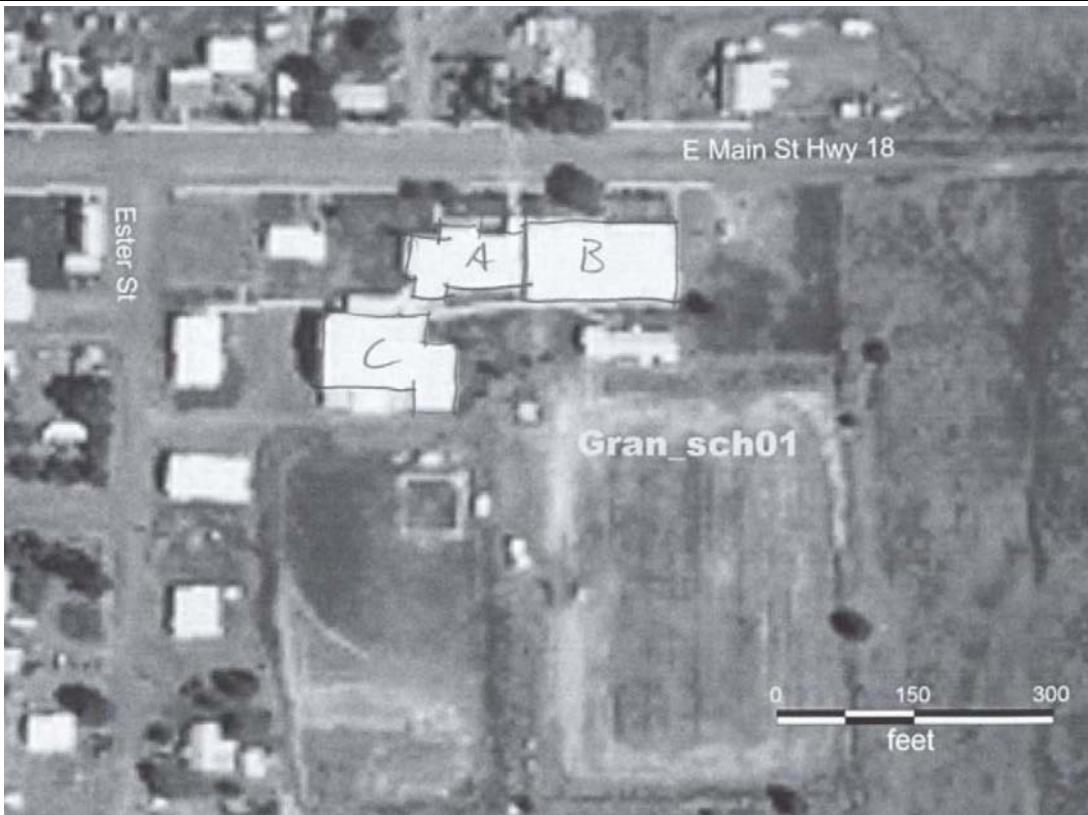
Type	Basic Score	Vert Irreg	Plan Irreg	Pre-Code	Post-Bench	Soil C	Soil D	Soil E	RVS Score
Primary	RM1	3.6	-2	-0.5	0	0	-0.8	0	0	0.3
Secondary		0	0	0	0	0	0	0	0	0
Tertiary		0	0	0	0	0	0	0	0	0

Final Type	Final Score
RM1	0.3

High (>10%)

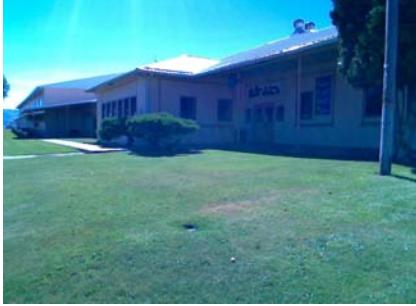
NW Elevation View		SW Plan Irregularity Secondary

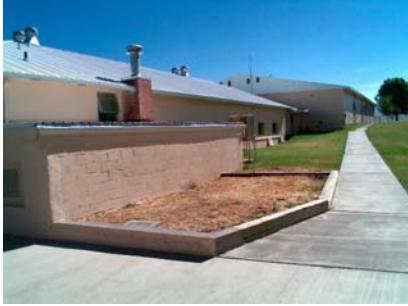
Enrollment 50	Year Built (Field Verified) 1971	Year Built (Alt. Source) 1950	Est. Decade Built
Total Area (square ft) 11885	Number of Stories 1	Basement	Pounding Potential No
Plan Irregularities Reentrant Corners: T shaped Reentrant Corners: Other None		Vertical Irregularities Steps in Elevation View: Single Change (Adjacent Building/Entity) None None	
Falling Hazards None None None		Poor Conditions None None None

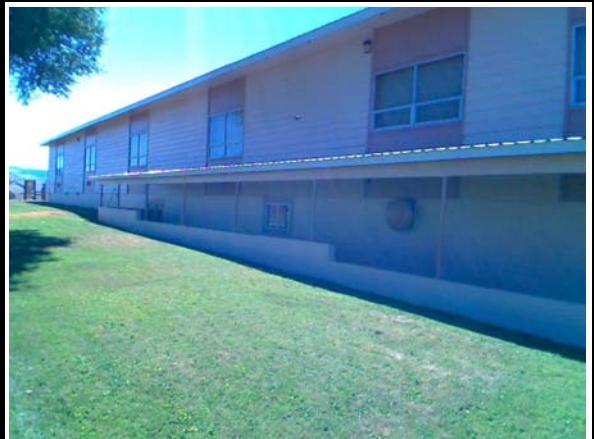
Gran_sch01B

Building Type School	County Grant	
Street 375 E Main St.		
City Long Creek	State OR	Zip 97856
Latitude 44.71342	Longitude 119.09899	
Tracking Code RVS in 2006	Inspection Date 7/28/2006

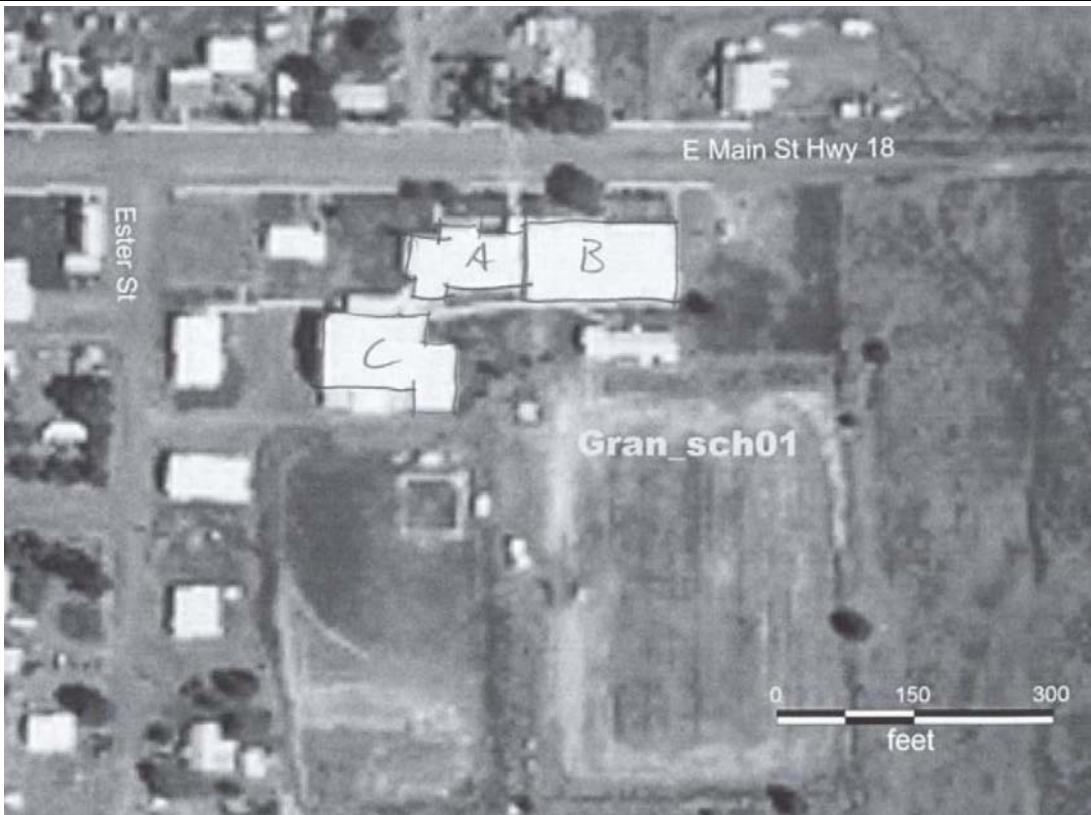
Type	Basic Score	Vert Irreg	Plan Irreg	Pre-Code	Post-Bench	Soil C	Soil D	Soil E	RVS Score
Primary	W2	4.8	-3	-0.5	0	0	-0.8	0	0	0.5
Secondary		0	0	0	0	0	0	0	0	0
Tertiary		0	0	0	0	0	0	0	0	0

Final Type	Final Score
W2	0.5

High (>10%)

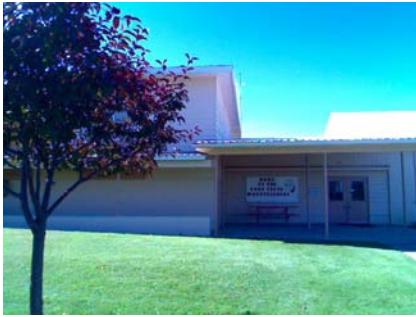
Enrollment 50	Year Built (Field Verified) 1971	Year Built (Alt. Source) 1971	Est. Decade Built 1960
Total Area (square ft) 11885	Number of Stories 1	Basement	Pounding Potential No
Plan Irregularities Reentrant Corners:L shaped (Adjacent Build/Entity) None None		Vertical Irregularities Steps in Elevation View: Single Change (Adjacent Building/Entity) None None	
Falling Hazards None None None		Poor Conditions None None None

N Vertical Irregularity Primary		E Elevation View

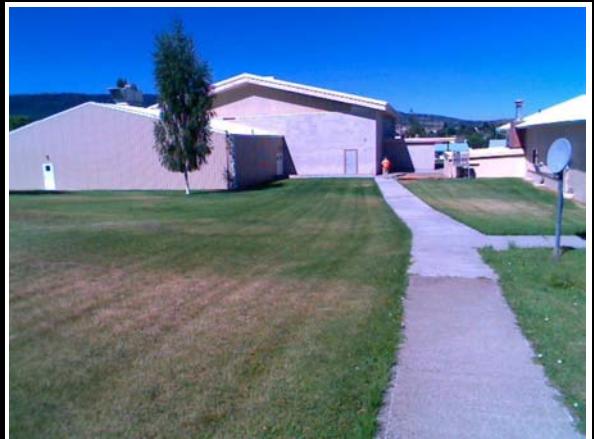
Gran_sch01C

Building Type School	County Grant	
Street 375 E Main St.		
City Long Creek	State OR	Zip 97856
Latitude 44.71313	Longitude 119.0999	
Tracking Code RVS in 2006	Inspection Date 7/28/2006

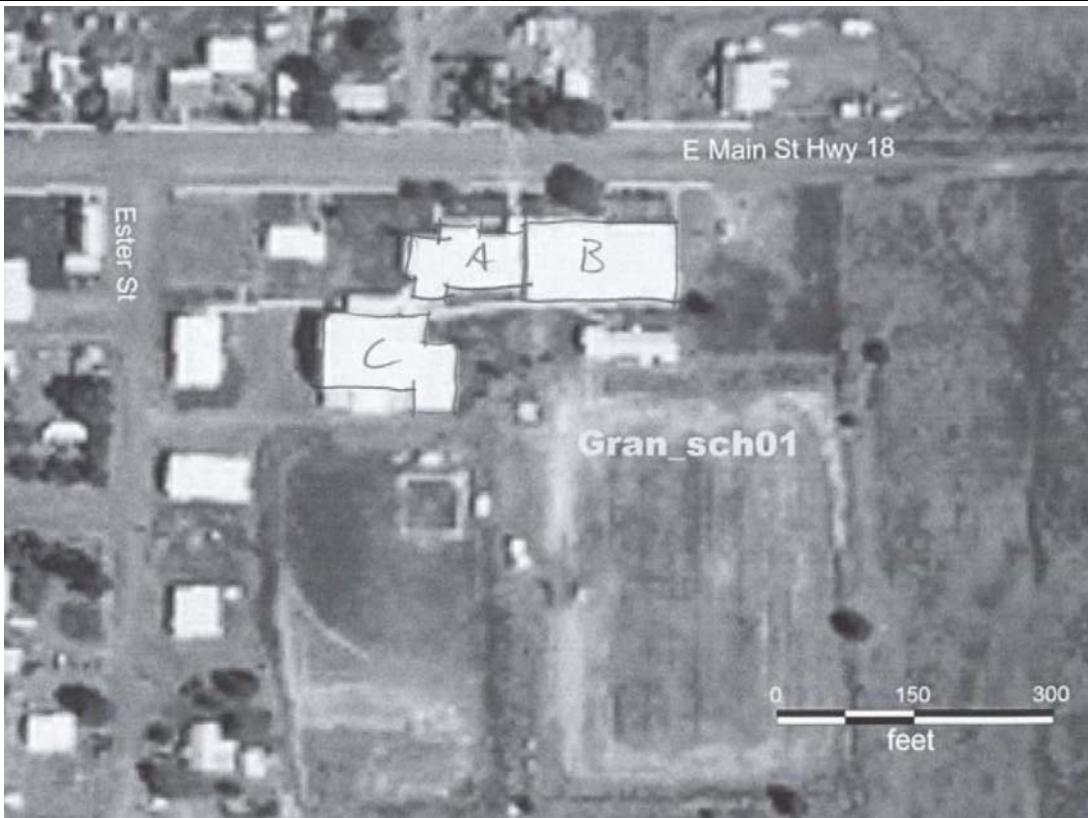
Type	Basic Score	Vert Irreg	Plan Irreg	Pre-Code	Post-Bench	Soil C	Soil D	Soil E	RVS Score
Primary	RM1	3.6	-2	-0.5	0	0	-0.8	0	0	0.3
Secondary	S3	3.8	0	-0.5	0	0	-0.6	0	0	2.7
Tertiary		0	0	0	0	0	0	0	0	0

Final Type	Final Score
RM1	0.3

High (>10%)
