Humbolt Elementary School

John Day SD 3

Gran_sch06A

FEMA 154 Rapid Visual Screening Score Card

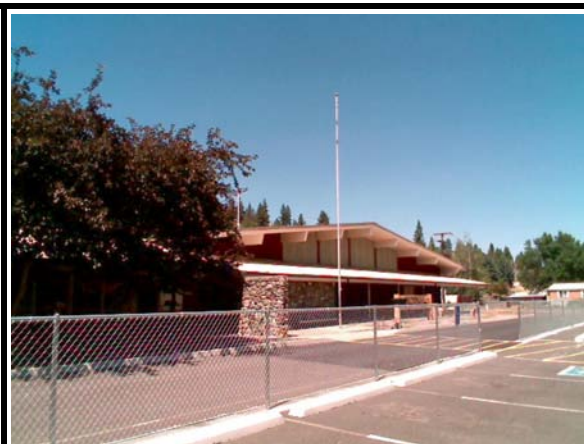
Type	Basic Score	Vert Irreg	Plan Irreg	Pre-Code	Post-Bench	Soil C	Soil D	Soil E	RVS Score
Primary	W2	4.8	-3	-0.5	0	0	0	-1.2	0	0.1
Secondary	RM1	3.6	-2	-0.5	0	0	0	-1.2	0	-0.1
Tertiary		0	0	0	0	0	0	0	0	0

RM1

-0.1

Very High (100%)

Plan Irregularities	Vertical Irregularities
Reentrant Corners: L Shaped	Steps in Elevation View: Single Change
None	None
None	None

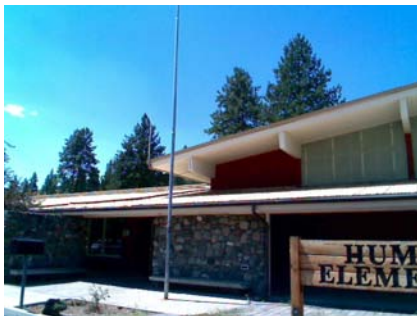
E Vertical Irregularity Primary

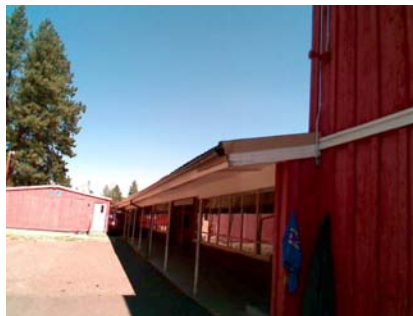
W Elevation View

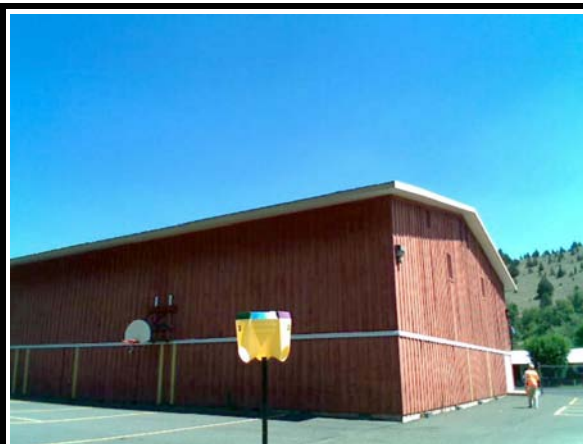
Gran_sch06B

Type	Basic Score	Vert Irreg	Plan Irreg	Pre-Code	Post-Bench	Soil C	Soil D	Soil E	RVS Score
Primary	W2	4.8	0	0	0	0	0	-1.2	0	3.6
Secondary	RM1	3.6	0	0	0	0	0	-1.2	0	2.4
Tertiary		0	0	0	0	0	0	0	0	0

RM1

2.4

Low (<1%)
