Monument School

Gran_sch08A

FEMA 154 Rapid Visual Screening Score Card

Rapid Visual Screening - Senate Bill #2 - Seismic Needs Assessment
Oregon Department of Geology and Mineral Industries

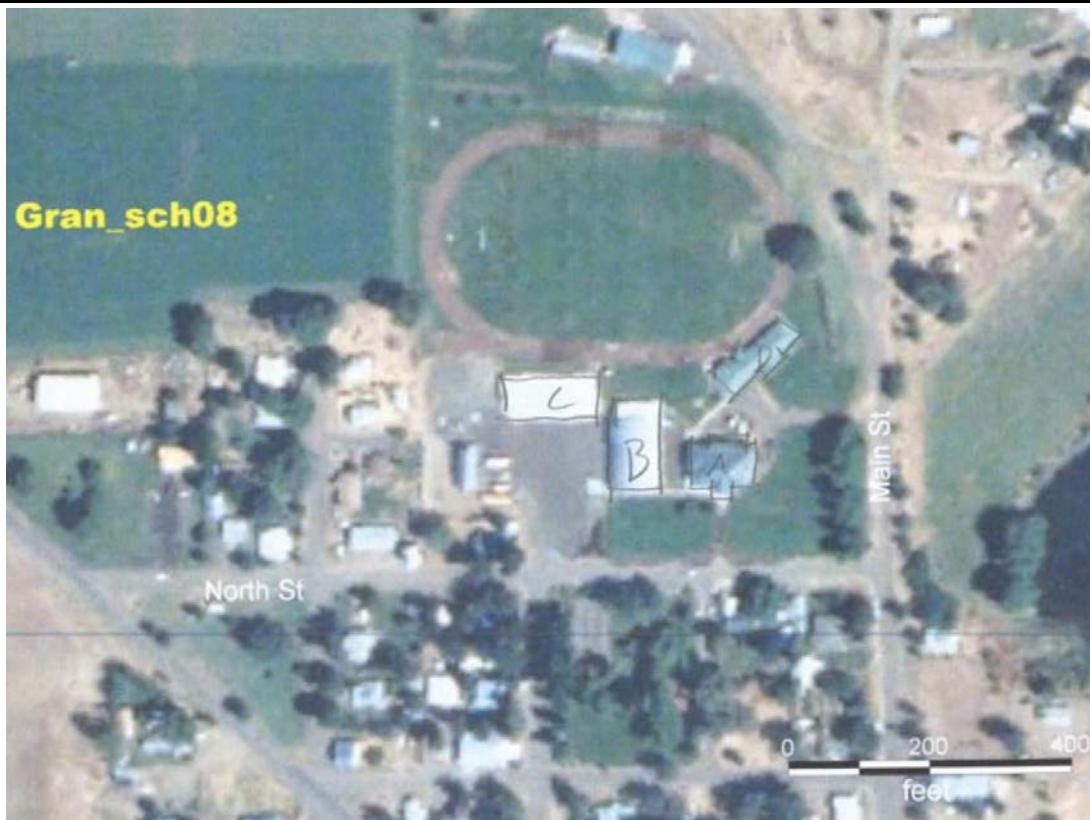
Type	Basic Score	Vert Irreg	Plan Irreg	Pre-Code	Post-Bench	Soil C	Soil D	Soil E	RVS Score
Primary	URM	3.4	-1.5	-0.5	-0.4	0	-0.4	0	0	0.6
Secondary		0	0	0	0	0	0	0	0	0
Tertiary		0	0	0	0	0	0	0	0	0

Final Type	Final Score
URM	0.6

High (>10%)

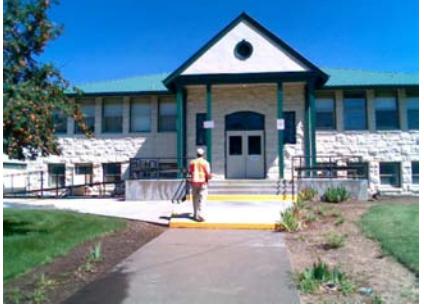
S Elevation View

Enrollment 56	Year Built (Field Verified) 1929	Year Built (Alt. Source) 1920	Est. Decade Built 1920
Total Area (square ft) 10000	Number of Stories 1	Basement	Pounding Potential No
Plan Irregularities Reentrant Corners: Other None None		Vertical Irregularities Internal Discontinuous Diaphram (large internal opening) None None	
Falling Hazards None None None		Poor Conditions None None None

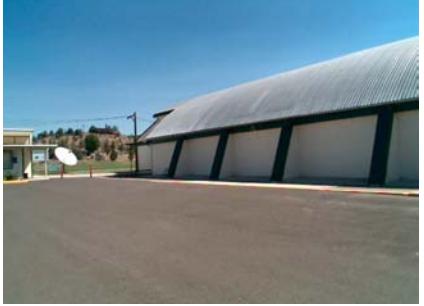
SW General Site

Enrollment 56	Year Built (Field Verified) 1929	Year Built (Alt. Source) 1940	Est. Decade Built 1940
Total Area (square ft) 10000	Number of Stories 1	Basement	Pounding Potential No
Plan Irregularities Reentrant Corners: Other None None		Vertical Irregularities Steps in Elevation View: Single Change None None	
Falling Hazards None None None		Poor Conditions None None None

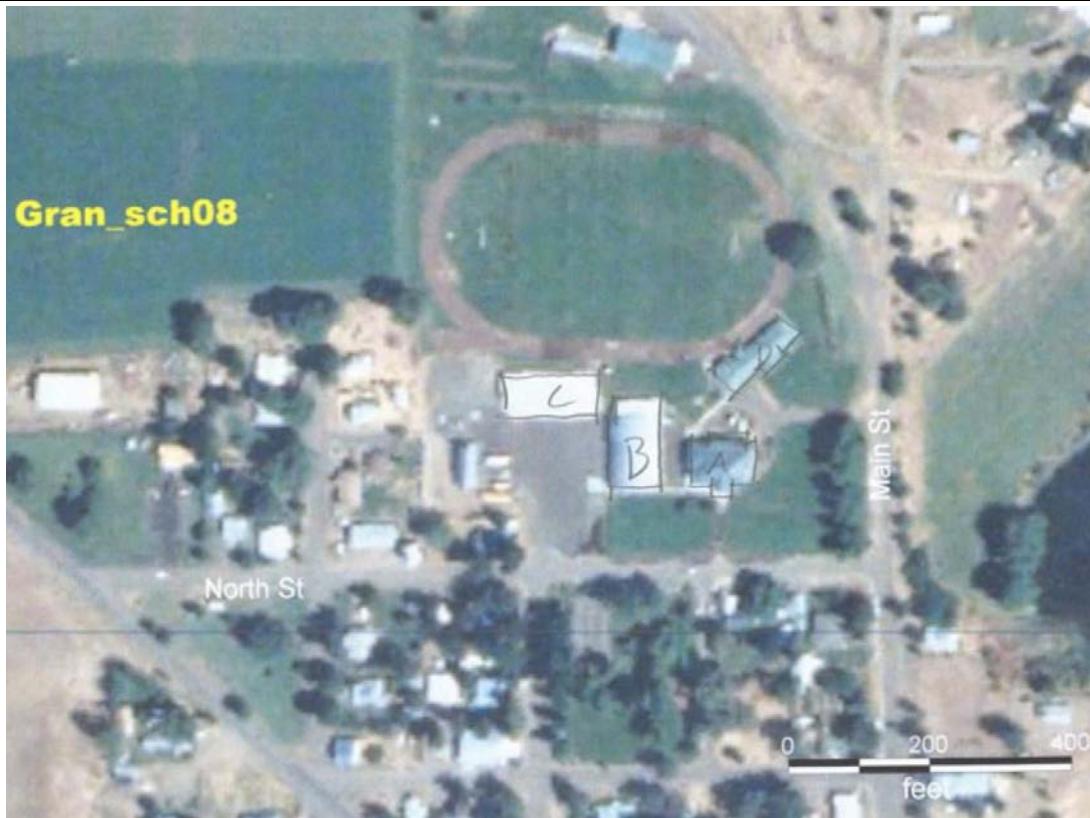
Gran_sch08C

Type	Basic Score	Vert Irreg	Plan Irreg	Pre-Code	Post-Bench	Soil C	Soil D	Soil E	RVS Score
Primary	W2	4.8	-3	0	0	0	-0.8	0	0	1
Secondary		0	0	0	0	0	0	0	0	0
Tertiary		0	0	0	0	0	0	0	0	0

Final Type	Final Score
W2	1

High (>10%)

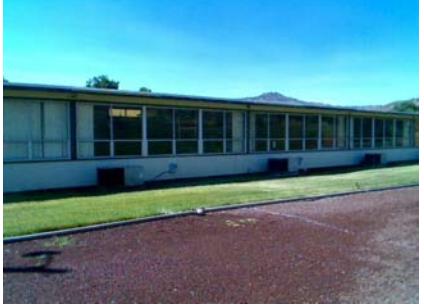
N Elevation View

Enrollment 56	Year Built (Field Verified) 1929	Year Built (Alt. Source) 1950	Est. Decade Built 1950
Total Area (square ft) 10000	Number of Stories 1	Basement	Pounding Potential No
Plan Irregularities None None None		Vertical Irregularities Steps in Elevation View: Single Change None None	
Falling Hazards None None None		Poor Conditions None None None

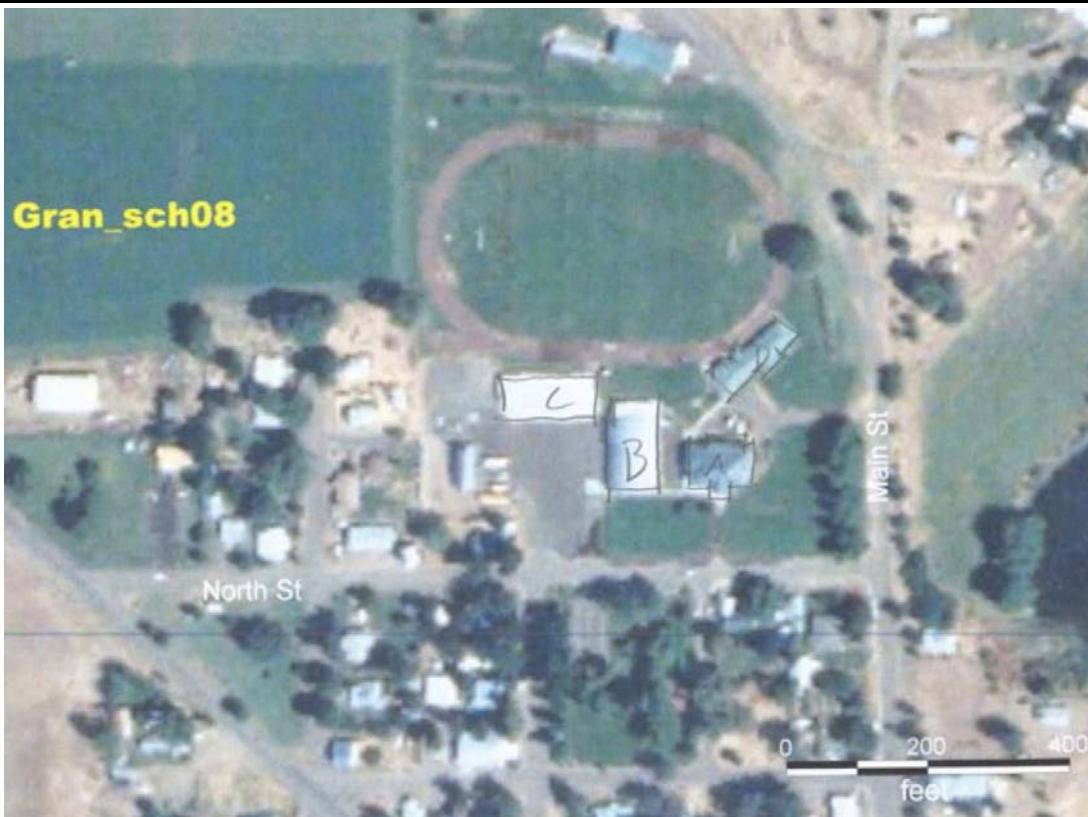
Gran_sch08D

Type	Basic Score	Vert Irreg	Plan Irreg	Pre-Code	Post-Bench	Soil C	Soil D	Soil E	RVS Score
Primary	W2	4.8	0	-0.5	0	1.6	-0.8	0	0	5.1
Secondary		0	0	0	0	0	0	0	0	0
Tertiary		0	0	0	0	0	0	0	0	0

Final Type	Final Score
W2	5.1

Low (<1%)

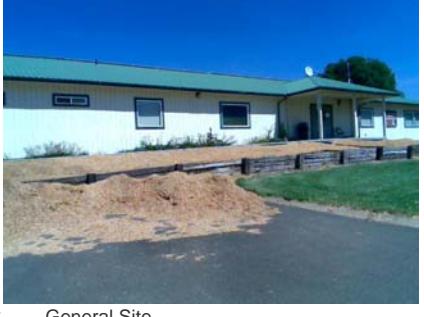
S General Site

Enrollment 56	Year Built (Field Verified) 1929	Year Built (Alt. Source) 1929	Est. Decade Built 1980
Total Area (square ft) 10000	Number of Stories 1	Basement	Pounding Potential No
Plan Irregularities Reentrant Corners: Other None None		Vertical Irregularities None None None	
Falling Hazards None None None		Poor Conditions None None None
