Odell RFPD

FEMA 154 Rapid Visual Screening Score Card

Rapid Visual Screening - Senate Bill #2 - Seismic Needs Assessment
Oregon Department of Geology and Mineral Industries

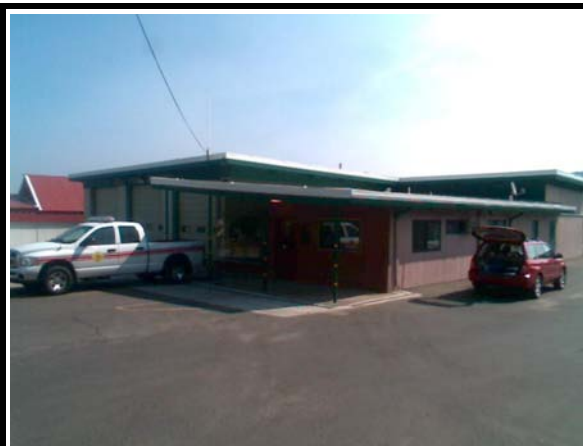
Building Type		County	
Fire - RFPD		Hood	
Street			
3431 O'Dell Highway			
City	State	Zip	
Hood River	OR	97031	
Latitude	Longitude		
45.625	121.54079		
Tracking Code	Inspection Date		
RVS in 2006	8/4/2006

Seismicity Zone: Moderate

Type	Basic Score	Vert Irreg	Plan Irreg	Pre-Code	Post-Bench	Soil C	Soil D	Soil E	RVS Score
Primary	C2	3.6	-2	-0.5	0	0	-0.8	0	0	0.3
Secondary		0	0	0	0	0	0	0	0	0
Tertiary		0	0	0	0	0	0	0	0	0

High (>10%)

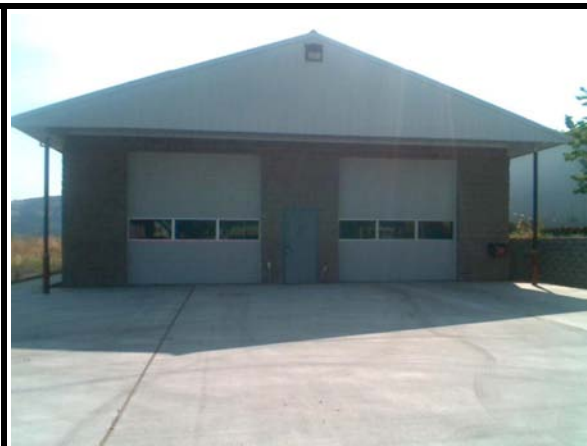
Building Type		County	
Fire - RFPD		Hood	
Street			
3431 O'Dell Highway			
City	State	Zip	
Hood River	OR	97031	
Latitude		Longitude	
45.62482		121.54025	
Tracking Code		Inspection Date	
RVS in 2006		8/4/2006

Seismicity Zone: Moderate
