# Parkdale Elementary School

Hood\_sch01A

## FEMA 154 Rapid Visual Screening Score Card

Rapid Visual Screening - Senate Bill #2 - Seismic Needs Assessment  
Oregon Department of Geology and Mineral Industries

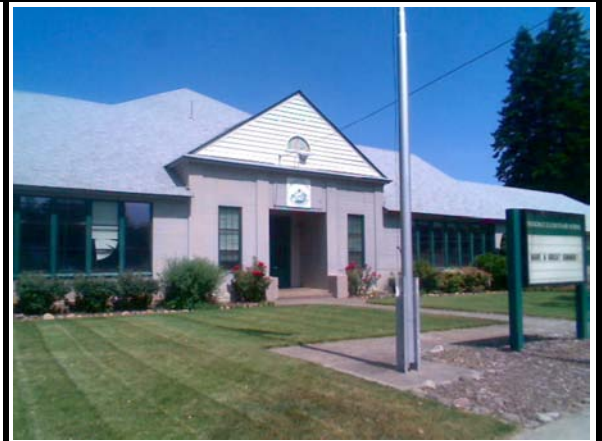
Type	Basic Score	Vert Irreg	Plan Irreg	Pre-Code	Post-Bench	Soil C	Soil D	Soil E	RVS Score
Primary	C2	3.6	-2	-0.5	-0.4	0	0	-1.2	0	-0.5
Secondary		0	0	0	0	0	0	0	0	0
Tertiary		0	0	0	0	0	0	0	0	0

-0.5

Very High (100%)

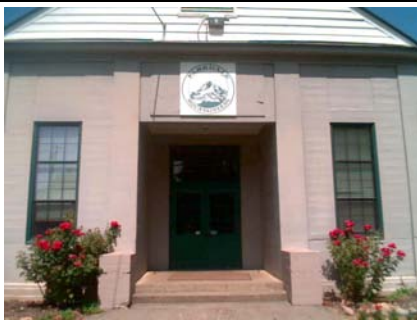
S Primary Structural Type

C2

Plan Irregularities	Vertical Irregularities
Reentrant Corners: L Shaped	Building On Hill or Sloped Site
Reentrant Corners: Other (Adjacent Build/Entity	None
None	None

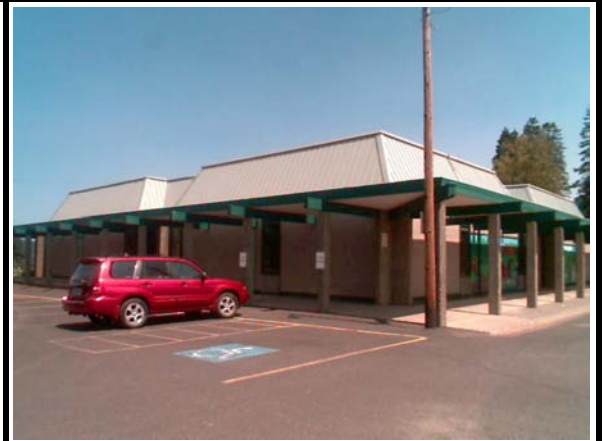
Hood\_sch01B

Type	Basic Score	Vert Irreg	Plan Irreg	Pre-Code	Post-Bench	Soil C	Soil D	Soil E	RVS Score
Primary	C2	3.6	0	-0.5	0	0	0	-1.2	0	1.9
Secondary	W2	4.8	0	-0.5	0	1.6	0	-1.2	0	4.7
Tertiary	PC1	3.2	0	-0.5	0	0	0	-1	0	1.7

1.7

Moderate (>1%)

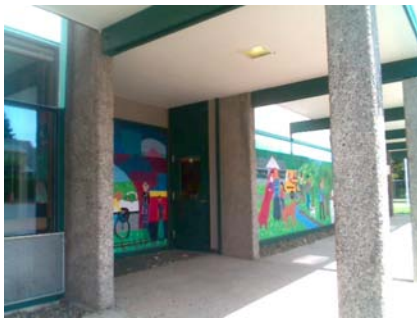
S Primary Structural Type

PC1

Plan Irregularities	Vertical Irregularities
Reentrant Corners: L Shaped	None
Reentrant Corners: L Shaped (Adjacent Build/Entity	None
None	None

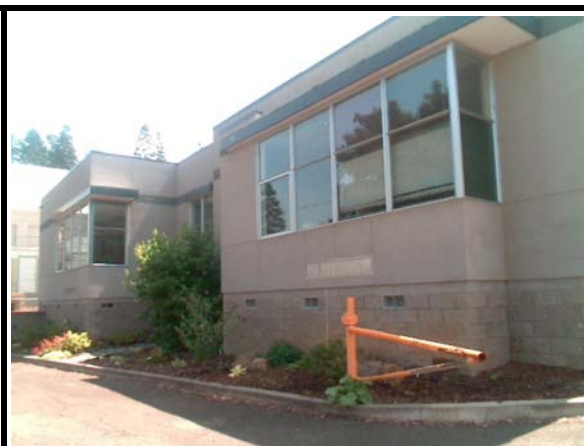
Hood\_sch01C

Type	Basic Score	Vert Irreg	Plan Irreg	Pre-Code	Post-Bench	Soil C	Soil D	Soil E	RVS Score
Primary	RM1	3.6	0	-0.5	0	2	0	-1.2	0	3.9
Secondary		0	0	0	0	0	0	0	0	0
Tertiary		0	0	0	0	0	0	0	0	0

3.9

Low (<1%)

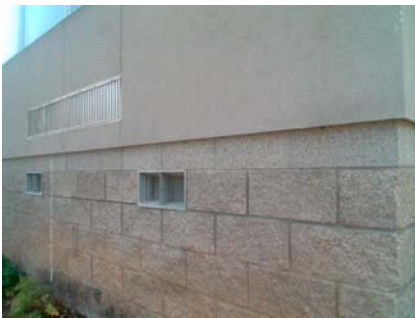
N Primary Structural Type

RM1

Plan Irregularities	Vertical Irregularities
Reentrant Corners: Other	None
None	None
None	None
