Westside Elementary School

Hood River County SD

FEMA 154 Rapid Visual Screening Score Card

Rapid Visual Screening - Senate Bill #2 - Seismic Needs Assessment
Oregon Department of Geology and Mineral Industries

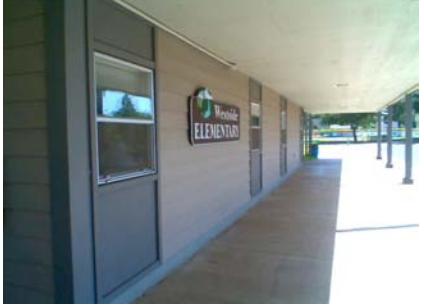
S General Site

Enrollment 460	Year Built (Field Verified) 1969	Year Built (Alt. Source) 1969	Est. Decade Built 1960
Total Area (square ft) 64760	Number of Stories 1	Basement	Pounding Potential Yes
Plan Irregularities Reentrant Corners:L shaped (Adjacent Build/Entity) None None		Vertical Irregularities None None None	
Falling Hazards None None None		Poor Conditions None None None

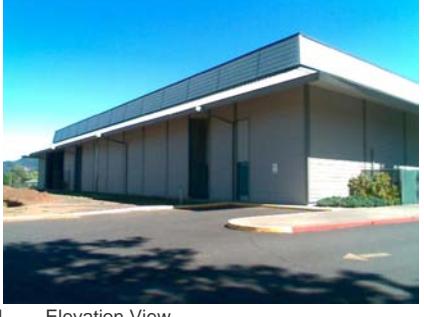
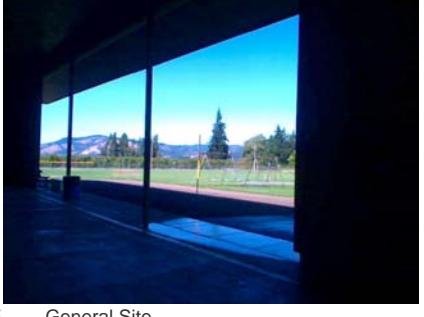
Enrollment 460	Year Built (Field Verified) 1969	Year Built (Alt. Source) 1969	Est. Decade Built 1960
Total Area (square ft) 64760	Number of Stories 1	Basement	Pounding Potential Yes
Plan Irregularities None None None		Vertical Irregularities None None None	
Falling Hazards None None None		Poor Conditions None None None

N Elevation View		E General Site steel posts w wood beams

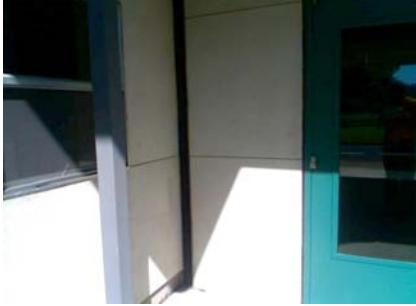
S General Site

Enrollment 460	Year Built (Field Verified) 1995	Year Built (Alt. Source) 1969	Est. Decade Built 1990
Total Area (square ft) 64760	Number of Stories 1	Basement	Pounding Potential No
Plan Irregularities None None None		Vertical Irregularities Steps in Elevation View: Single Change None None	
Falling Hazards None None None		Poor Conditions None None None

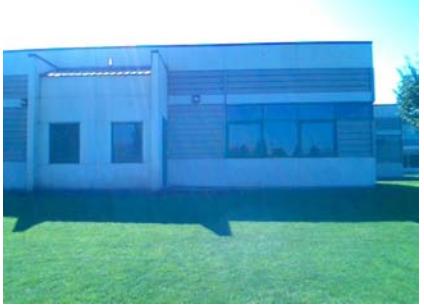
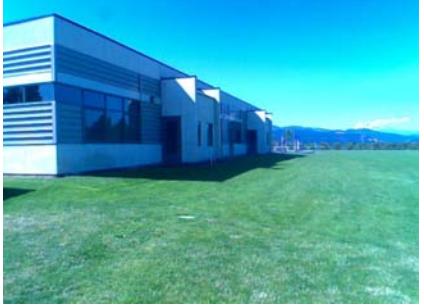
E	Elevation View	E	Elevation View

Enrollment 460	Year Built (Field Verified) 1995	Year Built (Alt. Source) 1969	Est. Decade Built 1990
Total Area (square ft) 64760	Number of Stories 1	Basement	Pounding Potential Yes
Plan Irregularities Reentrant Corners:L shaped (Adjacent Build/Entity) None None		Vertical Irregularities None None None	
Falling Hazards None None None		Poor Conditions None None None
