Wy'East Middle School

Hood River County SD

FEMA 154 Rapid Visual Screening Score Card

Rapid Visual Screening - Senate Bill #2 - Seismic Needs Assessment
Oregon Department of Geology and Mineral Industries

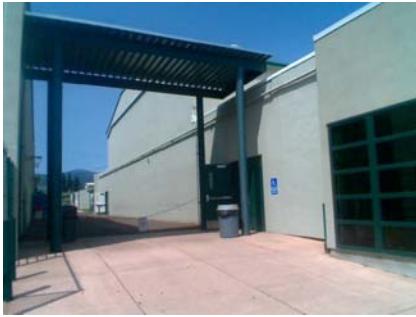
Enrollment 460	Year Built (Field Verified) 1951	Year Built (Alt. Source) 1951	Est. Decade Built 1950
Total Area (square ft) 84616	Number of Stories 1	Basement	Pounding Potential Yes
Plan Irregularities		Vertical Irregularities	
Reentrant Corners: L Shaped		Steps in Elevation View: Single Change	
Torsion: Eccentric Stiffness		Short Columns	
None		None	
Falling Hazards		Poor Conditions	
Other: Smokestack		None	
None		None	
None		None

S	Elevation View	S	Primary Structural Type

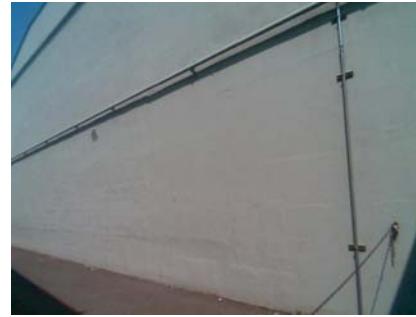
Type	Basic Score	Vert Irreg	Plan Irreg	Pre-Code	Post-Bench	Soil C	Soil D	Soil E	RVS Score
Primary	C2	3.6	-2	-0.5	0	0	0	0	-1.6	-0.5
Secondary		0	0	0	0	0	0	0	0	0
Tertiary		0	0	0	0	0	0	0	0	0

Very High (100%)

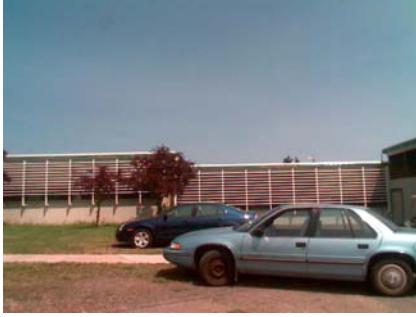
S	Elevation View	N	Elevation View

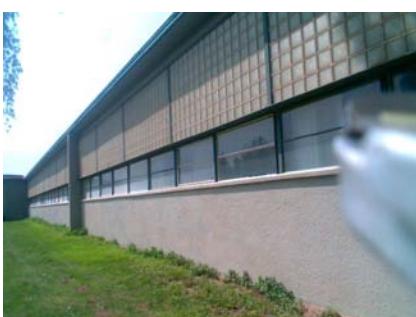
N	General Site	E	Elevation View

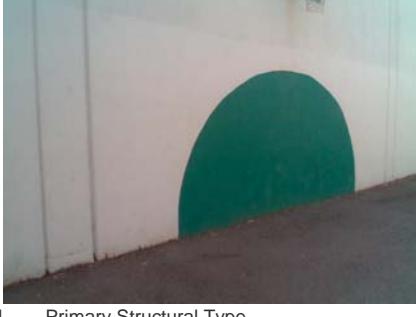
Type	Basic Score	Vert Irreg	Plan Irreg	Pre-Code	Post-Bench	Soil C	Soil D	Soil E	RVS Score
Primary	PC1	3.2	0	0	0	0	0	0	-1.6	1.6
Secondary		0	0	0	0	0	0	0	0	0
Tertiary		0	0	0	0	0	0	0	0	0

Moderate (>1%)

N Primary Structural Type

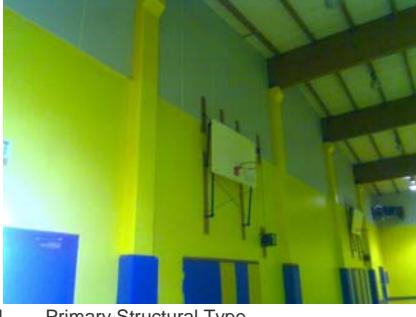
N Primary Structural Type

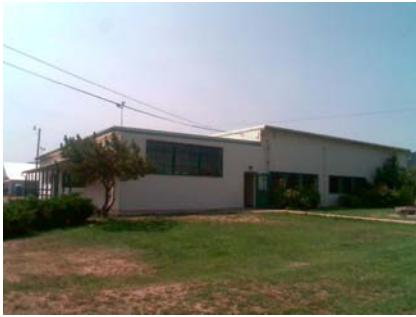
Enrollment 460	Year Built (Field Verified) 1951	Year Built (Alt. Source) 1951	Est. Decade Built 1960
Total Area (square ft) 84616	Number of Stories 1	Basement	Pounding Potential No
Plan Irregularities Reentrant Corners: L Shaped None None		Vertical Irregularities Steps in Elevation View: Single Change None None	
Falling Hazards None None None		Poor Conditions None None None

N General Site

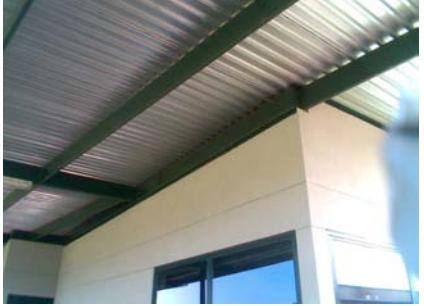
Type	Basic Score	Vert Irreg	Plan Irreg	Pre-Code	Post-Bench	Soil C	Soil D	Soil E	RVS Score
Primary	S2	3.6	0	0	0	1.4	0	0	-1.6	3.4
Secondary	C2	3.6	0	0	0	1.6	0	0	-1.6	3.6
Tertiary		0	0	0	0	0	0	0	0	0

Low (<1%)

W Primary Structural Type	N Elevation View

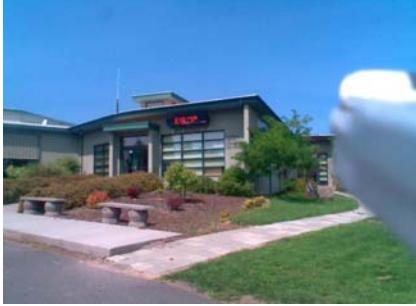
Type	Basic Score	Vert Irreg	Plan Irreg	Pre-Code	Post-Bench	Soil C	Soil D	Soil E	RVS Score
Primary	C2	3.6	0	-0.5	0	1.6	0	0	-1.6	3.1
Secondary	S2	3.6	0	-0.5	0	1.4	0	0	-1.6	2.9
Tertiary		0	0	0	0	0	0	0	0	0

Enrollment 460	Year Built (Field Verified) 1951	Year Built (Alt. Source) 1951	Est. Decade Built 2000
Total Area (square ft) 84616	Number of Stories 1	Basement	Pounding Potential Yes
Plan Irregularities Torsion: Building Shape None None		Vertical Irregularities None None None	
Falling Hazards None None None		Poor Conditions None None None

SE Elevation View
