Mid Valley Elementary School

Hood River County SD

FEMA 154 Rapid Visual Screening Score Card

Rapid Visual Screening - Senate Bill #2 - Seismic Needs Assessment
Oregon Department of Geology and Mineral Industries

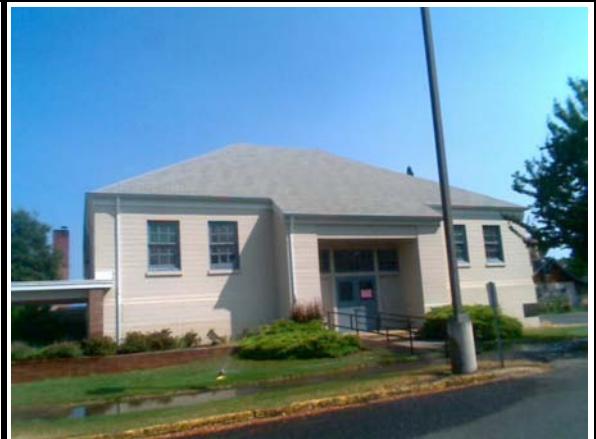
Hood_sch07A

Building Type School	County Hood	
Street 3686 Davis Road		
City Odell	State OR	Zip 97044
Latitude 45.62488	Longitude 121.54256	
Tracking Code RVS in 2006	Inspection Date 8/4/2006

Seismicity Zone: Moderate

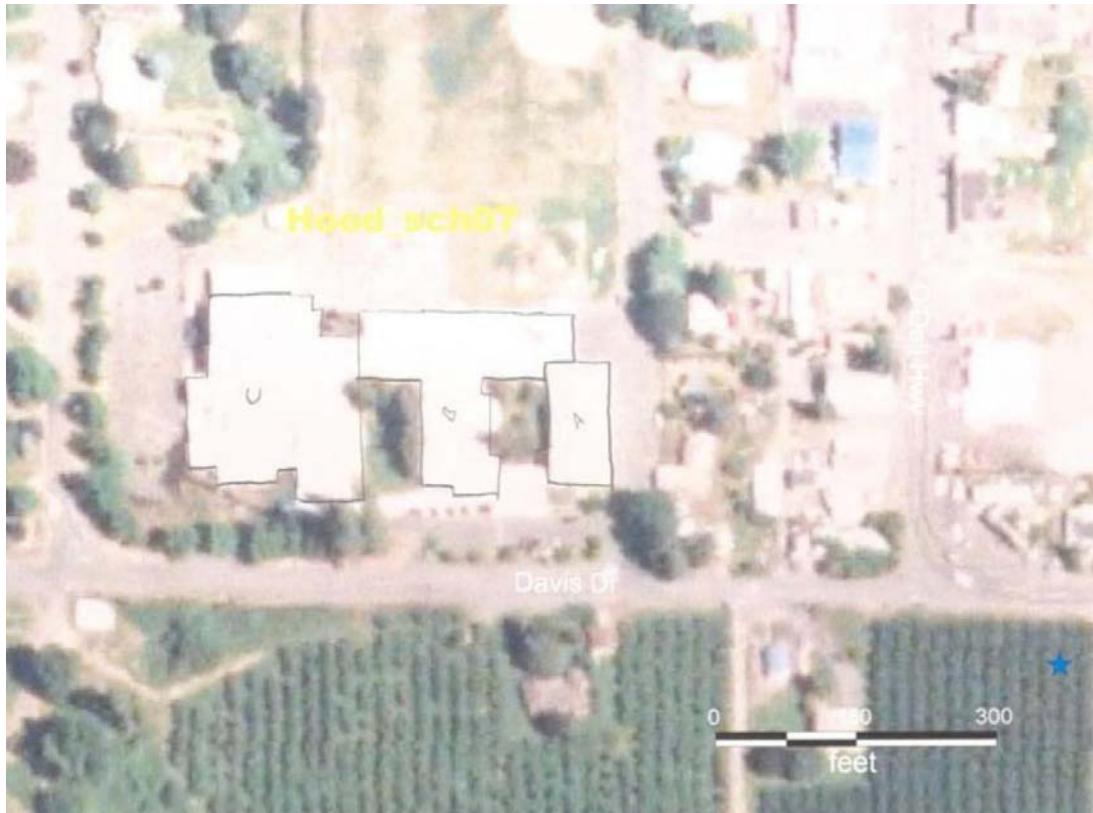
Final Type	Final Score
C2	-0.1

Very High (100%)

Enrollment 409	Year Built (Field Verified) 1937	Year Built (Alt. Source) 1937	Est. Decade Built 1930
Total Area (square ft) 68162	Number of Stories 2	Basement	Pounding Potential Yes
Plan Irregularities Reentrant Corners:L shaped (Adjacent Build/Entity) None None		Vertical Irregularities Steps in Elevation View: Single Change (Adjacent Building/Entity) None None	
Falling Hazards Other: Smokestack None None		Poor Conditions None None None

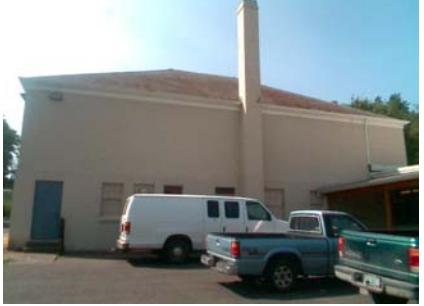
N Falling Hazard

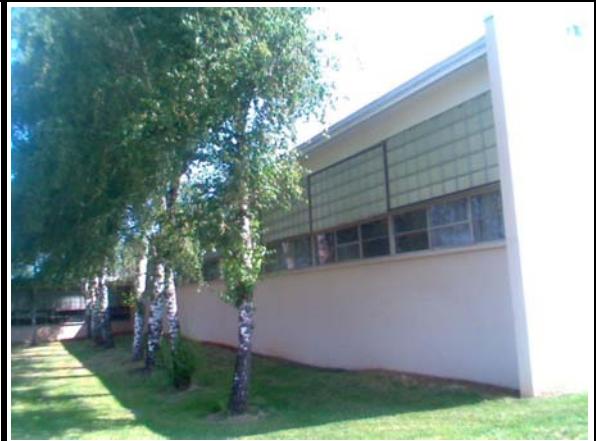
Hood_sch07B

Building Type School	County Hood	
Street 3686 Davis Road		
City Odell	State OR	Zip 97044
Latitude 45.62502	Longitude 121.54309	
Tracking Code RVS in 2006	Inspection Date 8/4/2006

Seismicity Zone: Moderate

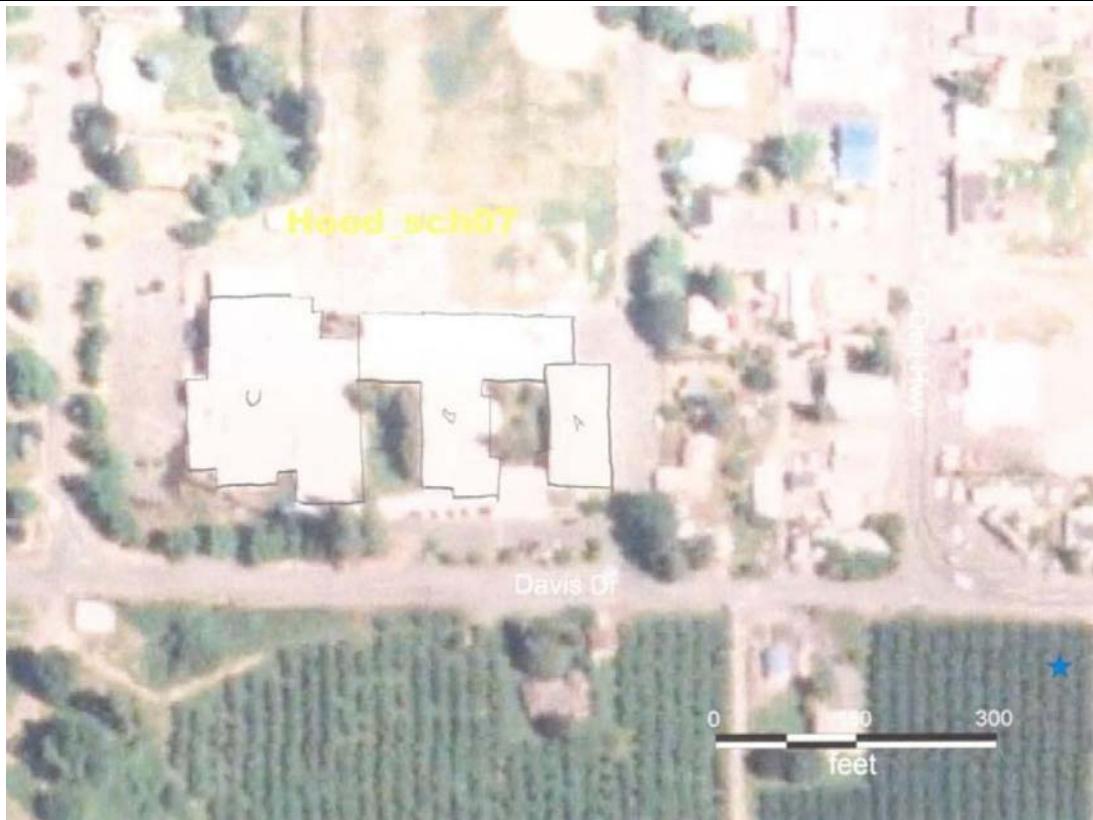
Final Type	Final Score
C2	0.3

High (>10%)

Enrollment 409	Year Built (Field Verified) 1954	Year Built (Alt. Source) 1937	Est. Decade Built 1950
Total Area (square ft) 68162	Number of Stories 1	Basement	Pounding Potential Yes
Plan Irregularities Reentrant Corners: T shaped Reentrant Corners: L Shaped (Adjacent Build/Entity) None		Vertical Irregularities Steps in Elevation View: Single Change (Adjacent Building/Entity) Short Columns None	
Falling Hazards Other: Smokestack None None		Poor Conditions None None None

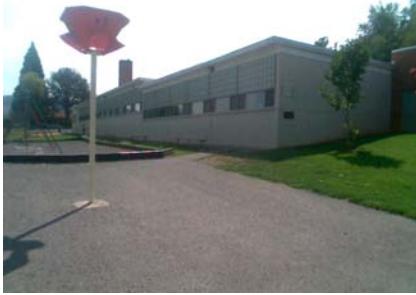
N Elevation View

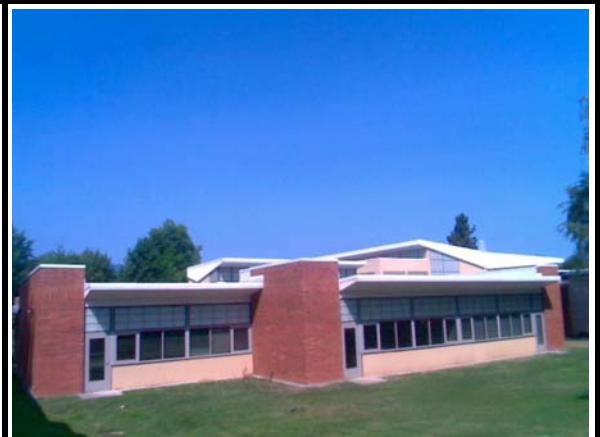
Hood_sch07C

Building Type	County	
School	Hood	
Street		
3686 Davis Road		
City	State	Zip
Odell	OR	97044
Latitude	Longitude	
45.625	121.54386	
Tracking Code	Inspection Date	
RVS in 2006	8/4/2006

Seismicity Zone: Moderate

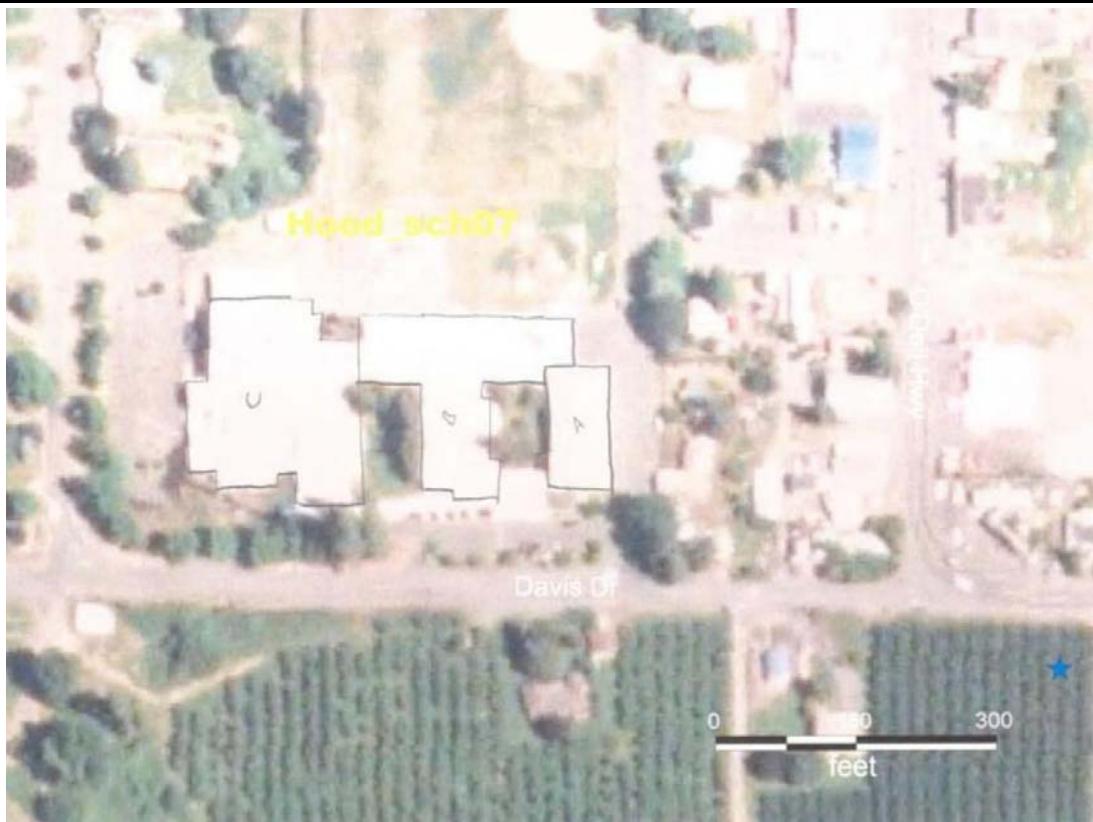
Final Type	Final Score
S4	3.5

Low (<1%)

Enrollment 409	Year Built (Field Verified) 1937	Year Built (Alt. Source) 1937	Est. Decade Built 2000
Total Area (square ft) 68162	Number of Stories 1	Basement	Pounding Potential Yes
Plan Irregularities Reentrant Corners:L shaped (Adjacent Build/Entity) None None		Vertical Irregularities None None None	
Falling Hazards None None None		Poor Conditions None None None

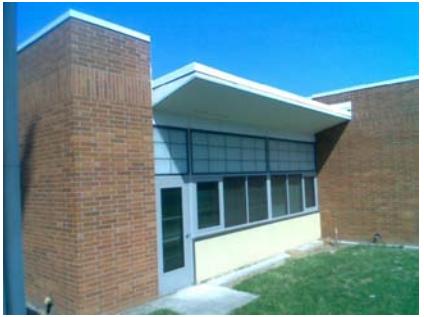
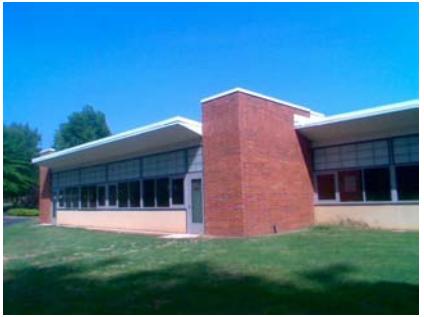
E Primary Structural Type		S Elevation View	
		W Elevation View

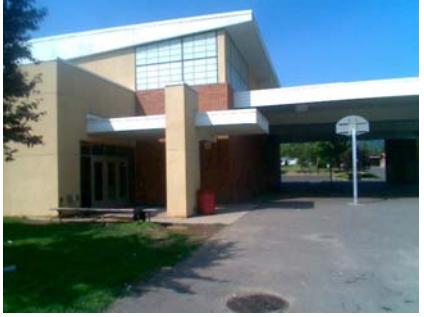
NE Elevation View gym
