Talent Police Dept

FEMA 154 Rapid Visual Screening Score Card

Rapid Visual Screening - Senate Bill #2 - Seismic Needs Assessment
Oregon Department of Geology and Mineral Industries

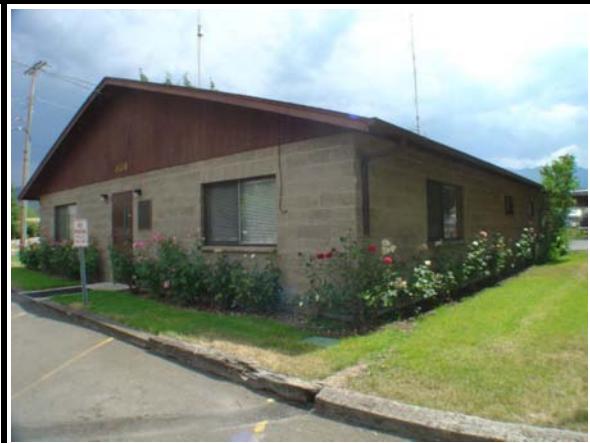
E Field Verified Year Built		W Falling Hazard Simple moment-wood-frame on top of police cars (not connected to building).
