Jewett Elementary School

Jack_sch09A

FEMA 154 Rapid Visual Screening Score Card

Rapid Visual Screening - Senate Bill #2 - Seismic Needs Assessment
Oregon Department of Geology and Mineral Industries

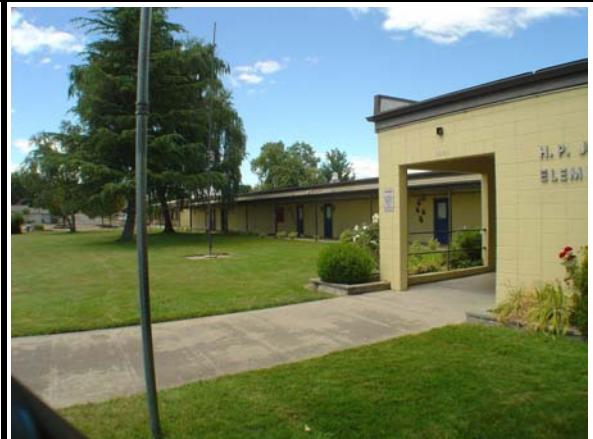
Type	Basic Score	Vert Irreg	Plan Irreg	Pre-Code	Post-Bench	Soil C	Soil D	Soil E	RVS Score
Primary	RM1	3.6	0	-0.5	0	0	0	-1.2	0	1.9
Secondary		0	0	0	0	0	0	0	0	0
Tertiary		0	0	0	0	0	0	0	0	0

Final Type	Final Score
RM1	1.9

Moderate (>1%)

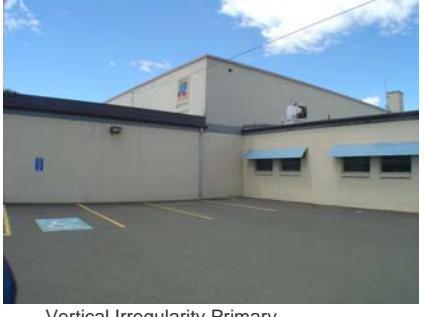
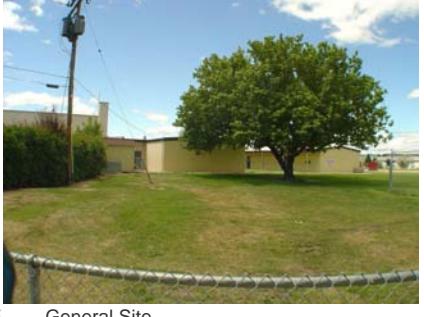
Enrollment 483	Year Built (Field Verified) 1955	Year Built (Alt. Source) 1950	Est. Decade Built 1950
Total Area (square ft) 45018	Number of Stories 1	Basement	Pounding Potential No
Plan Irregularities		Vertical Irregularities	
Reentrant Corners: U shaped		Steps in Elevation View: 2 to 3 Changes	
Torsion: Eccentric Stiffness		None	
None		None	
Falling Hazards		Poor Conditions	
Other: General		None	
None		None	
None		None

E	Vertical Irregularity Primary	E	General Site

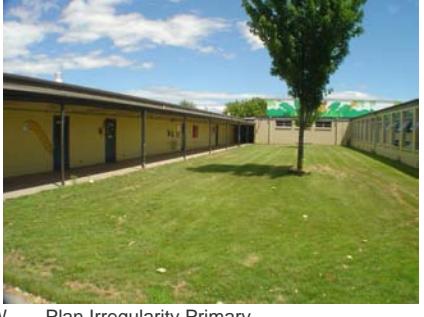
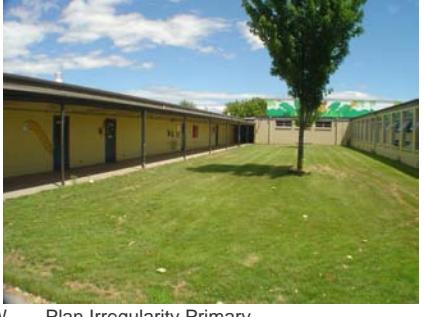
W	Plan Irregularity Primary

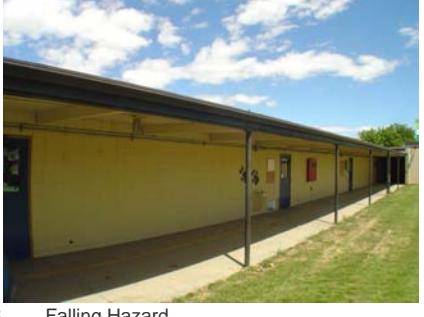
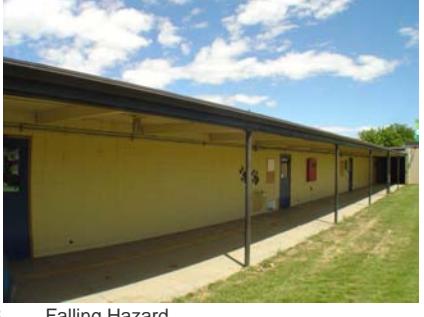
S	Falling Hazard overhead walkway

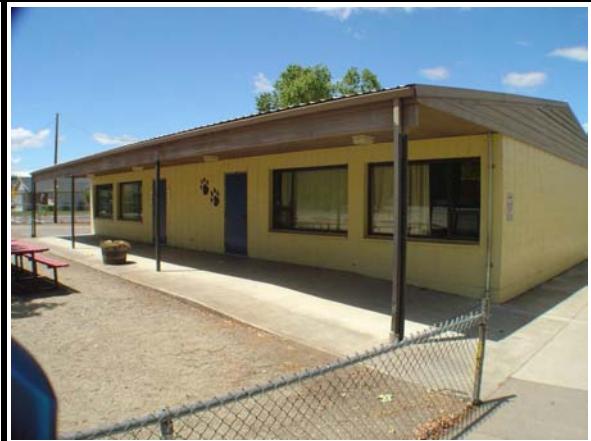
Jack_sch09B

Type	Basic Score	Vert Irreg	Plan Irreg	Pre-Code	Post-Bench	Soil C	Soil D	Soil E	RVS Score
Primary	RM1	3.6	0	0	0	0	0	-1.2	0	2.4
Secondary		0	0	0	0	0	0	0	0	0
Tertiary		0	0	0	0	0	0	0	0	0

Final Type	Final Score
RM1	2.4

Low (<1%)

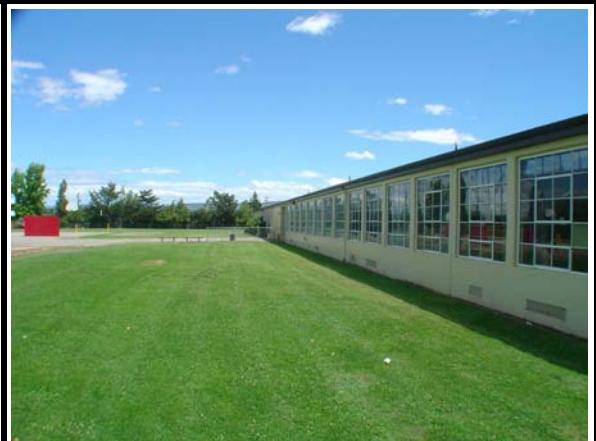
Jack_sch09C

Type	Basic Score	Vert Irreg	Plan Irreg	Pre-Code	Post-Bench	Soil C	Soil D	Soil E	RVS Score
Primary	C2	3.6	0	-0.5	0	0	0	-1.2	0	1.9
Secondary	C1	3	0	-0.5	0	0	0	-1	0	1.5
Tertiary		0	0	0	0	0	0	0	0	0

Final Type	Final Score
C1	1.5

Moderate (>1%)

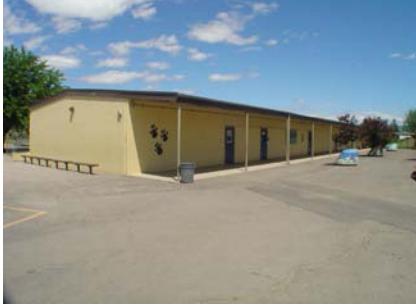
Enrollment 483	Year Built (Field Verified) 1955	Year Built (Alt. Source) 1955	Est. Decade Built 1960
Total Area (square ft) 45018	Number of Stories 1	Basement	Pounding Potential No
Plan Irregularities Torsion: Eccentric Stiffness None None		Vertical Irregularities None None None	
Falling Hazards None None None		Poor Conditions None None None

S General Site
