Rogue River Elementary School

Rogue River SD 35

FEMA 154 Rapid Visual Screening Score Card

Rapid Visual Screening - Senate Bill #2 - Seismic Needs Assessment
Oregon Department of Geology and Mineral Industries

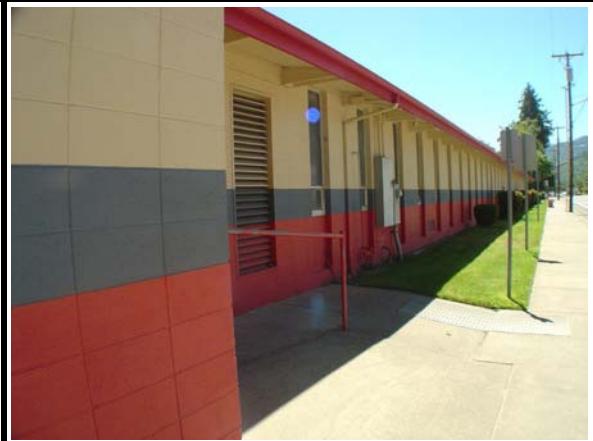
Jack_sch20A

Type	Basic Score	Vert Irreg	Plan Irreg	Pre-Code	Post-Bench	Soil C	Soil D	Soil E	RVS Score
Primary	RM1	2.8	0	-0.5	0	0	0	-0.6	0	1.7
Secondary		0	0	0	0	0	0	0	0	0
Tertiary		0	0	0	0	0	0	0	0	0

Final Type	Final Score
RM1	1.7

Moderate (>1%)

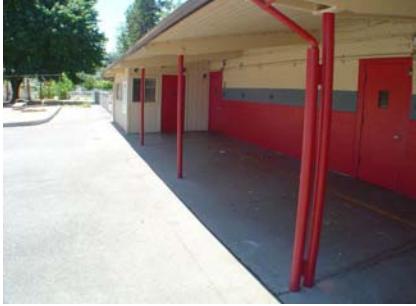
Enrollment 329	Year Built (Field Verified) 1950	Year Built (Alt. Source) 1950	Est. Decade Built 1950
Total Area (square ft) 31784	Number of Stories 1	Basement	Pounding Potential No
Plan Irregularities		Vertical Irregularities	
Reentrant Corners: Other		None	
Out of Plane Lateral-Force-Resistance Elements		None	
None		None	
Falling Hazards		Poor Conditions	
None		None	
None		None	
None		None

E Plan Irregularity Primary

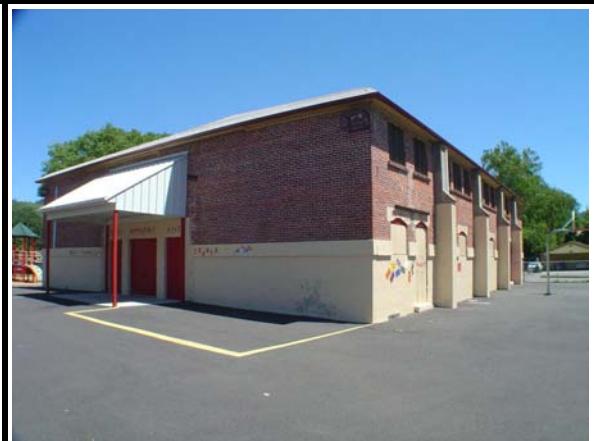
Jack_sch20B

Type	Basic Score	Vert Irreg	Plan Irreg	Pre-Code	Post-Bench	Soil C	Soil D	Soil E	RVS Score
Primary	URM	1.8	0	0	-0.2	0	0	-0.6	0	1
Secondary		0	0	0	0	0	0	0	0	0
Tertiary		0	0	0	0	0	0	0	0	0

Final Type	Final Score
URM	1

High (>10%)

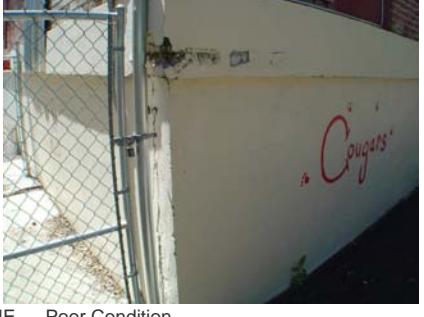
Enrollment 329	Year Built (Field Verified) 1950	Year Built (Alt. Source) 1950	Est. Decade Built 1930
Total Area (square ft) 31784	Number of Stories 1	Basement	Pounding Potential No
Plan Irregularities None None None		Vertical Irregularities None None None	
Falling Hazards None None None		Poor Conditions Cracks Poor Masonry Poor Concrete

NE Poor Condition

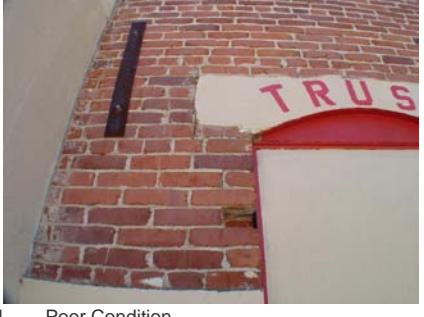
N Poor Condition Also shows primary structure type.

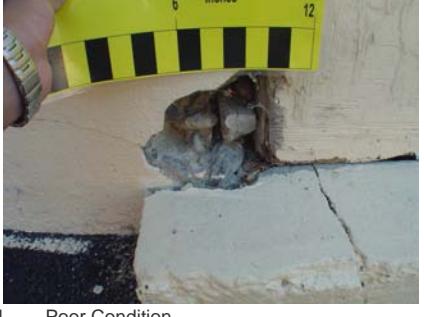
N Poor Condition There are some chunks of the building missing like this one.

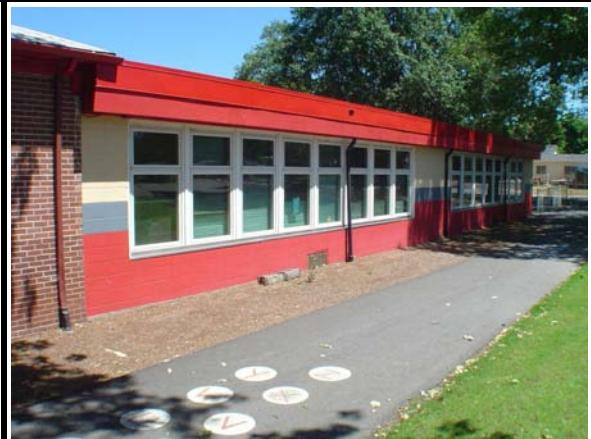
Jack_sch20C

Type	Basic Score	Vert Irreg	Plan Irreg	Pre-Code	Post-Bench	Soil C	Soil D	Soil E	RVS Score
Primary	RM1	2.8	0	0	0	0	0	-0.6	0	2.2
Secondary		0	0	0	0	0	0	0	0	0
Tertiary		0	0	0	0	0	0	0	0	0

Final Type	Final Score
RM1	2.2

Low (<1%)

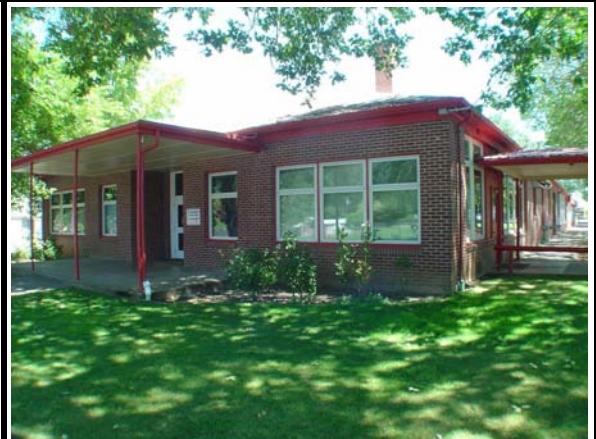
Jack_sch20D

Type	Basic Score	Vert Irreg	Plan Irreg	Pre-Code	Post-Bench	Soil C	Soil D	Soil E	RVS Score
Primary	W2	3.8	0	0	0	0	0	-0.8	0	3
Secondary		0	0	0	0	0	0	0	0	0
Tertiary		0	0	0	0	0	0	0	0	0

Final Type	Final Score
W2	3

Low (<1%)

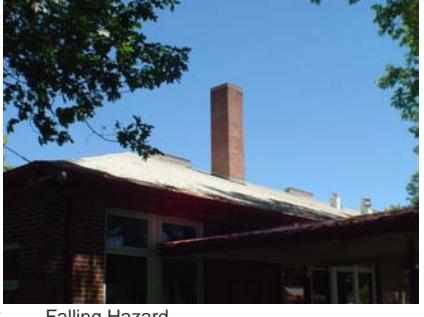
Enrollment 329	Year Built (Field Verified) 1950	Year Built (Alt. Source) 1950	Est. Decade Built 1950
Total Area (square ft) 31784	Number of Stories 1	Basement	Pounding Potential No
Plan Irregularities None None None		Vertical Irregularities None None None	
Falling Hazards Unreinforced Chimneys None None		Poor Conditions None None None

S Falling Hazard
