Jacksonville Elementary School

Medford SD 549C

FEMA 154 Rapid Visual Screening Score Card

Rapid Visual Screening - Senate Bill #2 - Seismic Needs Assessment
Oregon Department of Geology and Mineral Industries

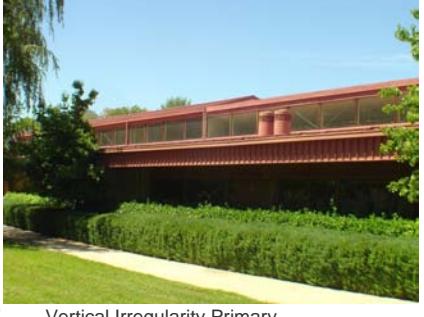
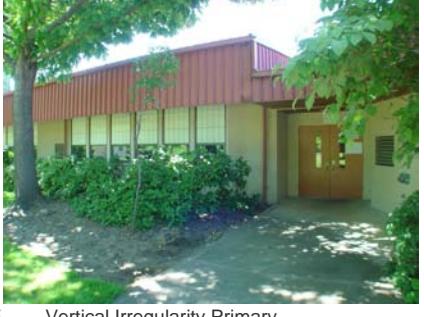
Enrollment 401	Year Built (Field Verified) 1959	Year Built (Alt. Source) 1959	Est. Decade Built 1980
Total Area (square ft) 31832	Number of Stories 1	Basement	Pounding Potential No
Plan Irregularities		Vertical Irregularities	
Reentrant Corners: Other		Steps in Elevation View: Single Change	
Non-Parallel System		Steps in Elevation View: Single Change (Adjacent Building/Entity)	
None		None	
Falling Hazards		Poor Conditions	
None		None	
None		None	
None		None

E	Vertical Irregularity Primary	E	Vertical Irregularity Primary

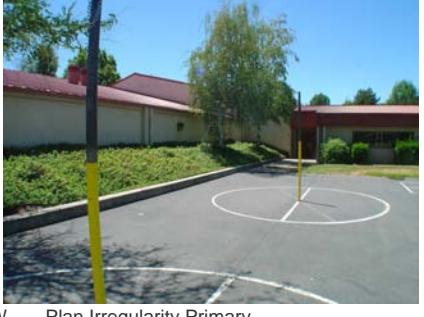
W Plan Irregularity Primary With Building "C"

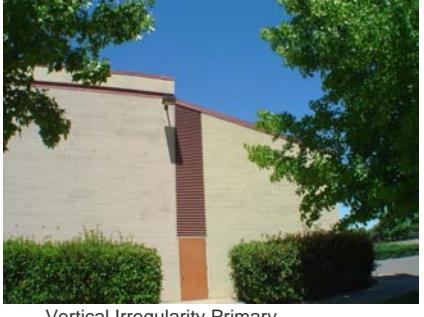
Enrollment 401	Year Built (Field Verified) 1959	Year Built (Alt. Source) 1959	Est. Decade Built 1980
Total Area (square ft) 31832	Number of Stories 1	Basement	Pounding Potential No
Plan Irregularities None None None		Vertical Irregularities Steps in Elevation View: Single Change None None	
Falling Hazards None None None		Poor Conditions None None None

E Vertical Irregularity Primary

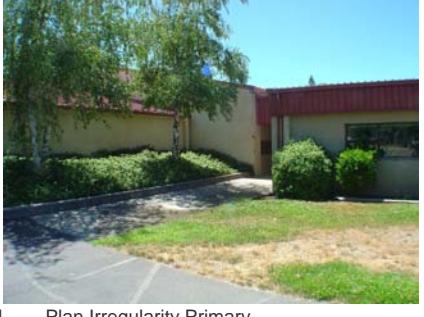
Enrollment 401	Year Built (Field Verified) 1959	Year Built (Alt. Source) 1959	Est. Decade Built 1990
Total Area (square ft) 31832	Number of Stories 1	Basement	Pounding Potential No
Plan Irregularities Reentrant Corners: Other Reentrant Corners: Other None		Vertical Irregularities None None None	
Falling Hazards None None None		Poor Conditions None None None

N Plan Irregularity Primary

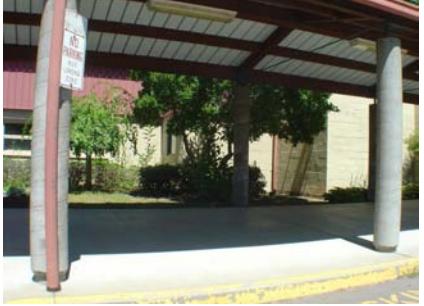
Enrollment 401	Year Built (Field Verified) 1959	Year Built (Alt. Source) 1950	Est. Decade Built 1950
Total Area (square ft) 31832	Number of Stories 1	Basement	Pounding Potential No
Plan Irregularities		Vertical Irregularities	
Out of Plane Lateral-Force-Resistance Elements		Steps in Elevation View: Single Change	
Non-Parallel System		Steps in Elevation View: Single Change (Adjacent Building/Entity)	
None		None	
Falling Hazards		Poor Conditions	
None		None	
None		None	
None		None

S Plan Irregularity Primary
