# Kennedy Elementary School

Medford SD 549C

## FEMA 154 Rapid Visual Screening Score Card

Rapid Visual Screening - Senate Bill #2 - Seismic Needs Assessment  
Oregon Department of Geology and Mineral Industries

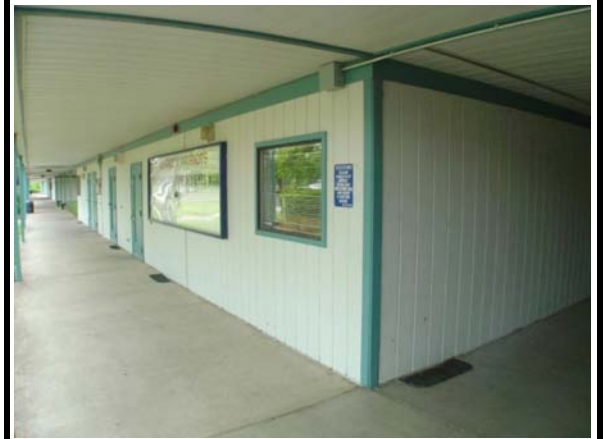
Jack\_sch31A

| | Type | Basic Score | Vert Irreg | Plan Irreg | Pre-Code | Post-Bench | Soil C | Soil D | Soil E | RVS Score |
|---|---|---|---|---|---|---|---|---|---|---|
| Primary | W2 | 4.8 | 0 | -0.5 | 0 | 0 | -0.8 | 0 | 0 | 3.5 |

FEMA-154 Collapse Potential

Low (<1%)

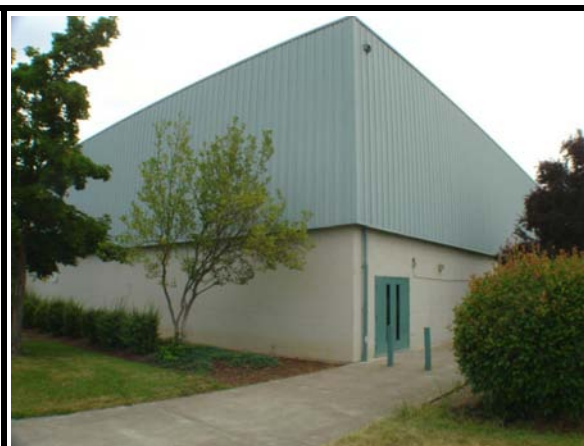
Jack\_sch31B

| | Type | Basic Score | Vert Irreg | Plan Irreg | Pre-Code | Post-Bench | Soil C | Soil D | Soil E | RVS Score |
|---|---|---|---|---|---|---|---|---|---|---|
| Primary | RM1 | 3.6 | -2 | -0.5 | 0 | 0 | -0.8 | 0 | 0 | 0.3 |
| Secondary | S3 | 3.8 | 0 | -0.5 | 0 | 0 | -0.6 | 0 | 0 | 2.7 |

FEMA-154 Collapse Potential

High (>10%)

| Reentrant Corners: Other | Steps in Elevation View: 2 to 3 Changes |
| Out of Plane Lateral-Force-Resistance Elements | Vertical Change in Structural Type (Soft over Stiff) |

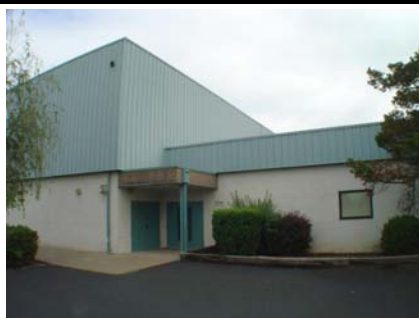
SE Vertical Irregularity Primary  
also shows reentrant corner.

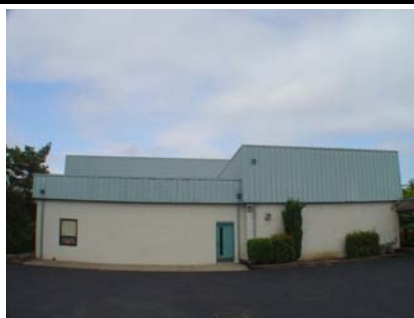
E Vertical Irregularity Primary  
also show out of plane lateral system

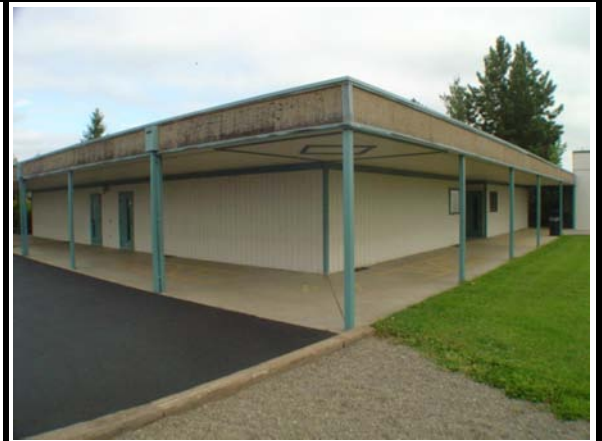
Jack\_sch31C

| | Type | Basic Score | Vert Irreg | Plan Irreg | Pre-Code | Post-Bench | Soil C | Soil D | Soil E | RVS Score |
|---|---|---|---|---|---|---|---|---|---|---|
| Primary | W2 | 4.8 | 0 | 0 | 0 | 0 | -0.8 | 0 | 0 | 4 |

FEMA-154 Collapse Potential

Low (<1%)

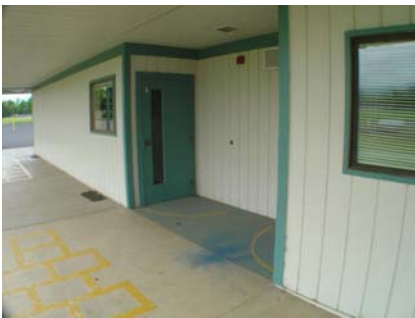
E Primary Structural Type

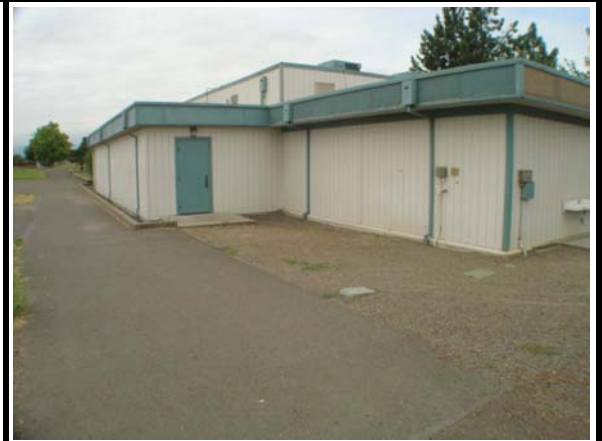
Jack\_sch31D

| | Type | Basic Score | Vert Irreg | Plan Irreg | Pre-Code | Post-Bench | Soil C | Soil D | Soil E | RVS Score |
|---|---|---|---|---|---|---|---|---|---|---|
| Primary | W2 | 4.8 | -3 | -0.5 | 0 | 0 | -0.8 | 0 | 0 | 0.5 |

FEMA-154 Collapse Potential

High (>10%)

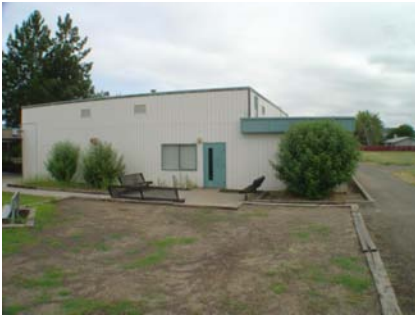
| Reentrant Corners: Other | Steps in Elevation View: 2 to 3 Changes |

SE Vertical Irregularity Primary

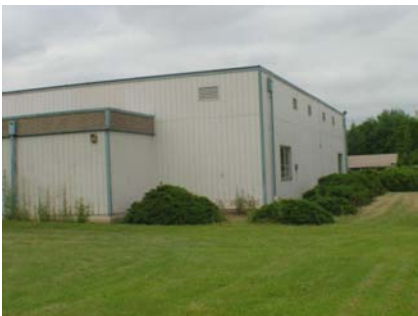
| | Type | Basic Score | Vert Irreg | Plan Irreg | Pre-Code | Post-Bench | Soil C | Soil D | Soil E | RVS Score |
|---|---|---|---|---|---|---|---|---|---|---|
| Primary | W2 | 4.8 | 0 | -0.5 | 0 | 0 | -0.8 | 0 | 0 | 3.5 |

| Reentrant Corners: Other | Steps in Elevation View: Single Change |

NE Elevation View  
also shows reentrant corner and elevation step.
