Phoenix Elementary School

Jack_sch46A

FEMA 154 Rapid Visual Screening Score Card

Rapid Visual Screening - Senate Bill #2 - Seismic Needs Assessment
Oregon Department of Geology and Mineral Industries

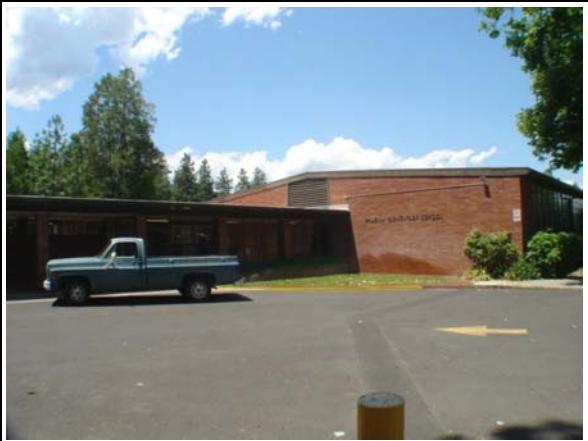
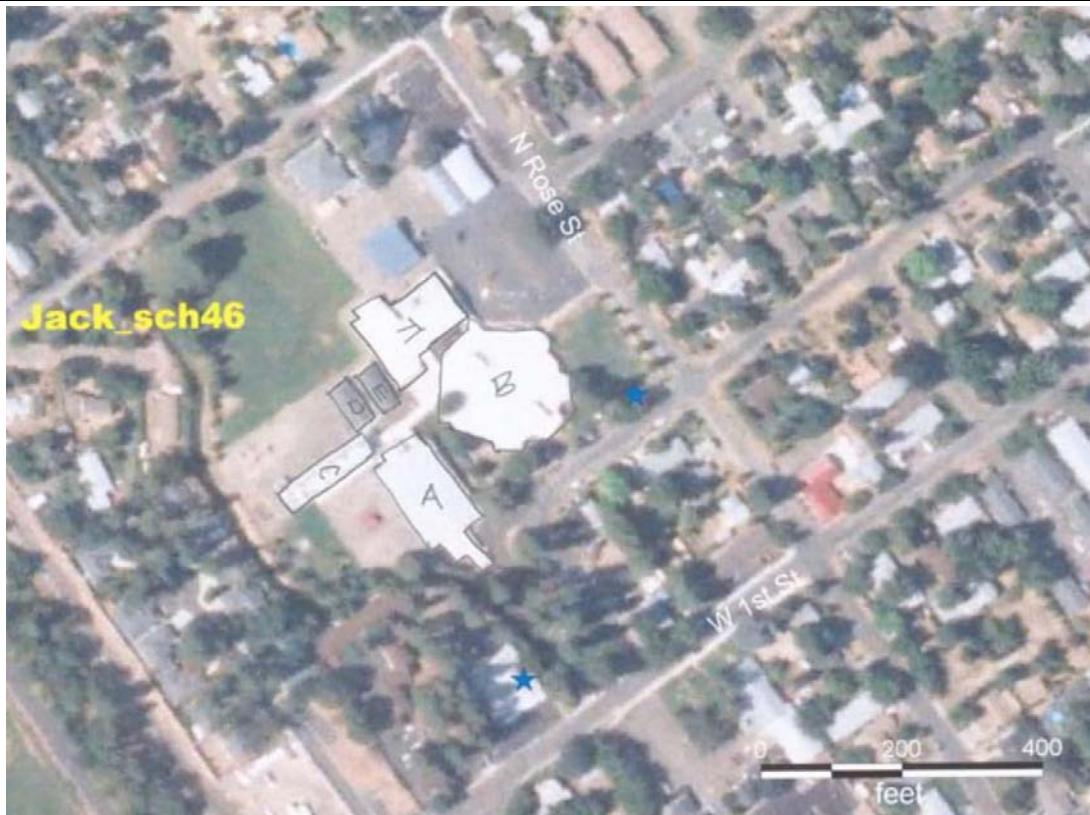
Type	Basic Score	Vert Irreg	Plan Irreg	Pre-Code	Post-Bench	Soil C	Soil D	Soil E	RVS Score
Primary	W2	4.8	-3	-0.5	0	0	0	-1.2	0	0.1
Secondary	RM1	3.6	-2	-0.5	0	0	0	-1.2	0	-0.1
Tertiary		0	0	0	0	0	0	0	0	0

Final Type	Final Score
RM1	-0.1

Very High (100%)

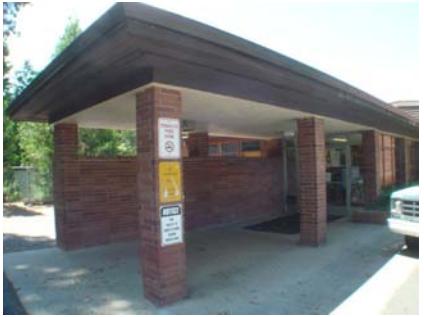
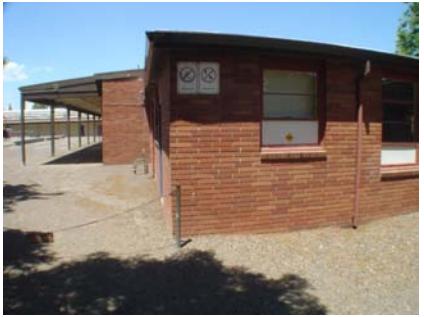
Enrollment 461	Year Built (Field Verified) 1974	Year Built (Alt. Source) 1974	Est. Decade Built 1960
Total Area (square ft) 50262	Number of Stories 1	Basement	Pounding Potential No
Plan Irregularities Reentrant Corners: Other None None		Vertical Irregularities Steps in Elevation View: Single Change None None	
Falling Hazards None None Other: General		Poor Conditions None None None

SE Falling Hazard		SW Plan Irregularity Primary

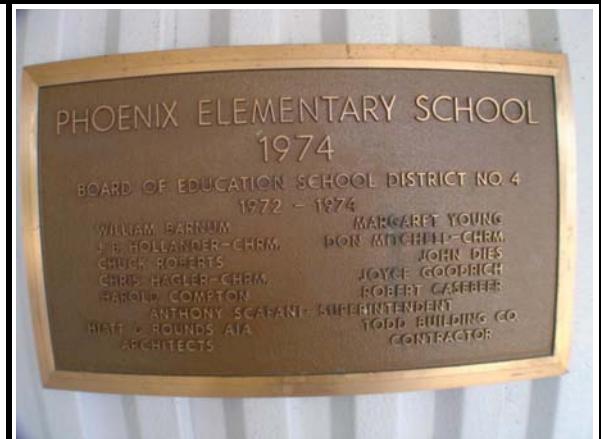
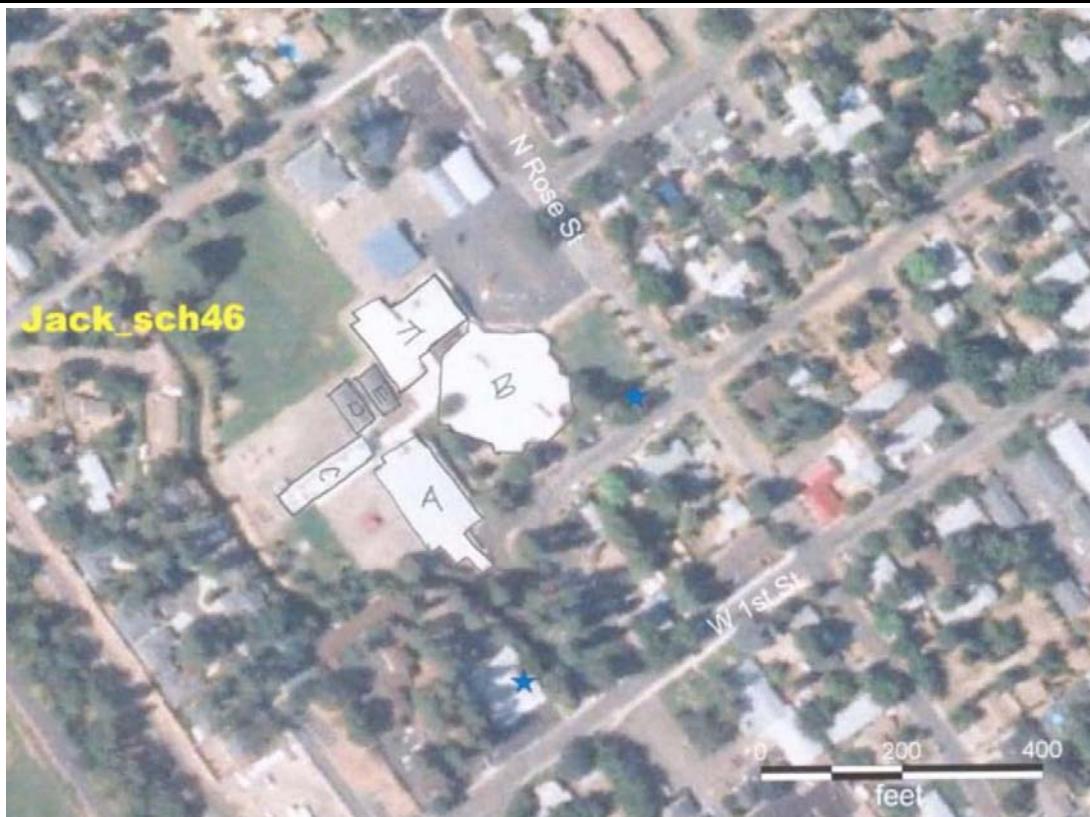
Jack_sch46B

Type	Basic Score	Vert Irreg	Plan Irreg	Pre-Code	Post-Bench	Soil C	Soil D	Soil E	RVS Score
Primary	S3	3.8	0	-0.5	0	0	-0.6	0	0	2.7
Secondary	RM1	3.6	0	-0.5	0	0	-0.8	0	0	2.3
Tertiary		0	0	0	0	0	0	0	0	0

Final Type	Final Score
RM1	2.3

Low (<1%)

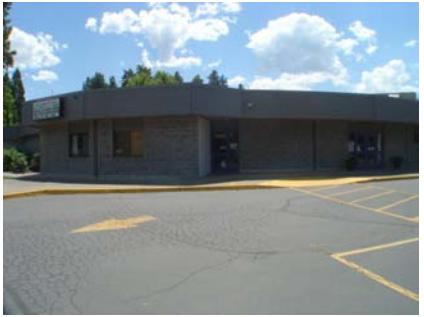
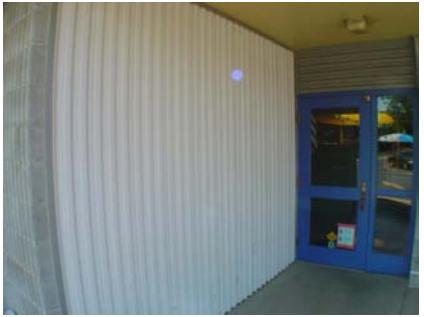
N Elevation View		N Primary Structural Type

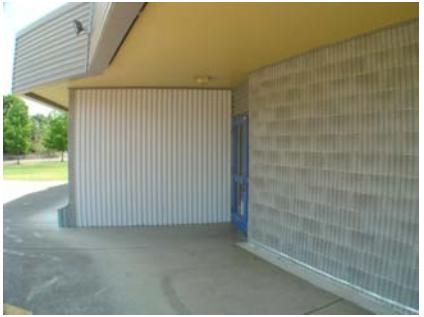
N Plan Irregularity Primary

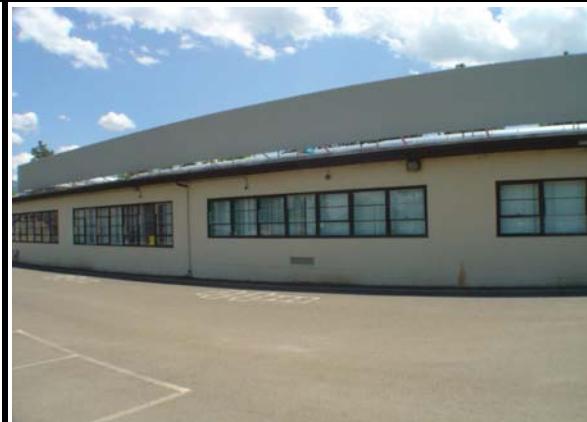
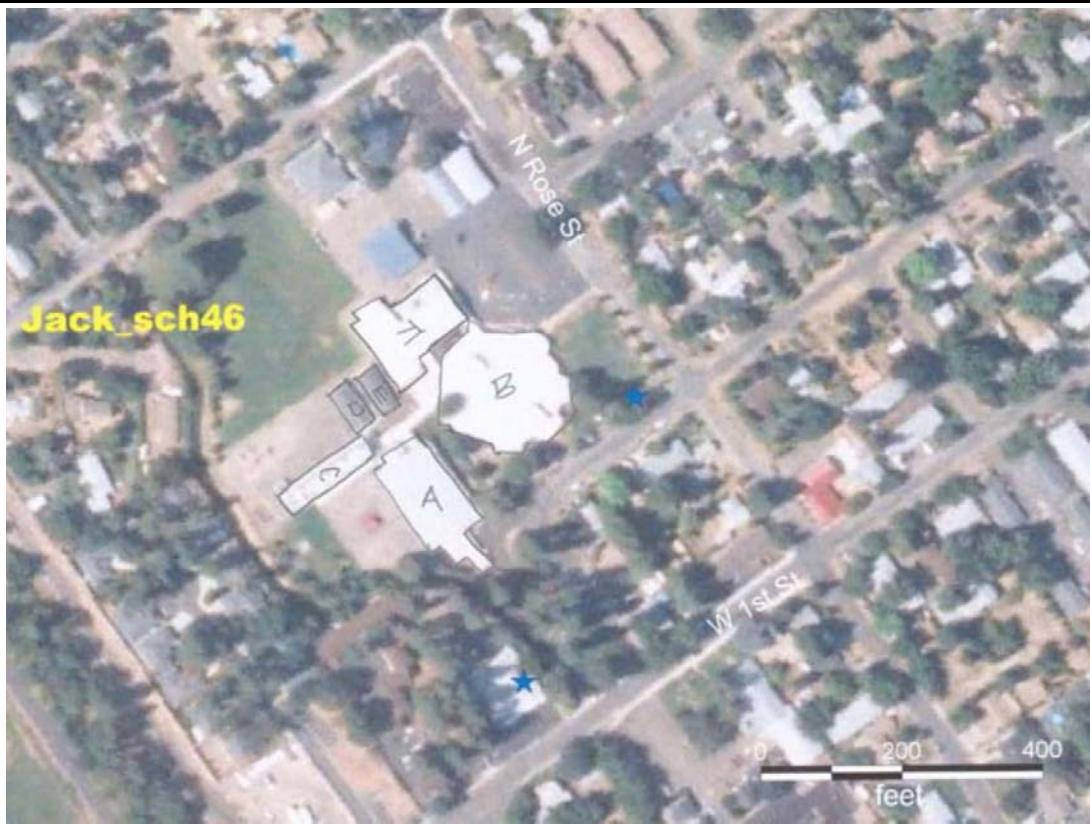
Jack_sch46C

Type	Basic Score	Vert Irreg	Plan Irreg	Pre-Code	Post-Bench	Soil C	Soil D	Soil E	RVS Score
Primary	W2	4.8	0	0	0	0	0	-1.2	0	3.6
Secondary		0	0	0	0	0	0	0	0	0
Tertiary		0	0	0	0	0	0	0	0	0

Final Type	Final Score
W2	3.6

Low (<1%)

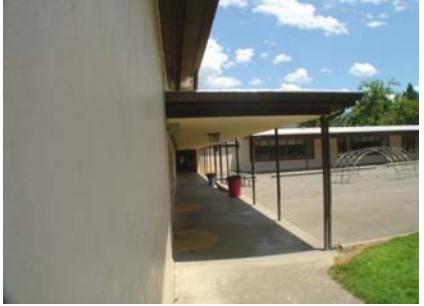
Enrollment 461	Year Built (Field Verified) 1974	Year Built (Alt. Source) 1974	Est. Decade Built 1960
Total Area (square ft) 50262	Number of Stories 1	Basement	Pounding Potential No
Plan Irregularities None None None		Vertical Irregularities None None None	
Falling Hazards Other: General None None		Poor Conditions None None None

S Falling Hazard

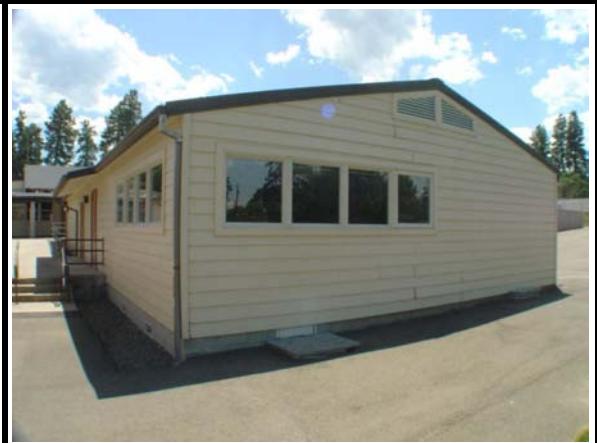
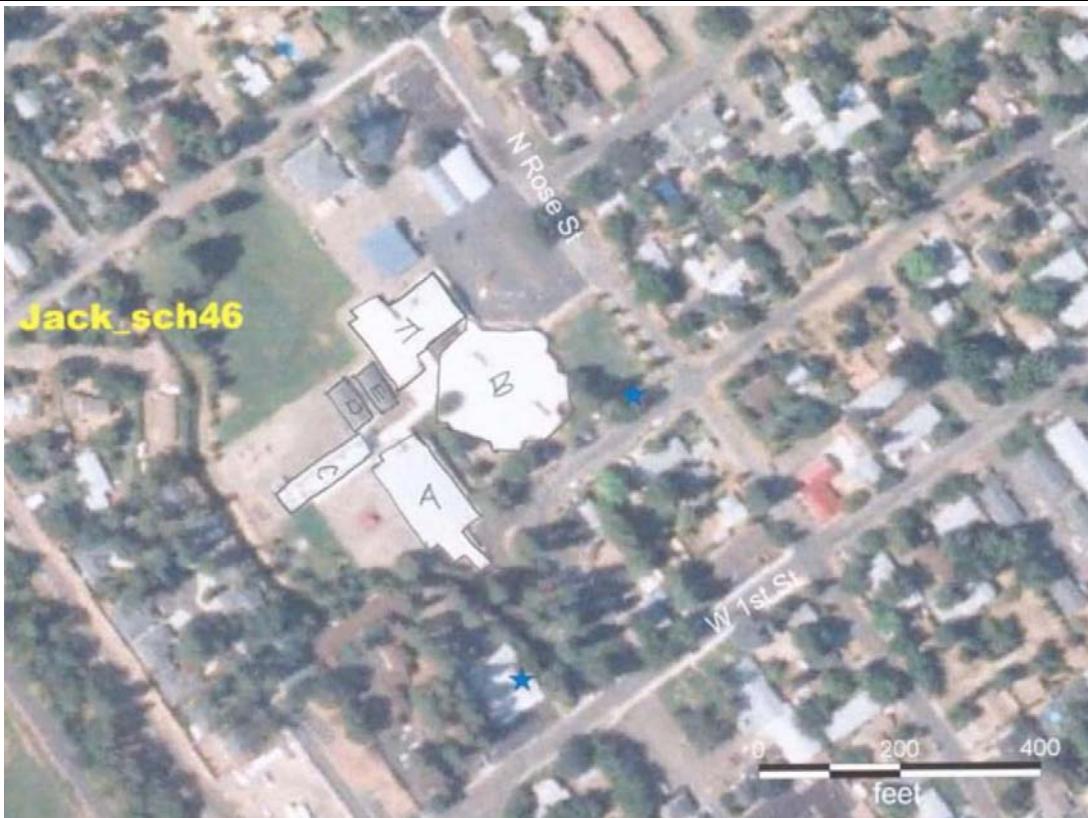
Jack_sch46D

Type	Basic Score	Vert Irreg	Plan Irreg	Pre-Code	Post-Bench	Soil C	Soil D	Soil E	RVS Score
Primary	W1	5.2	0	0	0	1.6	-0.2	0	0	6.6
Secondary		0	0	0	0	0	0	0	0	0
Tertiary		0	0	0	0	0	0	0	0	0

Final Type	Final Score
W1	6.6

Low (<1%)

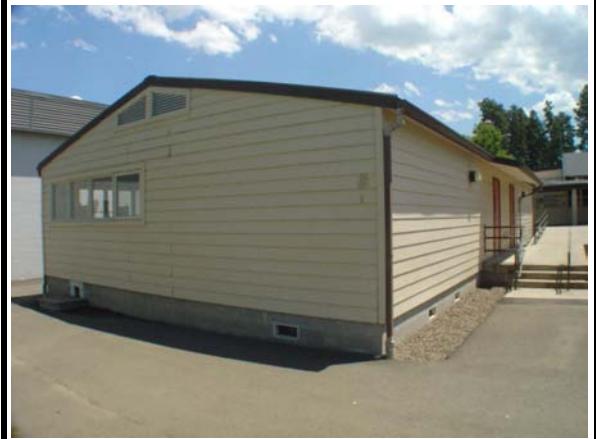
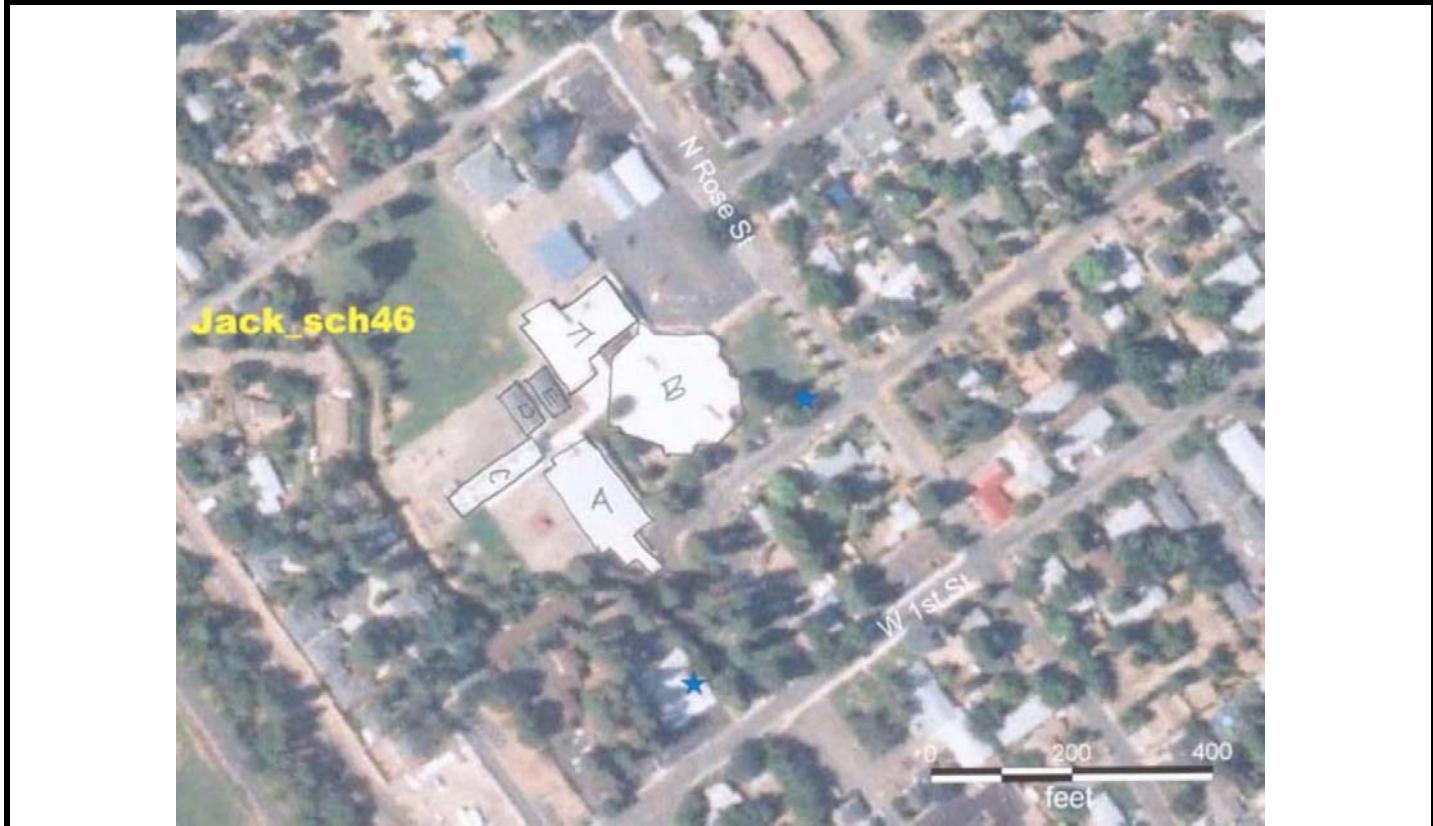
Jack_sch46E

Type	Basic Score	Vert Irreg	Plan Irreg	Pre-Code	Post-Bench	Soil C	Soil D	Soil E	RVS Score
Primary	W1	5.2	0	0	0	1.6	-0.2	0	0	6.6
Secondary		0	0	0	0	0	0	0	0	0
Tertiary		0	0	0	0	0	0	0	0	0

Final Type	Final Score
W1	6.6

Low (<1%)

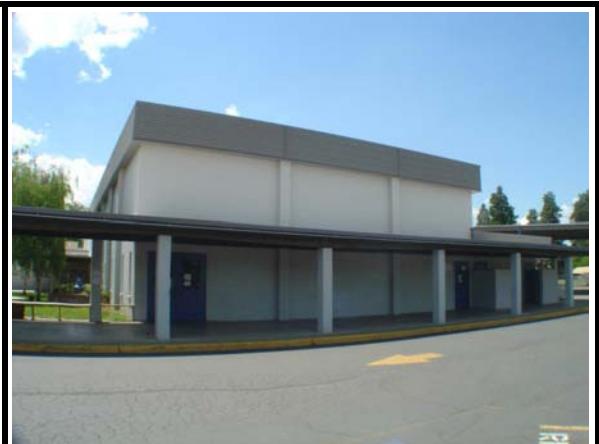
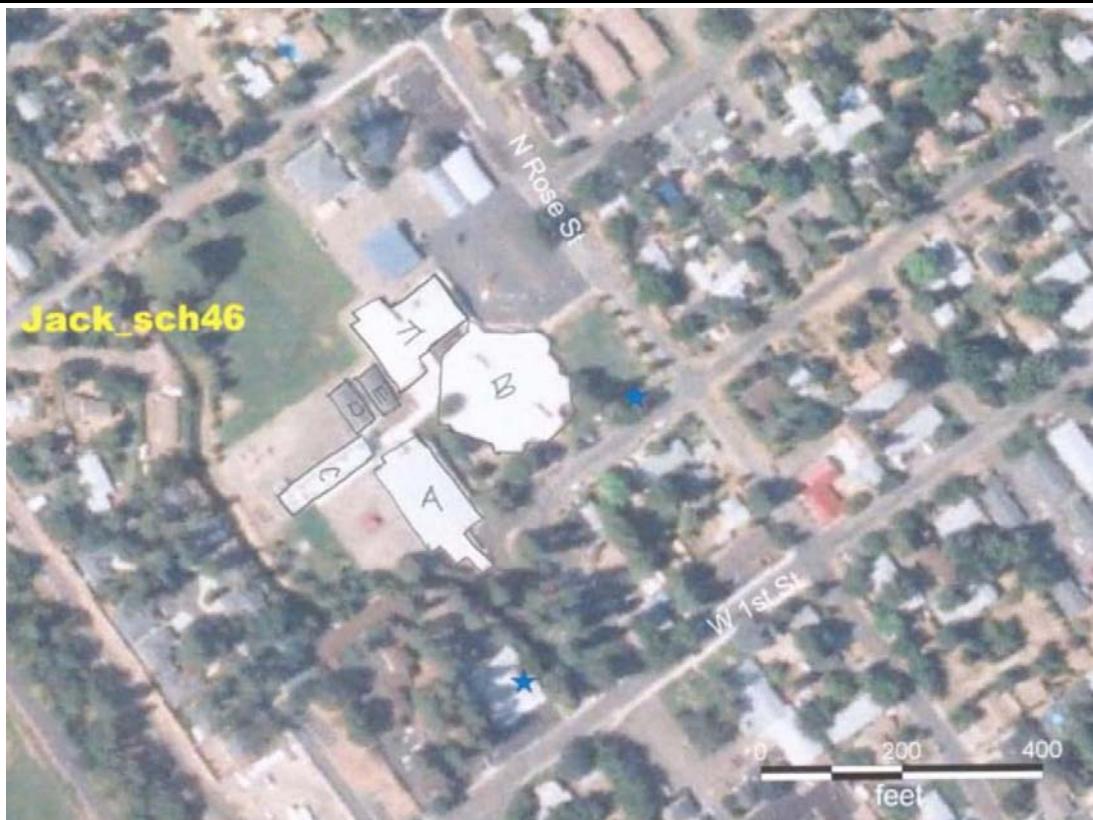
Jack_sch46F

Type	Basic Score	Vert Irreg	Plan Irreg	Pre-Code	Post-Bench	Soil C	Soil D	Soil E	RVS Score
Primary	RM1	3.6	-2	-0.5	0	0	-0.8	0	0	0.3
Secondary		0	0	0	0	0	0	0	0	0
Tertiary		0	0	0	0	0	0	0	0	0

Final Type	Final Score
RM1	0.3

High (>10%)

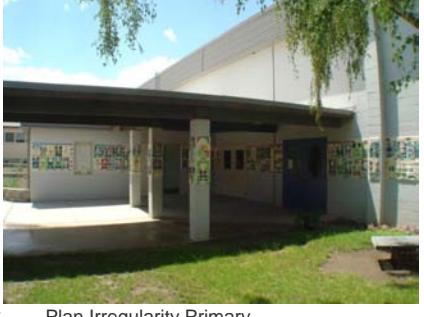
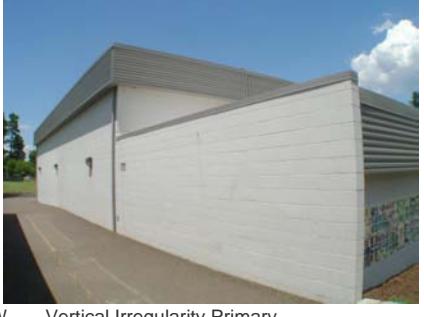
Enrollment 461	Year Built (Field Verified) 1974	Year Built (Alt. Source) 1974	Est. Decade Built 1960
Total Area (square ft) 50262	Number of Stories 1	Basement	Pounding Potential No
Plan Irregularities Reentrant Corners: L Shaped None None		Vertical Irregularities Steps in Elevation View: 2 to 3 Changes None None	
Falling Hazards None None None		Poor Conditions None None None

S	Plan Irregularity Primary	W	Vertical Irregularity Primary
