# Manzanita Elementary School

Three Rivers/Josephine County SD

## FEMA 154 Rapid Visual Screening Score Card

Rapid Visual Screening - Senate Bill #2 - Seismic Needs Assessment  
Oregon Department of Geology and Mineral Industries

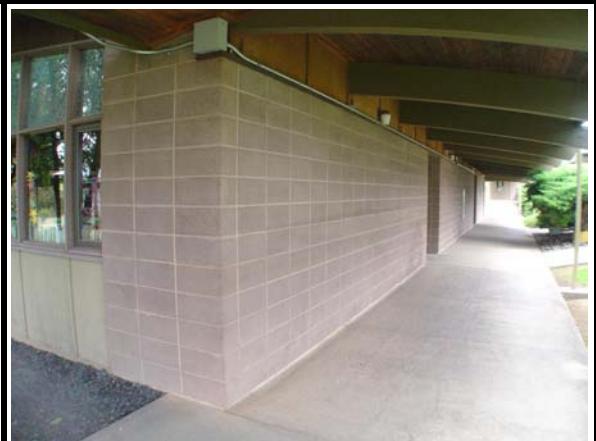
Jose\_sch14A

Type	Basic Score	Vert Irreg	Plan Irreg	Pre-Code	Post-Bench	Soil C	Soil D	Soil E	RVS Score
Primary	RM1	2.8	0	0	0	0	-0.4	0	0	2.4
Secondary		0	0	0	0	0	0	0	0	0
Tertiary		0	0	0	0	0	0	0	0	0

Final Type	Final Score
RM1	2.4

Low (<1%)

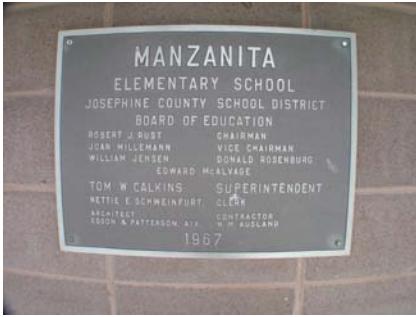
<p>MANZANITA ELEMENTARY SCHOOL JOSEPHINE COUNTY SCHOOL DISTRICT BOARD OF EDUCATION ROBERT J. RUST CHAIRMAN JOAN MUELEMANN VICE CHAIRMAN WILLIAM JENSEN DONALD ROSENBERG EDWARD McALVAGE TOM W. CALKINS SUPERINTENDENT NETTIE E. SCHWEINFURT CLERK ARCHITECT: EDDIE N. PATTERSON, AIA CONTRACTOR: W. H. AUSLAND 1967</p>			
S Field Verified Year Built

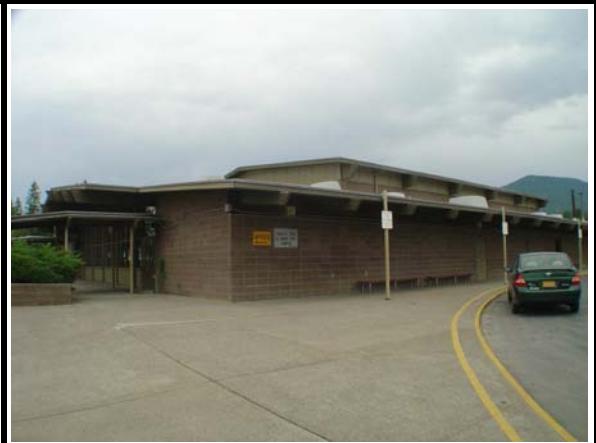
Jose\_sch14B

Type	Basic Score	Vert Irreg	Plan Irreg	Pre-Code	Post-Bench	Soil C	Soil D	Soil E	RVS Score
Primary	RM1	2.8	-1	-0.5	0	0	-0.4	0	0	0.9
Secondary		0	0	0	0	0	0	0	0	0
Tertiary		0	0	0	0	0	0	0	0	0

Final Type	Final Score
RM1	0.9

High (>10%)

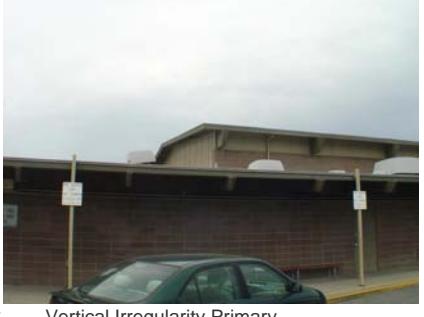
Enrollment 385	Year Built (Field Verified) 1967	Year Built (Alt. Source) 1960	Est. Decade Built 1960
Total Area (square ft) 48649	Number of Stories 1	Basement	Pounding Potential No
Plan Irregularities Reentrant Corners: Other None None		Vertical Irregularities Steps in Elevation View: Single Change None None	
Falling Hazards None None None		Poor Conditions None None None

S Vertical Irregularity Primary		SE Plan Irregularity Primary

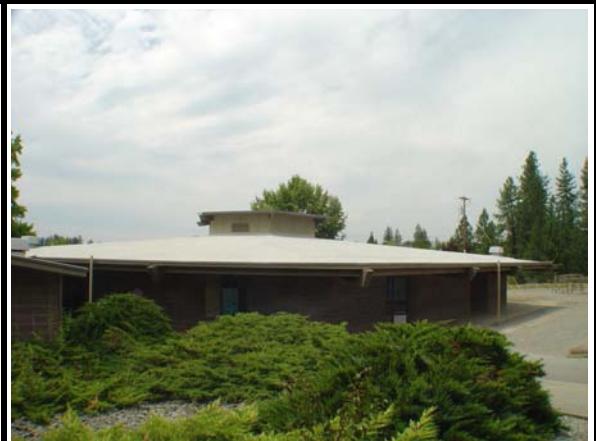
Jose\_sch14C

Type	Basic Score	Vert Irreg	Plan Irreg	Pre-Code	Post-Bench	Soil C	Soil D	Soil E	RVS Score
Primary	RM1	2.8	0	-0.5	0	0	-0.4	0	0	1.9
Secondary		0	0	0	0	0	0	0	0	0
Tertiary		0	0	0	0	0	0	0	0	0

Final Type	Final Score
RM1	1.9

Moderate (>1%)

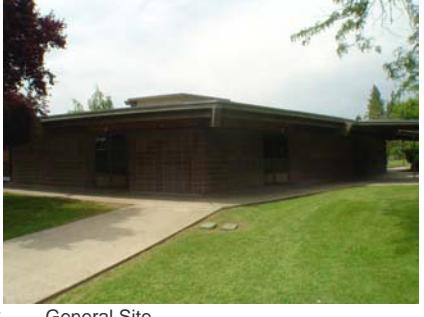
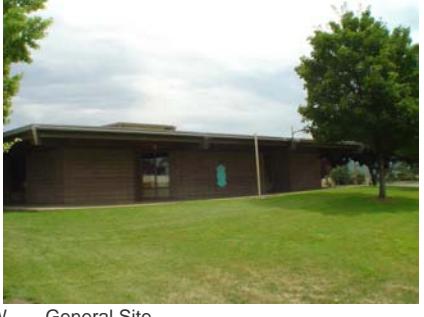
S General Site Building 2	W General Site Building 3	W Plan Irregularity Primary

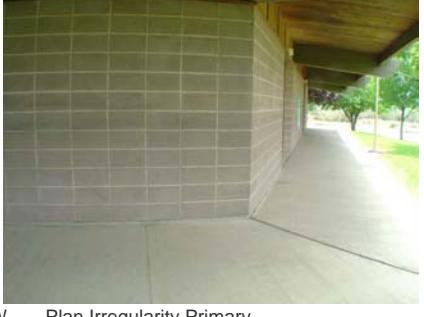
Enrollment 385	Year Built (Field Verified) 1967	Year Built (Alt. Source) 1967	Est. Decade Built 1960
Total Area (square ft) 48649	Number of Stories 1	Basement	Pounding Potential No
Plan Irregularities Non-Parallel System None None		Vertical Irregularities None None None	
Falling Hazards None None None		Poor Conditions None None None
