# Klamath County Fire District 1

Klam\_fir07A

Building Type Fire - RFPD	County Klamath	
Street 2342 Gettle St.		
City Klamath Falls	State OR	Zip 97603
Latitude 42.20586	Longitude 121.73296	
Tracking Code RVS in 2006	Inspection Date 7/21/2006

Rapid Visual Screening - Senate Bill #2 - Seismic Needs Assessment  
Oregon Department of Geology and Mineral Industries

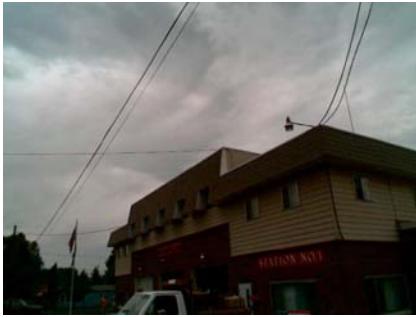
Enrollment	Year Built (Field Verified)	Year Built (Alt. Source)	Est. Decade Built
		1948	1940
Total Area (square ft)	Number of Stories	Basement	Pounding Potential
13500	2	No	No
Plan Irregularities		Vertical Irregularities	
Reentrant Corners: Other		Steps in Elevation View: Very Irregular Changes	
Torsion: Eccentric Stiffness		None	
None		None	
Falling Hazards		Poor Conditions	
None		None	
None		None	
None		None

E	Vertical Irregularity Primary	E	Plan Irregularity Primary

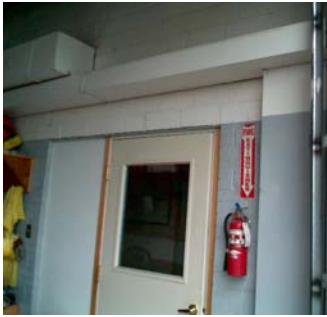
Type	Basic Score	Vert Irreg	Plan Irreg	Pre-Code	Post-Bench	Soil C	Soil D	Soil E	RVS Score
Primary	URM	1.8	-1	-0.5	0	0	0	-0.6	0	-0.3
Secondary	RM1	2.8	-1	-0.5	-1	0	0	-0.6	0	-0.3
Tertiary	S3	3.2	0	-0.5	0	0	0	-0.6	0	2.1

E	Primary Structural Type

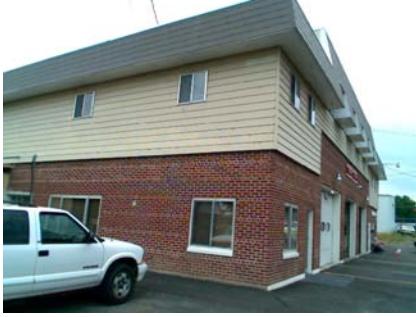
SE	Elevation View	SW	Plan Irregularity Primary
