# Lakeview Fire Dept

Lake\_fir02A

## FEMA 154 Rapid Visual Screening Score Card

Rapid Visual Screening - Senate Bill #2 - Seismic Needs Assessment  
 Oregon Department of Geology and Mineral Industries

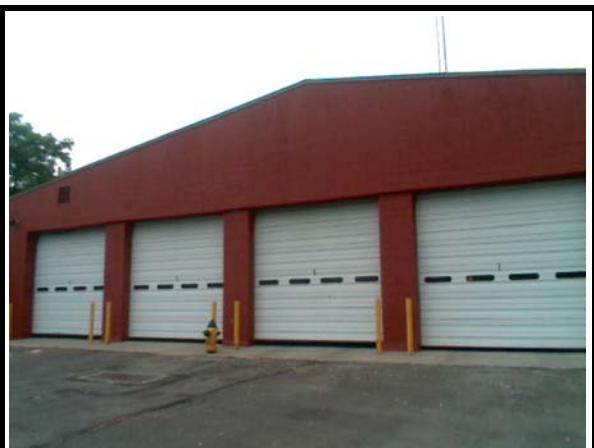
Seismicity Zone: Moderate

Type	Basic Score	Vert Irreg	Plan Irreg	Pre-Code	Post-Bench	Soil C	Soil D	Soil E	RVS Score
Primary	RM1	3.6	-2	-0.5	0	0	0	-1.2	0	-0.1
Secondary		0	0	0	0	0	0	0	0	0
Tertiary		0	0	0	0	0	0	0	0	0

Final Type	Final Score
RM1	-0.1

Very High (100%)

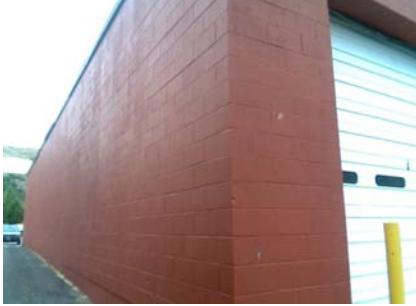
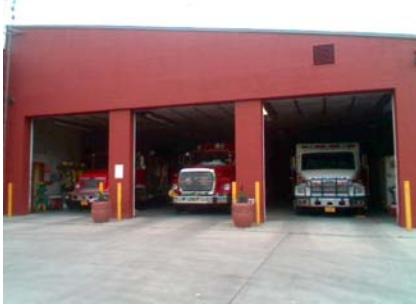
N	Primary Structural Type	E	Plan Irregularity Primary

Enrollment	Year Built (Field Verified)	Year Built (Alt. Source)	Est. Decade Built
	1984	1984	1980
Total Area (square ft)	Number of Stories	Basement	Pounding Potential
	1	No	Yes
Plan Irregularities		Vertical Irregularities	
Lateral-Force-Resistance in One Direction Only		Steps in Elevation View: Single Change (Adjacent Building/Entity)	
Reentrant Corners: L Shaped (Adjacent Build/Entity)		None	
None		None	
Falling Hazards		Poor Conditions	
None		None	
None		None	
None		None
