Silver Lake RFPD

Building Type		County	
Fire - RFPD		Lake	
Street			
53224 4th Street			
City	State	Zip	
Silver Lake	OR	97638	
Latitude		Longitude	
43.12553		121.04771	
Tracking Code		Inspection Date	
RVS in 2006		7/7/2006

FEMA 154 Rapid Visual Screening Score Card

Rapid Visual Screening - Senate Bill #2 - Seismic Needs Assessment
Oregon Department of Geology and Mineral Industries

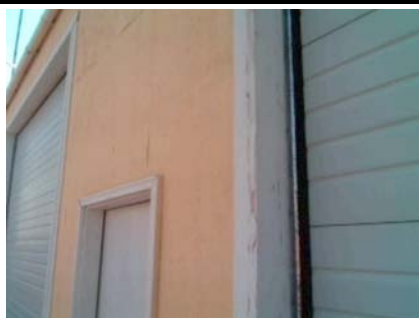
N Primary Structural Type

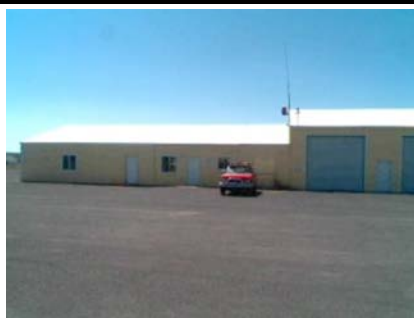
Plan Irregularities	Vertical Irregularities
<input type="text" value="None"/>	<input type="text" value="Steps in Elevation View: Single Change"/>
<input type="text" value="None"/>	<input type="text" value="None"/>
<input type="text" value="None"/>	<input type="text" value="None"/>

N Elevation View
