Physical Ed. Complex - Bldg "N"

FEMA 154 Rapid Visual Screening Score Card

Rapid Visual Screening - Senate Bill #2 - Seismic Needs Assessment
Oregon Department of Geology and Mineral Industries

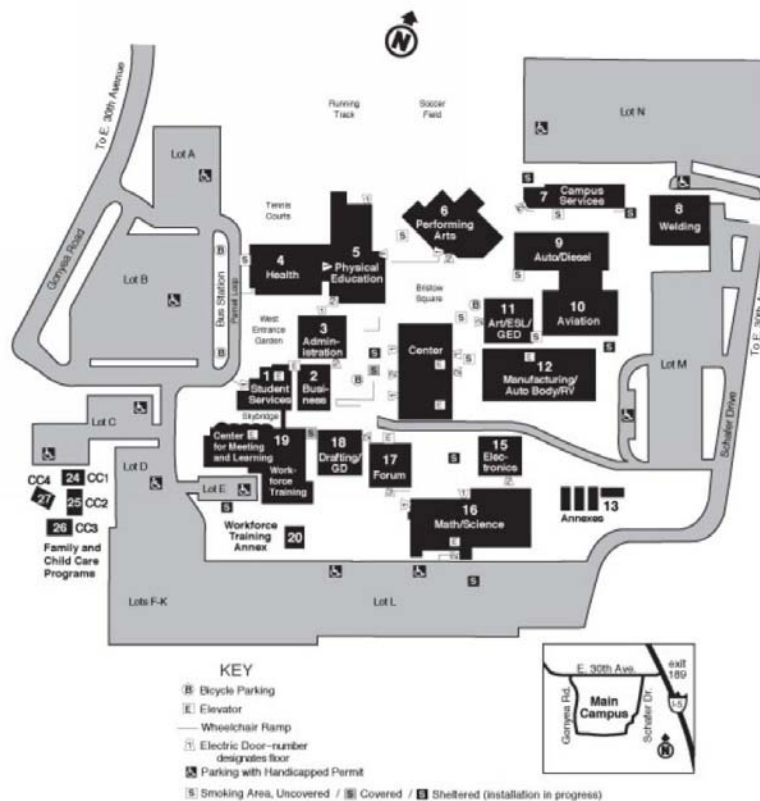
Type	Basic Score	Vert Irreg	Plan Irreg	Pre-Code	Post-Bench	Soil C	Soil D	Soil E	RVS Score
Primary	RM1	2.8	-1	-0.5	0	0	0	0	0	1.3
Secondary	C2	2.8	-1	-0.5	0	0	0	0	0	1.3
Tertiary		0	0	0	0	0	0	0	0	0

1.3

Moderate (>1%)

Plan Irregularities	Vertical Irregularities
Yes: Unknown	Yes: Unknown

Falling Hazards	Poor Conditions
Other: Light Cladding	
None	
None
