# Lane County Fire District 1

Lane\_fir11A

## FEMA 154 Rapid Visual Screening Score Card

Rapid Visual Screening - Senate Bill #2 - Seismic Needs Assessment  
Oregon Department of Geology and Mineral Industries

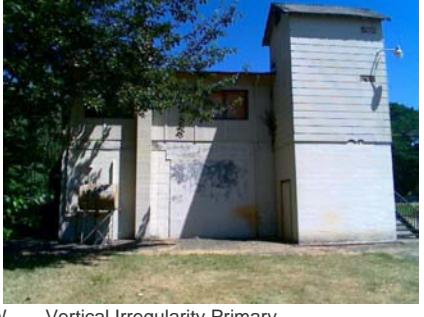
W    Vertical Irregularity Primary also shows a plan irregularity, and a solid back wall indicating a possible torsion problem.		NE    Other stairwell to the 2nd floor.
