Oakridge Fire Department

Lane_fir15A

FEMA 154 Rapid Visual Screening Score Card

Rapid Visual Screening - Senate Bill #2 - Seismic Needs Assessment
Oregon Department of Geology and Mineral Industries

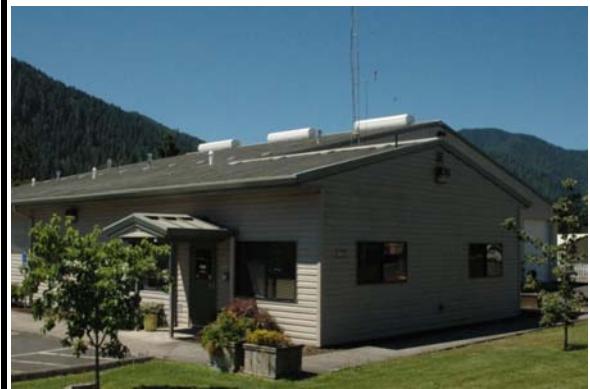
Type	Basic Score	Vert Irreg	Plan Irreg	Pre-Code	Post-Bench	Soil C	Soil D	Soil E	RVS Score
Primary	W2	4.8	-3	-0.5	0	1.6	-0.8	0	0	2.1
Secondary		0	0	0	0	0	0	0	0	0
Tertiary		0	0	0	0	0	0	0	0	0

Low (<1%)

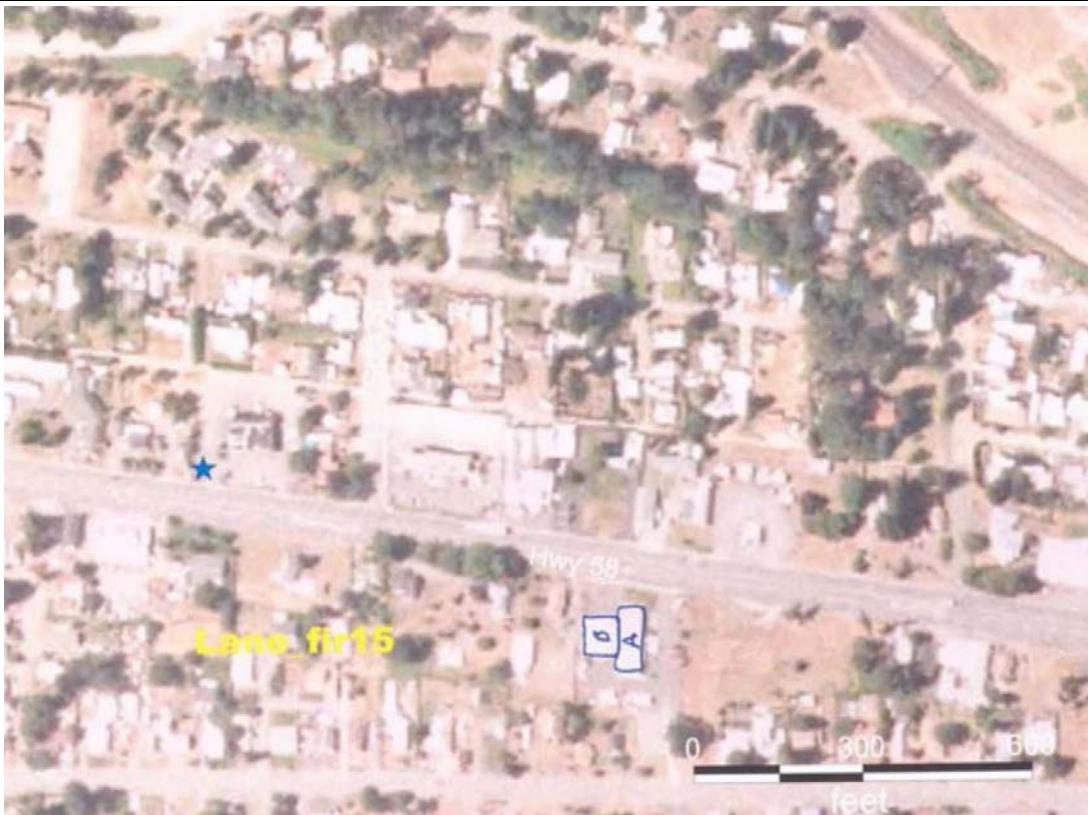
Final Type	Final Score
W2	2.1

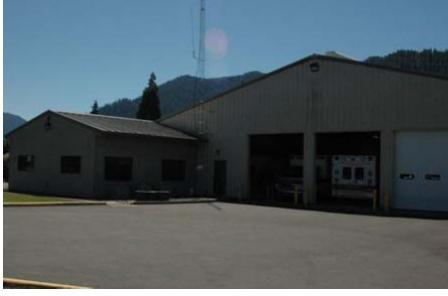
Enrollment	Year Built (Field Verified)	Year Built (Alt. Source)	Est. Decade Built
			1990
Total Area (square ft)	Number of Stories	Basement	Pounding Potential
	1	No	No
Plan Irregularities		Vertical Irregularities	
Reentrant Corners:T shaped (Adjacent Build/Entity)		Steps in Elevation View: Single Change (Adjacent Building/Entity)	
None		None	
None		None	
Falling Hazards		Poor Conditions	
None		None	
None		None	
None		None

NW Plan Irregularity Primary		SW Vertical Irregularity Primary

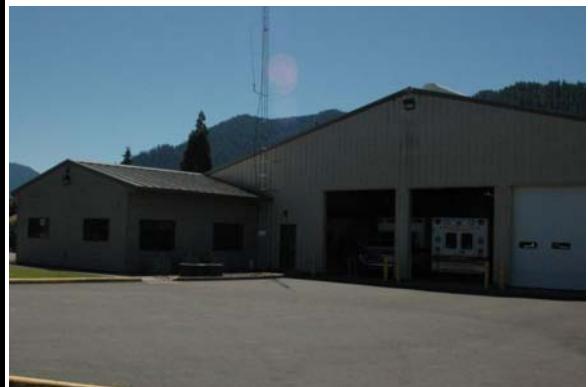
Type	Basic Score	Vert Irreg	Plan Irreg	Pre-Code	Post-Bench	Soil C	Soil D	Soil E	RVS Score
Primary	S3	3.8	0	-0.5	0	0	-0.6	0	0	2.7
Secondary		0	0	0	0	0	0	0	0	0
Tertiary		0	0	0	0	0	0	0	0	0

Low (<1%)

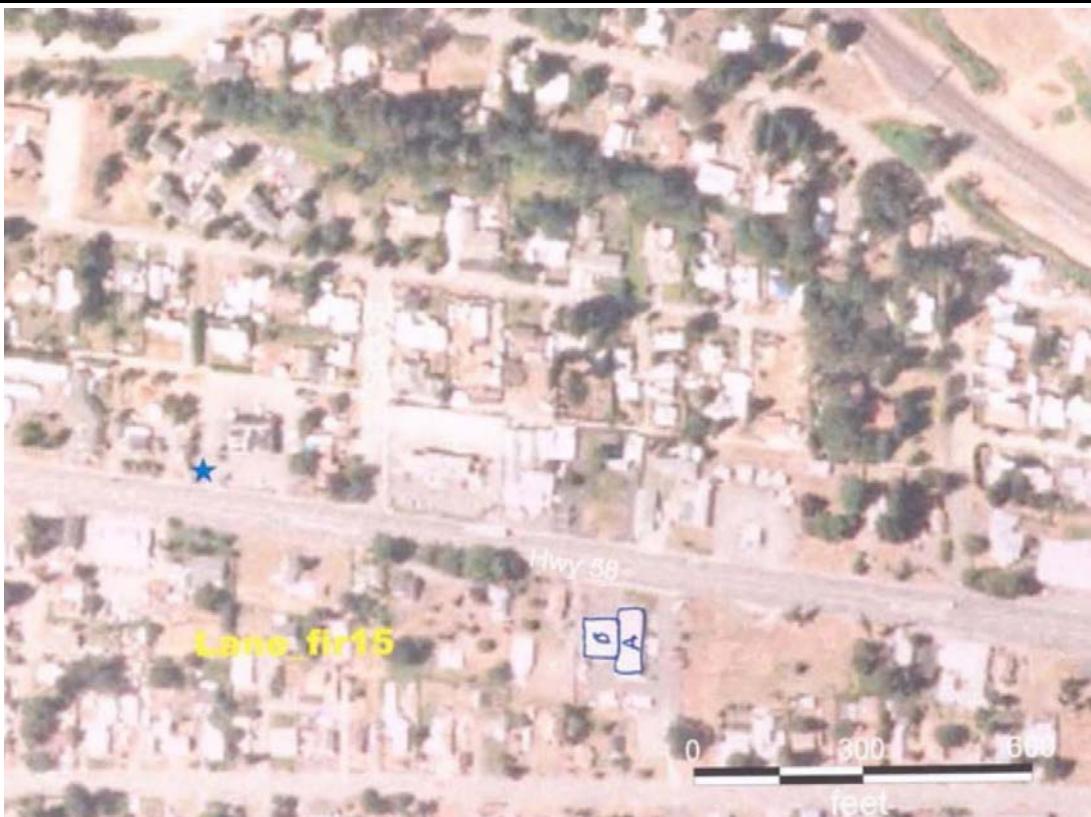
Final Type	Final Score
S3	2.7

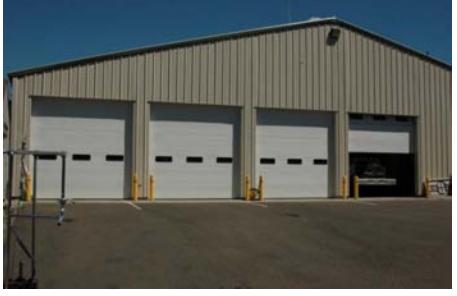
S	Primary Structural Type	SW	Vertical Irregularity Primary

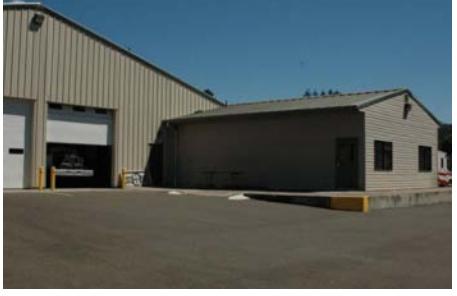
Enrollment	Year Built (Field Verified)	Year Built (Alt. Source)	Est. Decade Built
			1990
Total Area (square ft)	Number of Stories	Basement	Pounding Potential
	1	No	No
Plan Irregularities		Vertical Irregularities	
Reentrant Corners:T shaped (Adjacent Build/Entity)		Steps in Elevation View: Single Change (Adjacent Building/Entity)	
None		None	
None		None	
Falling Hazards		Poor Conditions	
None		None	
None		None	
None		None
