Lane Rural Fire Rescue

Lane_fir17A

FEMA 154 Rapid Visual Screening Score Card

Rapid Visual Screening - Senate Bill #2 - Seismic Needs Assessment
Oregon Department of Geology and Mineral Industries

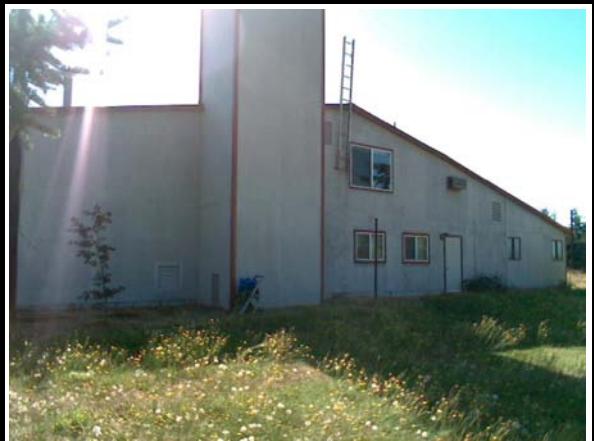
Type	Basic Score	Vert Irreg	Plan Irreg	Pre-Code	Post-Bench	Soil C	Soil D	Soil E	RVS Score
Primary	W1	4.4	-2.5	0	0	0	0	0	0	1.9
Secondary		0	0	0	0	0	0	0	0	0
Tertiary		0	0	0	0	0	0	0	0	0

Moderate (>1%)

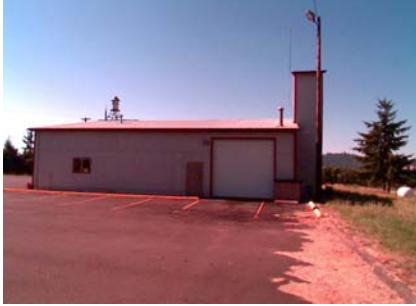
N Vertical Irregularity Primary Irregularity is due to hose tower		NE Plan Irregularity Secondary Large opening in the front of the building indicates possible torsion problem

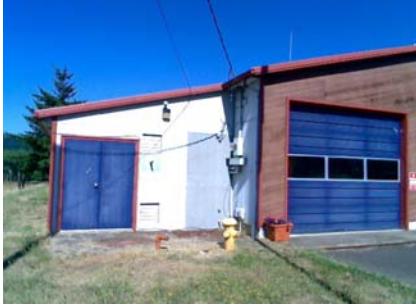
E Plan Irregularity Primary out of plane lateral system
