# Dexter RFPD

Building Type		County	
Fire - RFPD		Lane	
Street			
82781 Barbre Rd			
City	State	Zip	
Dexter	OR	97431	
Latitude		Longitude	
43.91467		122.82181	
Tracking Code		Inspection Date	
RVS in 2006		7/20/2006

## FEMA 154 Rapid Visual Screening Score Card

Rapid Visual Screening - Senate Bill #2 - Seismic Needs Assessment  
Oregon Department of Geology and Mineral Industries

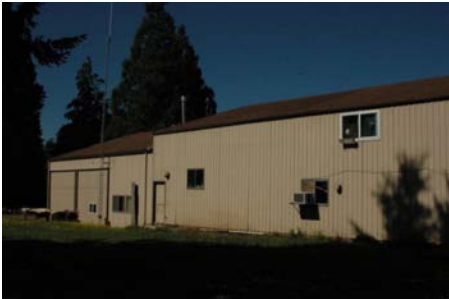
E General Site

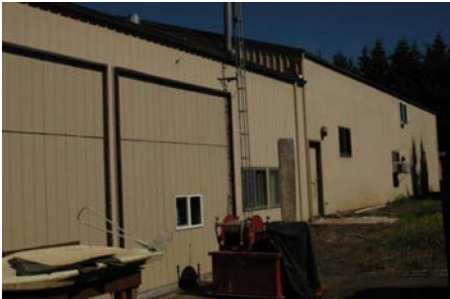
Plan Irregularities	Vertical Irregularities
Reentrant Corners: Other	Steps in Elevation View: Single Change
Torsion: Eccentric Stiffness	None
None	None

E Vertical Irregularity Primary

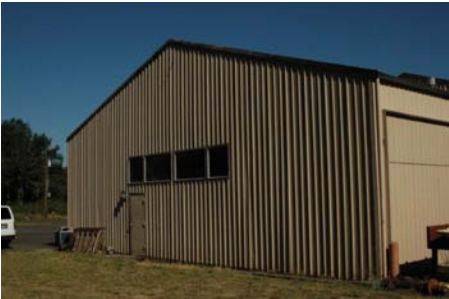
Type	Basic Score	Vert Irreg	Plan Irreg	Pre-Code	Post-Bench	Soil C	Soil D	Soil E	RVS Score
Primary	S3	3.8	0	-0.5	0	0	-0.6	0	0	2.7
Secondary		0	0	0	0	0	0	0	0	0
Tertiary		0	0	0	0	0	0	0	0	0

S Primary Structural Type
