Mohawk Valley RFD

Building Type		County	
Fire - RFPD		Lane	
Street			
89672 Hill Rd			
City		State	Zip
Springfield		OR	97478
Latitude		Longitude	
44.101		122.95807	
Tracking Code		Inspection Date	
RVS in 2006		7/20/2006

FEMA 154 Rapid Visual Screening Score Card

Rapid Visual Screening - Senate Bill #2 - Seismic Needs Assessment
Oregon Department of Geology and Mineral Industries

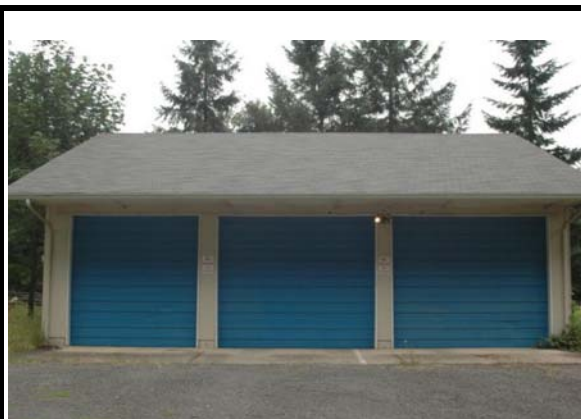
Seismicity Zone: Moderate

Type	Basic Score	Vert Irreg	Plan Irreg	Pre-Code	Post-Bench	Soil C	Soil D	Soil E	RVS Score
Primary	W1	5.2	0	-0.5	0	1.6	0	0	0	6.3
Secondary		0	0	0	0	0	0	0	0	0
Tertiary		0	0	0	0	0	0	0	0	0

Enrollment	Year Built (Field Verified)	Year Built (Alt. Source)	Est. Decade Built
			1980
Total Area (square ft)	Number of Stories	Basement	Pounding Potential
	1	No	No

Plan Irregularities	Vertical Irregularities
Torsion: Eccentric Stiffness	None
None	None
None	None

Falling Hazards	Poor Conditions
None	None
None	None
None	None
