Lane County Fire District 1

Lane_fir76A

FEMA 154 Rapid Visual Screening Score Card

Rapid Visual Screening - Senate Bill #2 - Seismic Needs Assessment
Oregon Department of Geology and Mineral Industries

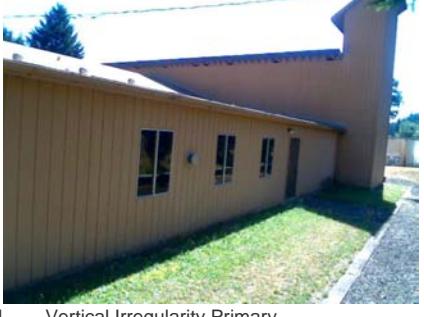
N Vertical Irregularity Primary Also shows out of plane lateral system.		NE Primary Structural Type The east wall of fir76 is sheathed with metal sheathing (S3).
