# Creswell Sheriff's Office

Lane\_pol04A

## FEMA 154 Rapid Visual Screening Score Card

Rapid Visual Screening - Senate Bill #2 - Seismic Needs Assessment  
Oregon Department of Geology and Mineral Industries

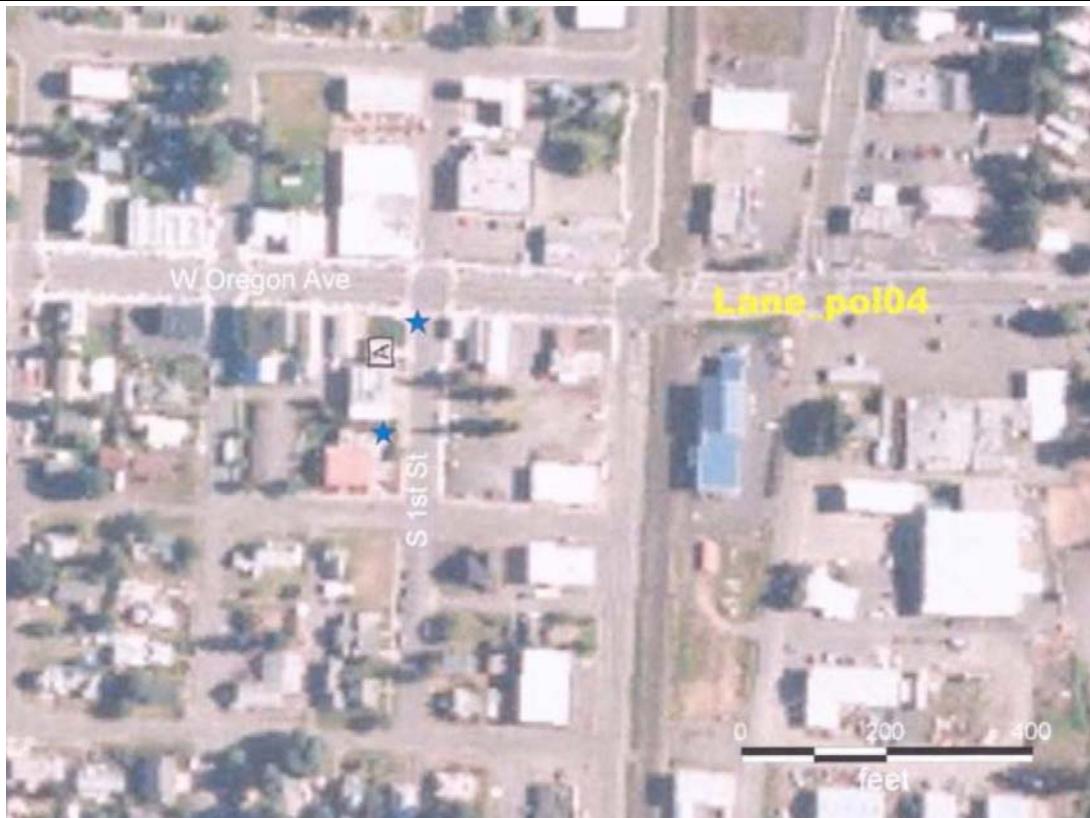
N	General Site	NE Vertical Irregularity Primary vertical irregularity is due to the fire station on the left side of the picture. Lane_pol04 is in the city hall building on the right side of the pic
